THE FAILURE AND RIGHTING OF THE TRANSCONA GRAIN ELEVATOR

THE FAILURE OF THE TRANSCONA GRAIN ELEVATOR

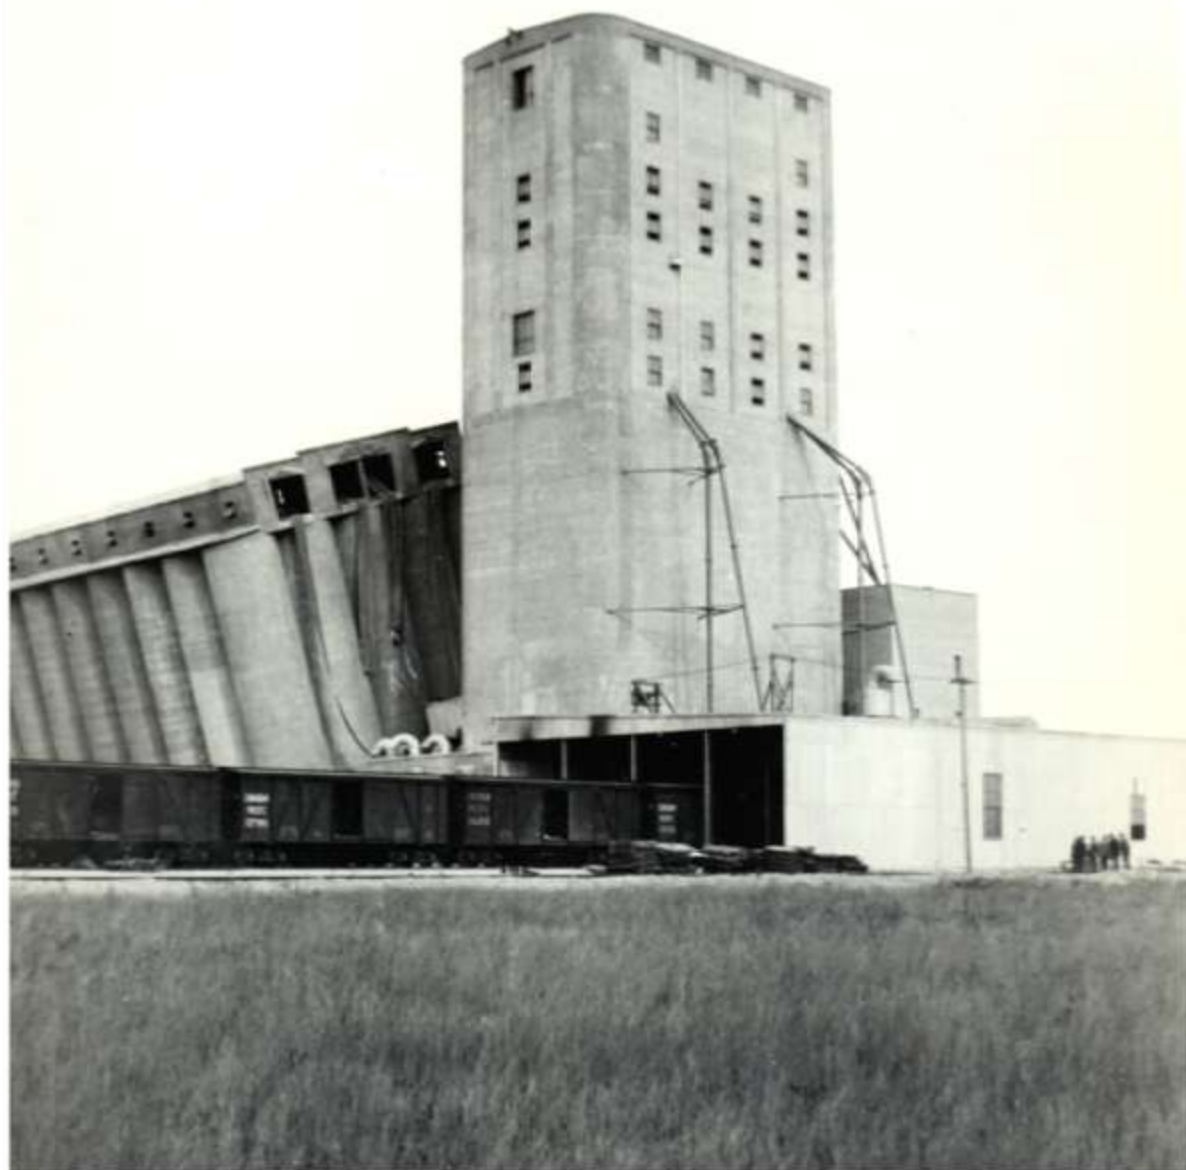
Elevator During Failure – Note Conveyor Belts and Cupola Still Attached

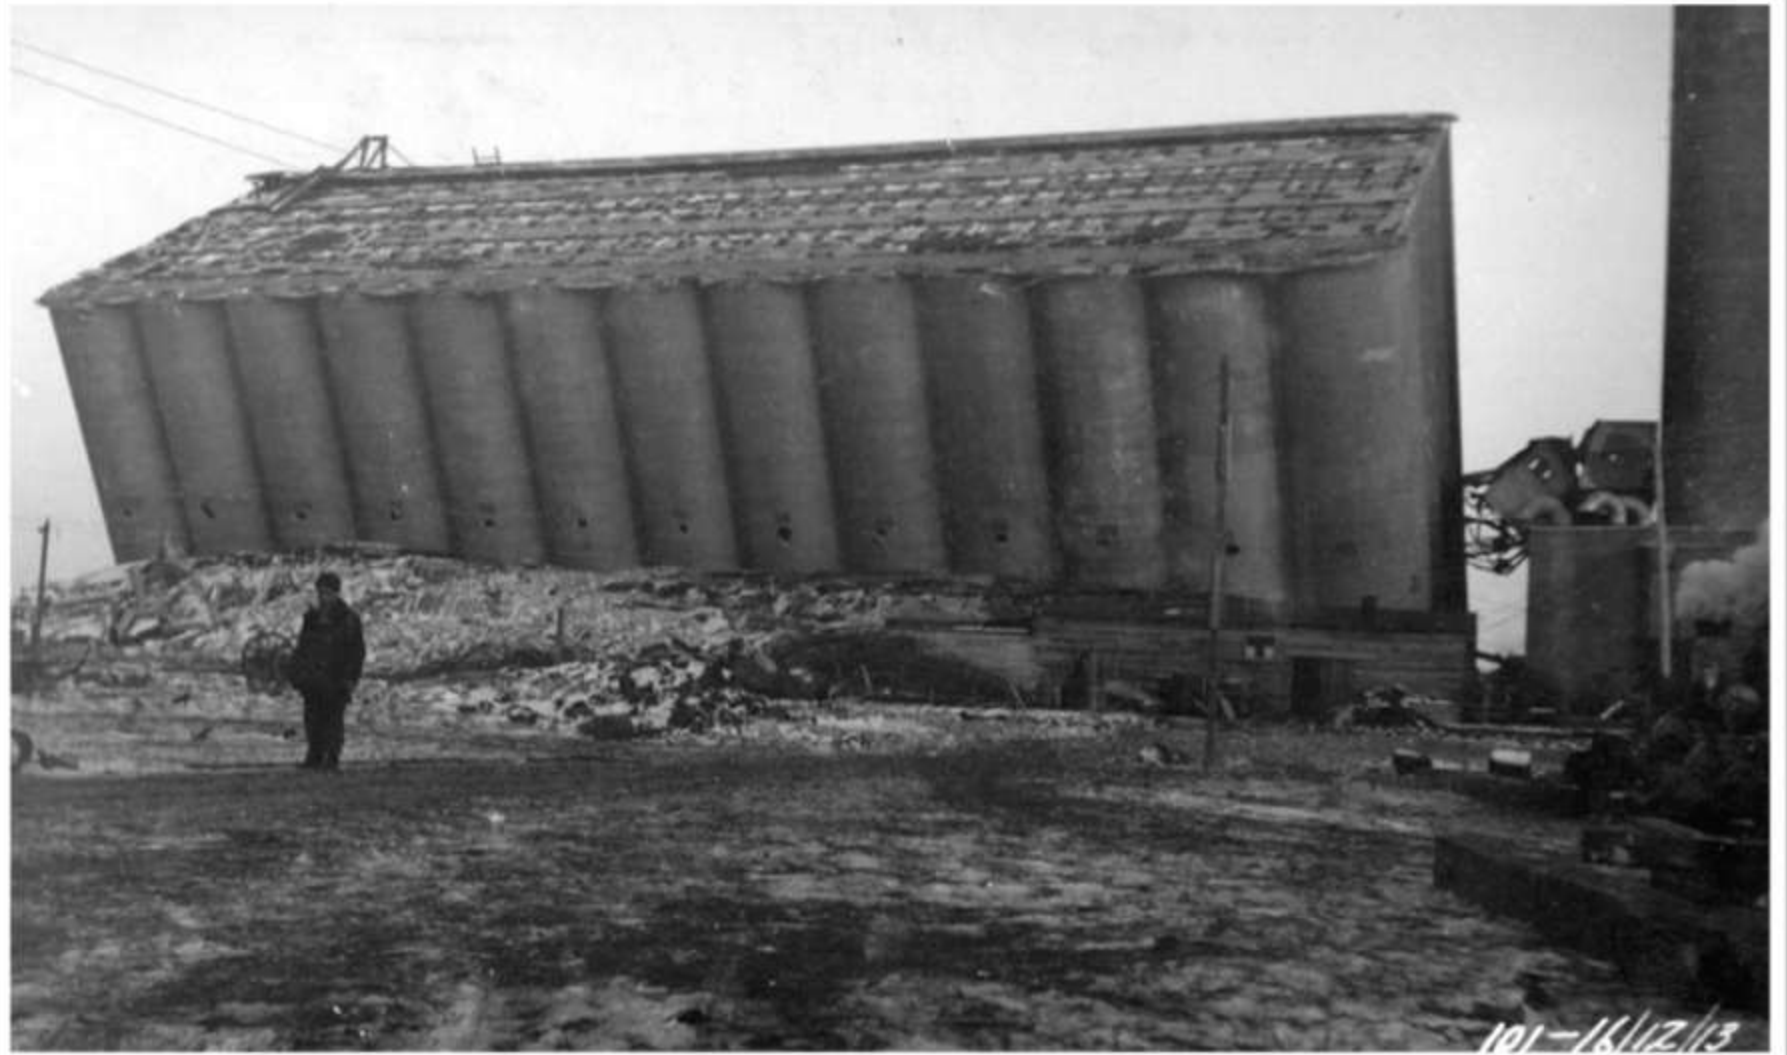
View of Bins Looking East – Note Cupola Detached

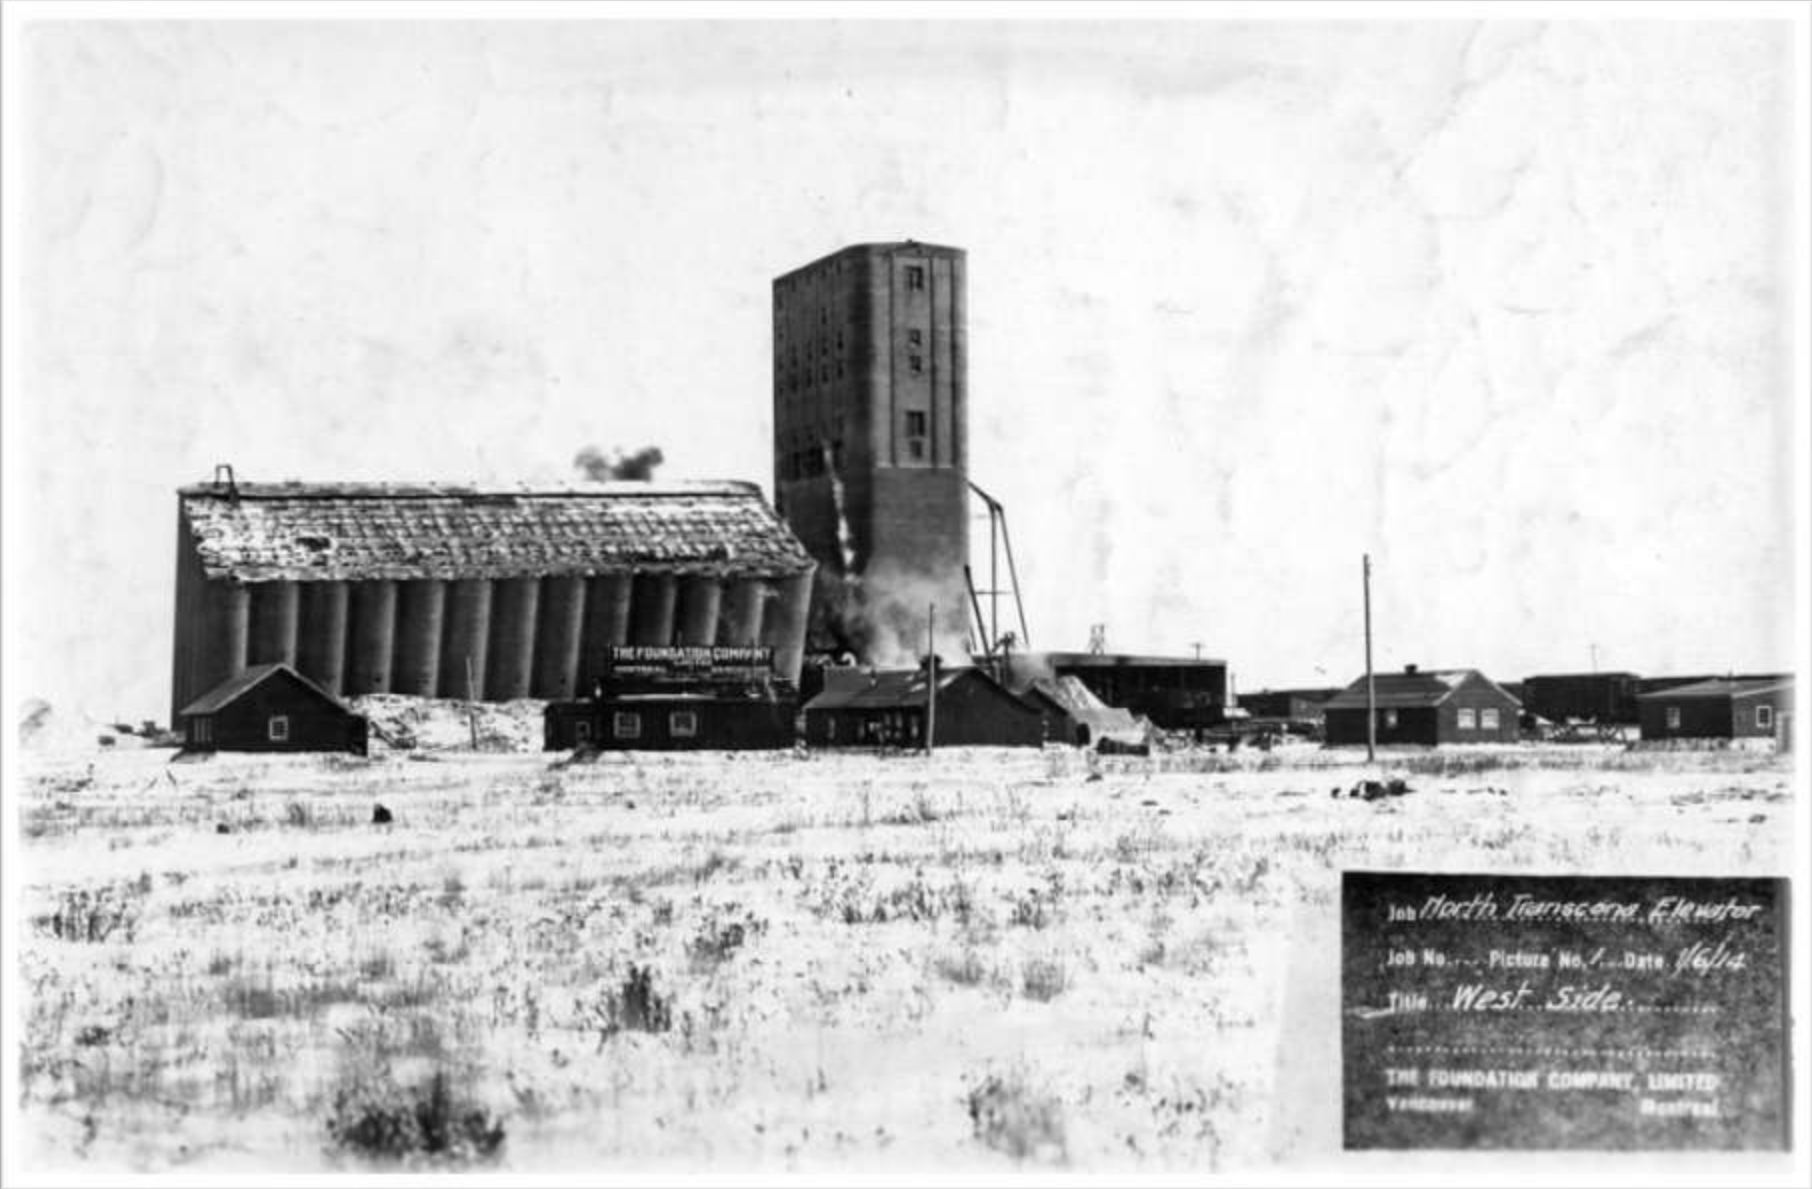
West Side of Elevator After Failure

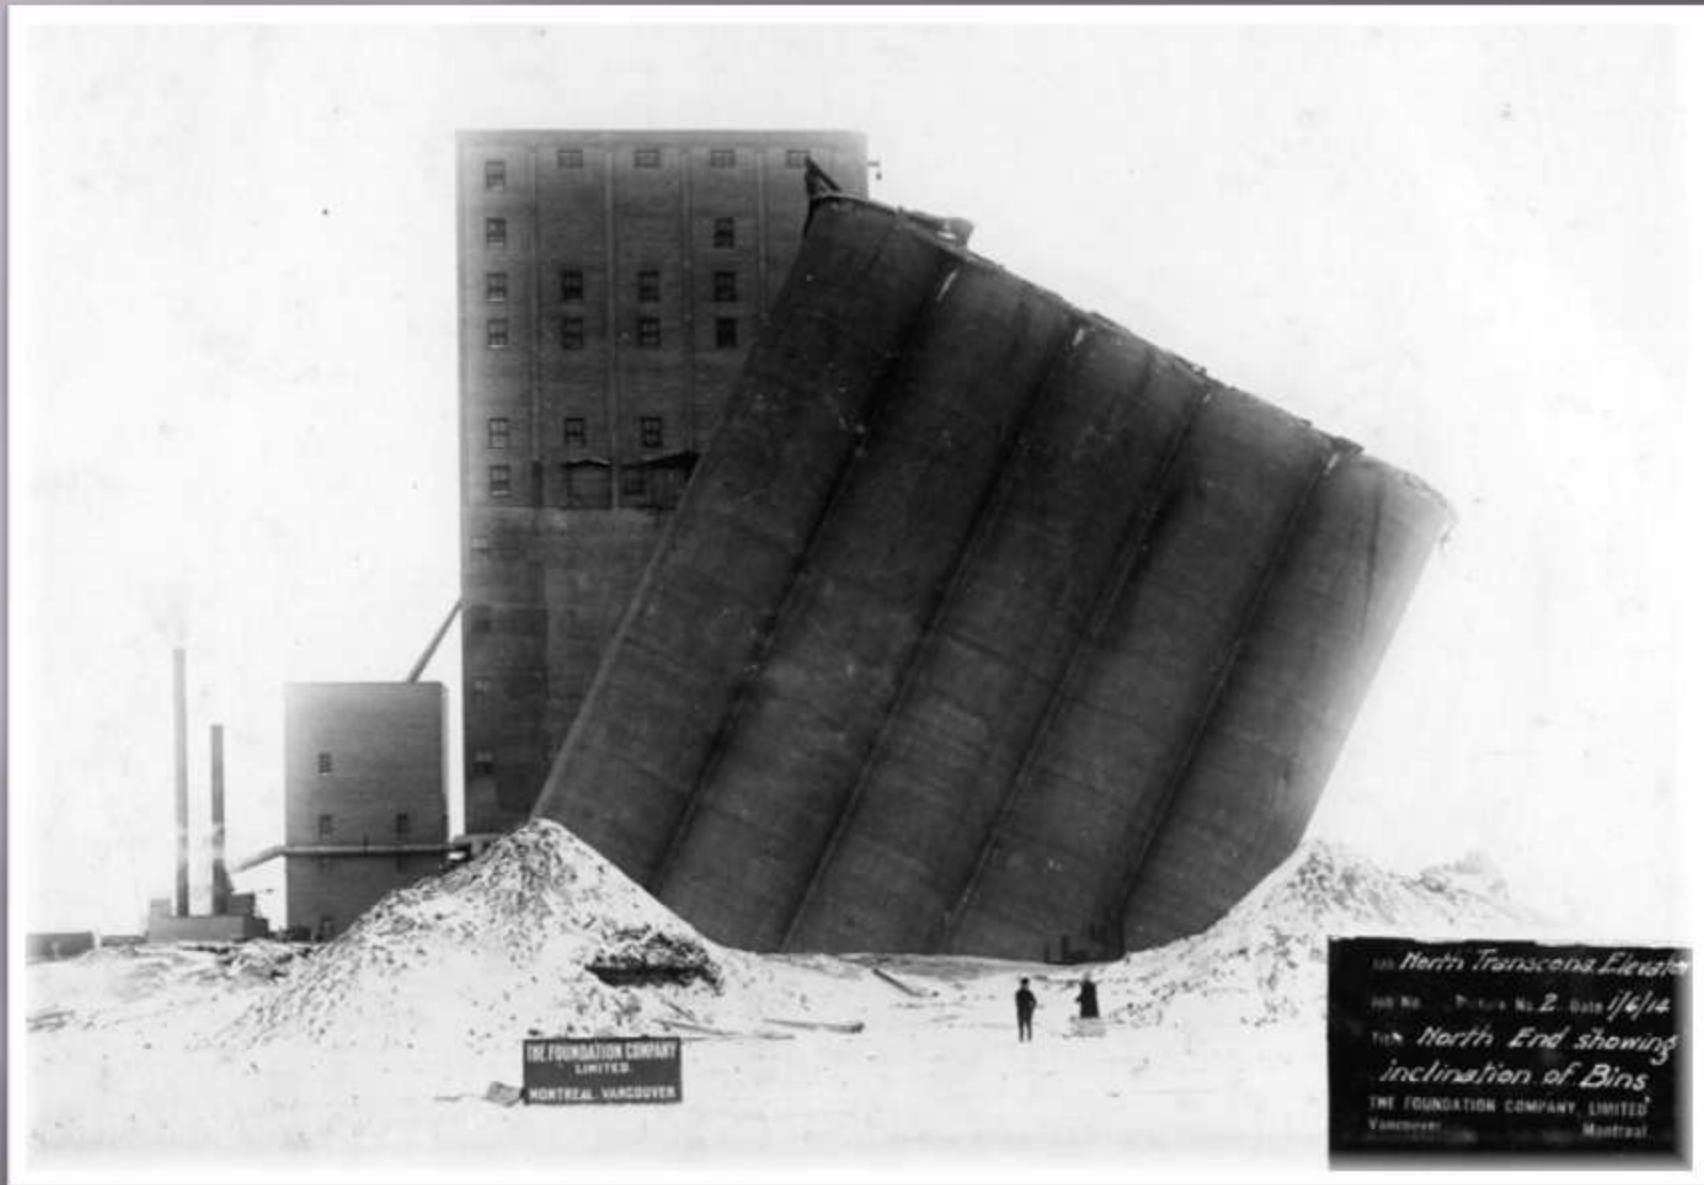
N End Showing Inclination of Bins – Note Heaved Earth

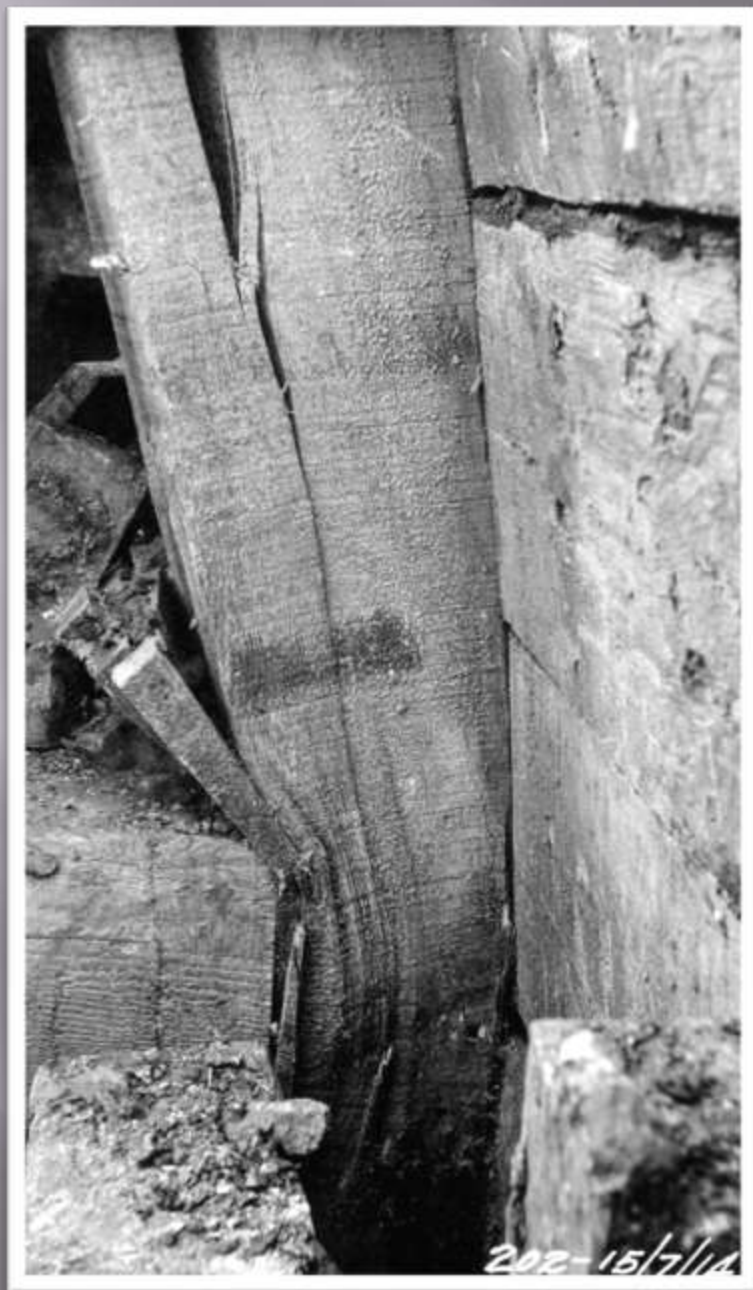
Failure of BC Fir Foot
Block of Kicking
Brace

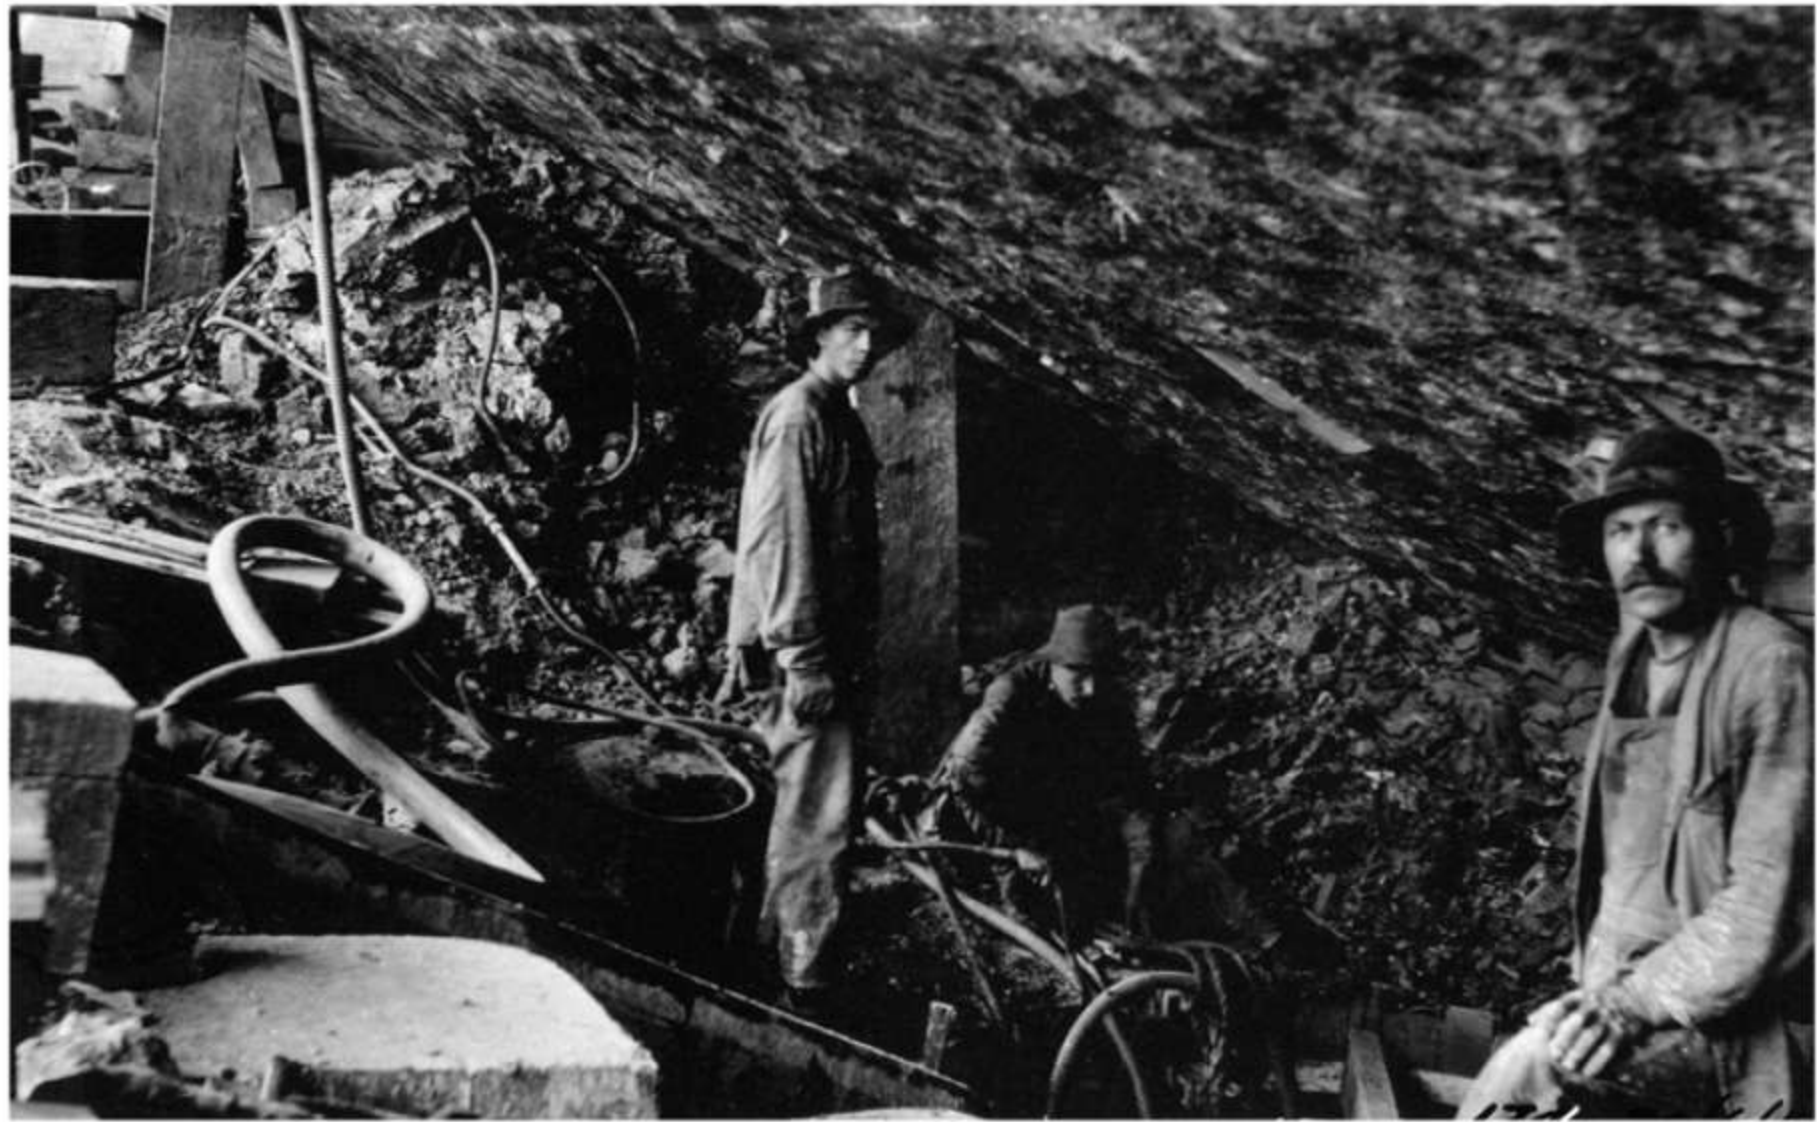
Earth Under Bins Failing

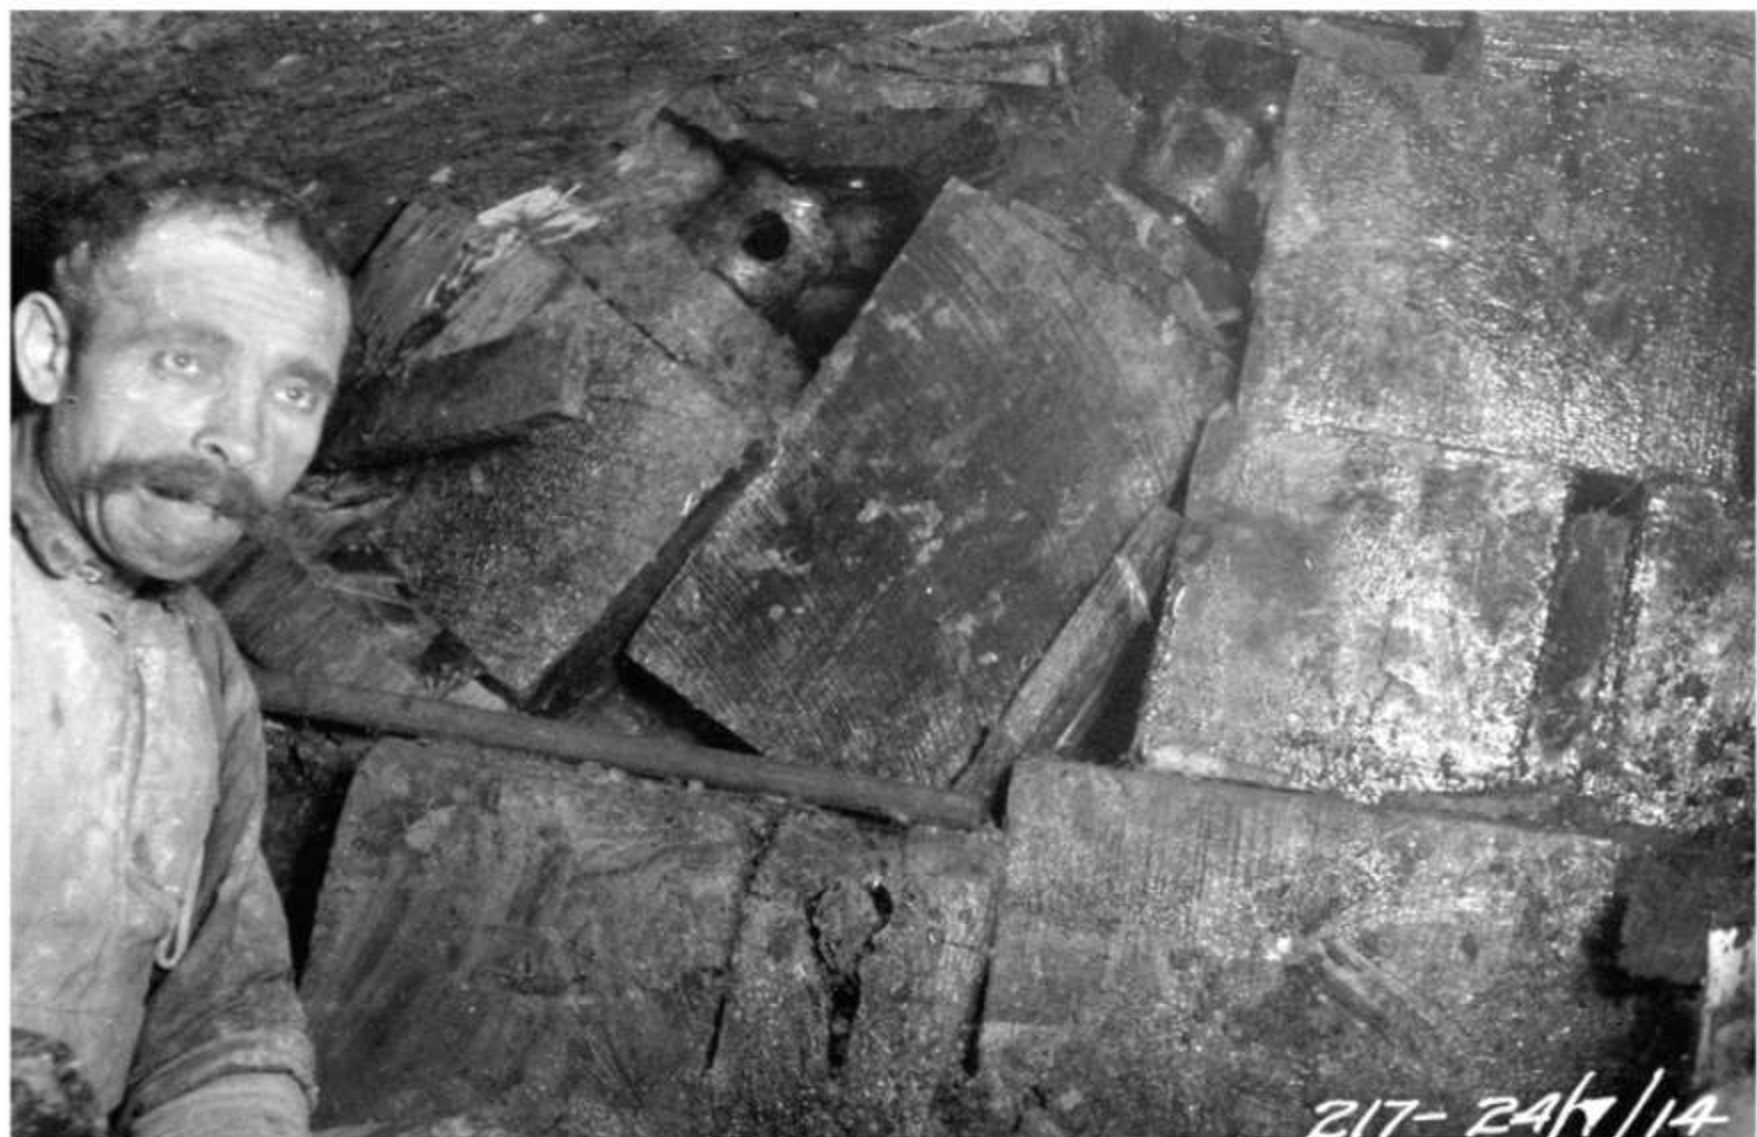
Crib Leaning on "K" Pier Due to Eastward
Movement of 2.5 Feet

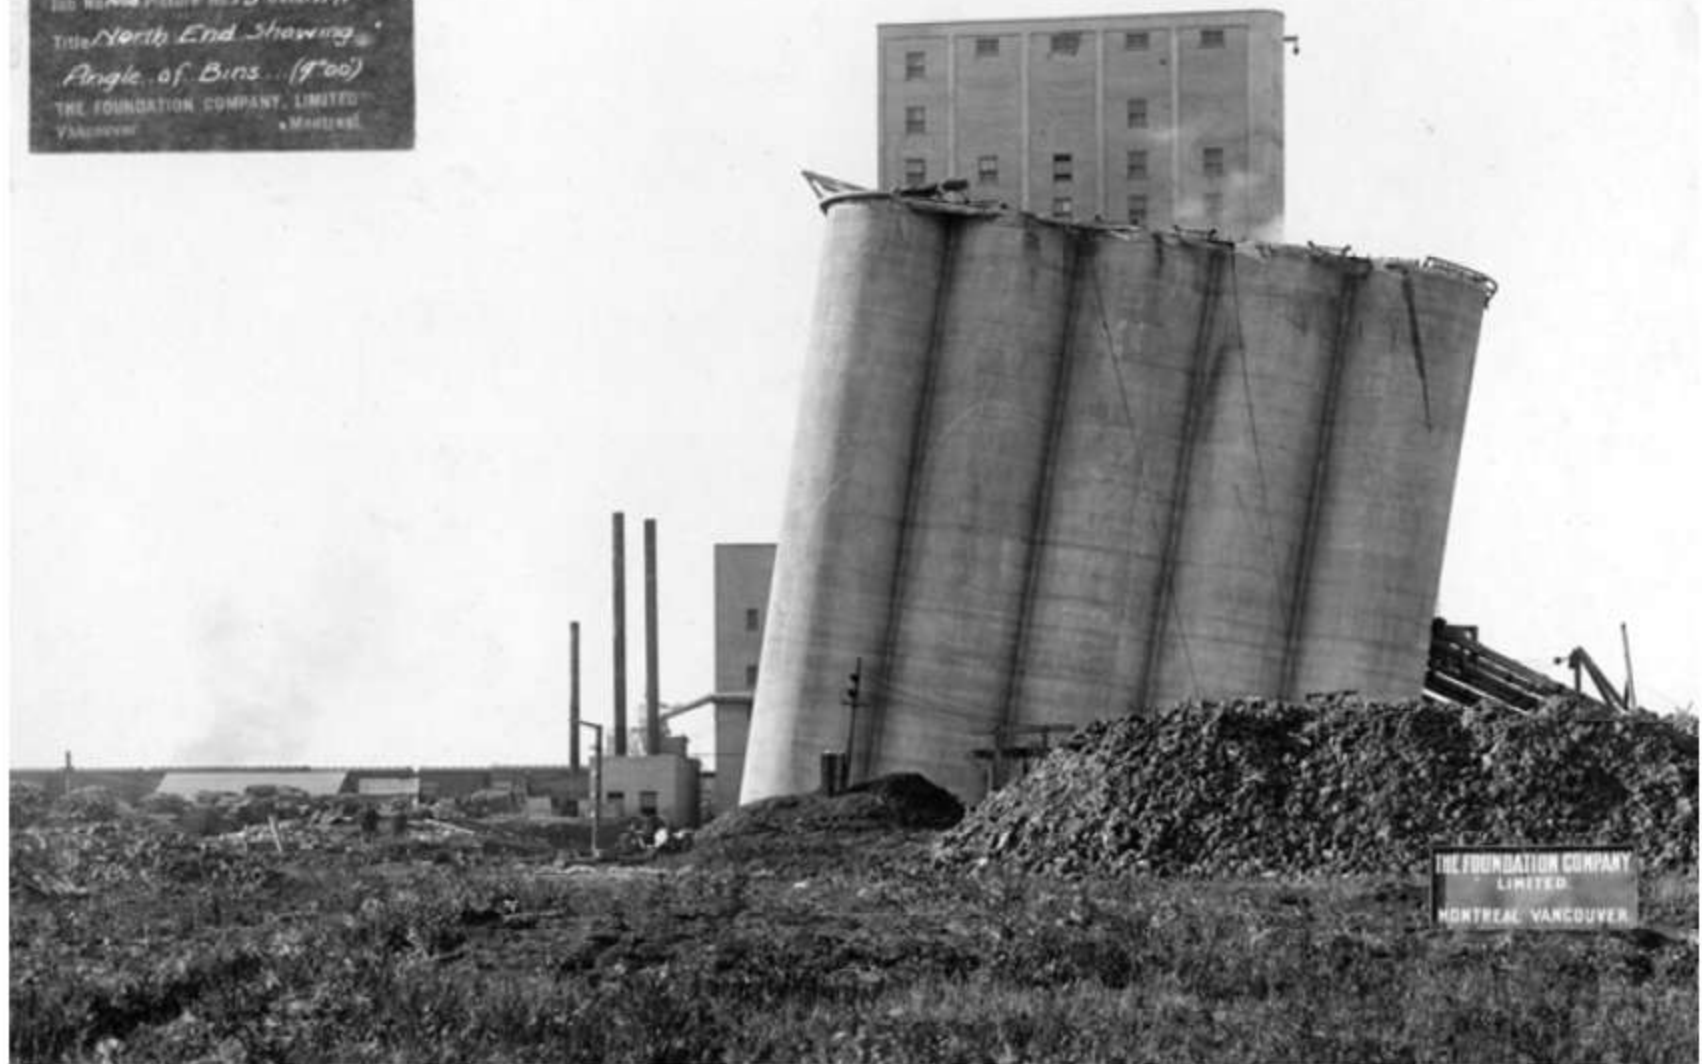
N End Showing Angle of Bins (9 deg)

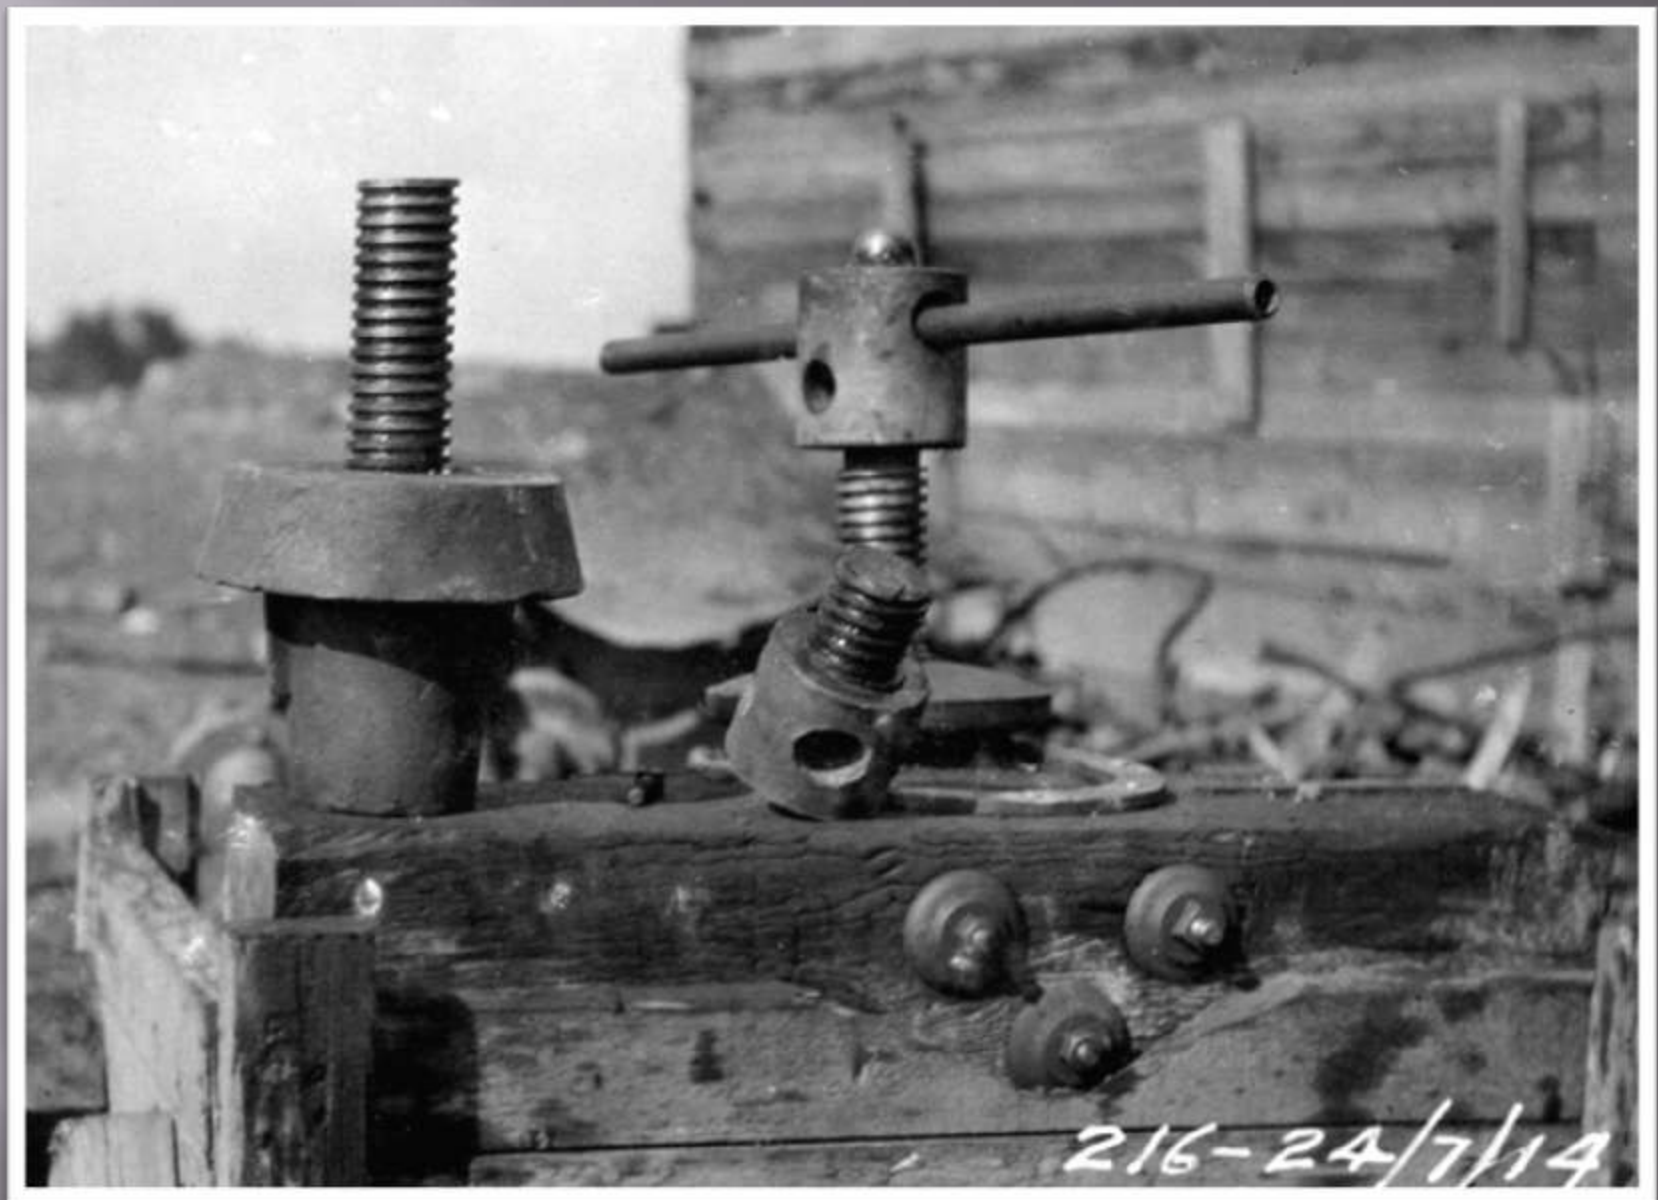
Broken Screw From "G" Row
