62nd Canadian Geotechnical Conference, Halifax September 2009

“Lessons Learned” or “Projects Gone Wild”

Two lessons learned from the construction of the Mactaquac Dam in New Brunswick

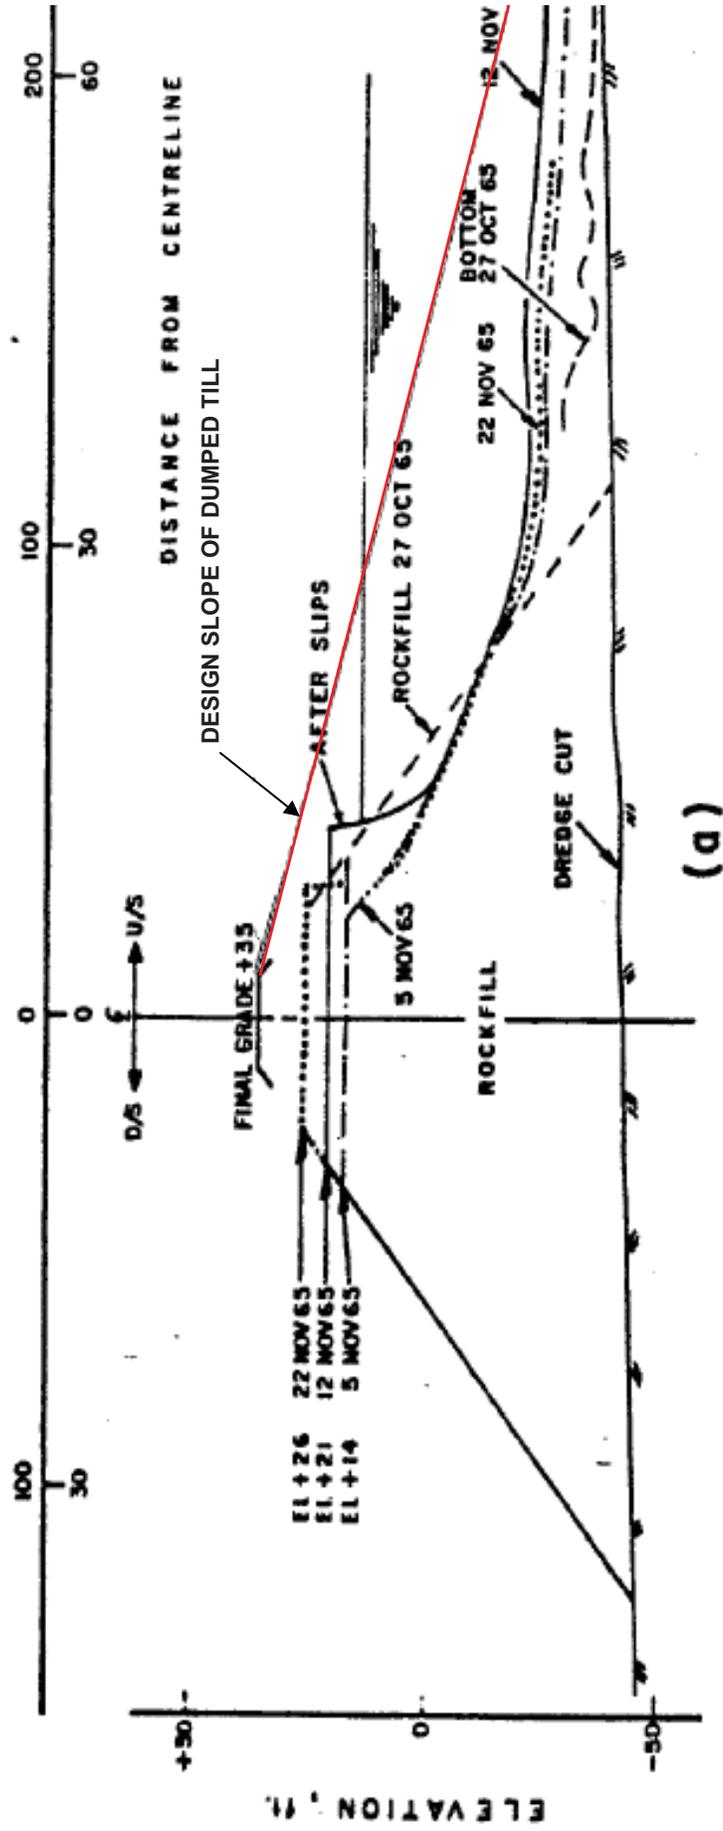
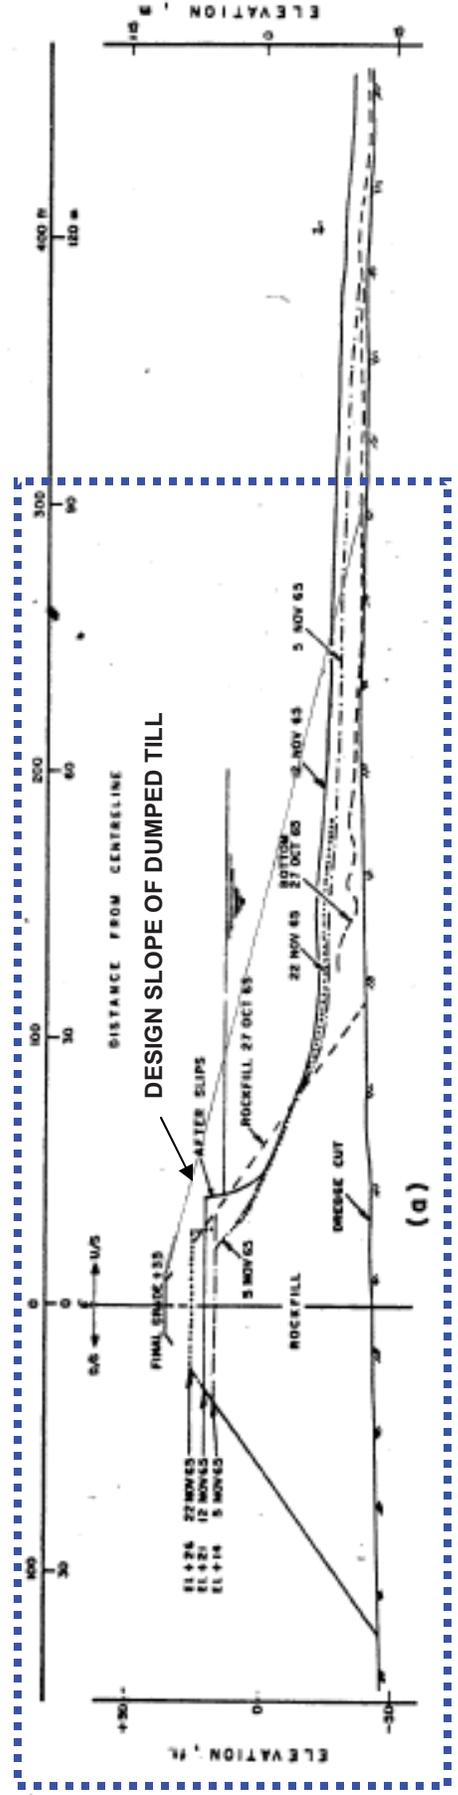
Fig. 1 - Section through the Mactaquac spur dyke cofferdam
 27 October to 7 December 1965

The original design called for 4H:1V slopes of the dumped till, as indicated in Figs. 1 to 3. The three cofferdams were all till-faced rockfill structures, constructed by end-dumping in water depths of up to 65 ft. Placing of till was started at the spur dyke cofferdam. Slips occurred after the placing of only 5,000 cu.yd. along a 450 ft length (Fig.1). The slips involved fine rock transition as well as glacial till. Soundings along several sections showed that the material had sloughed to the toe of the rockfill and formed underwater slopes as flat as 30H:1V. Subsequent dumping resulted in flat “slopes” extending as far as 500 ft from the centreline. Alternate layers of gravel, crushed rockfill and till did not improve this situation.

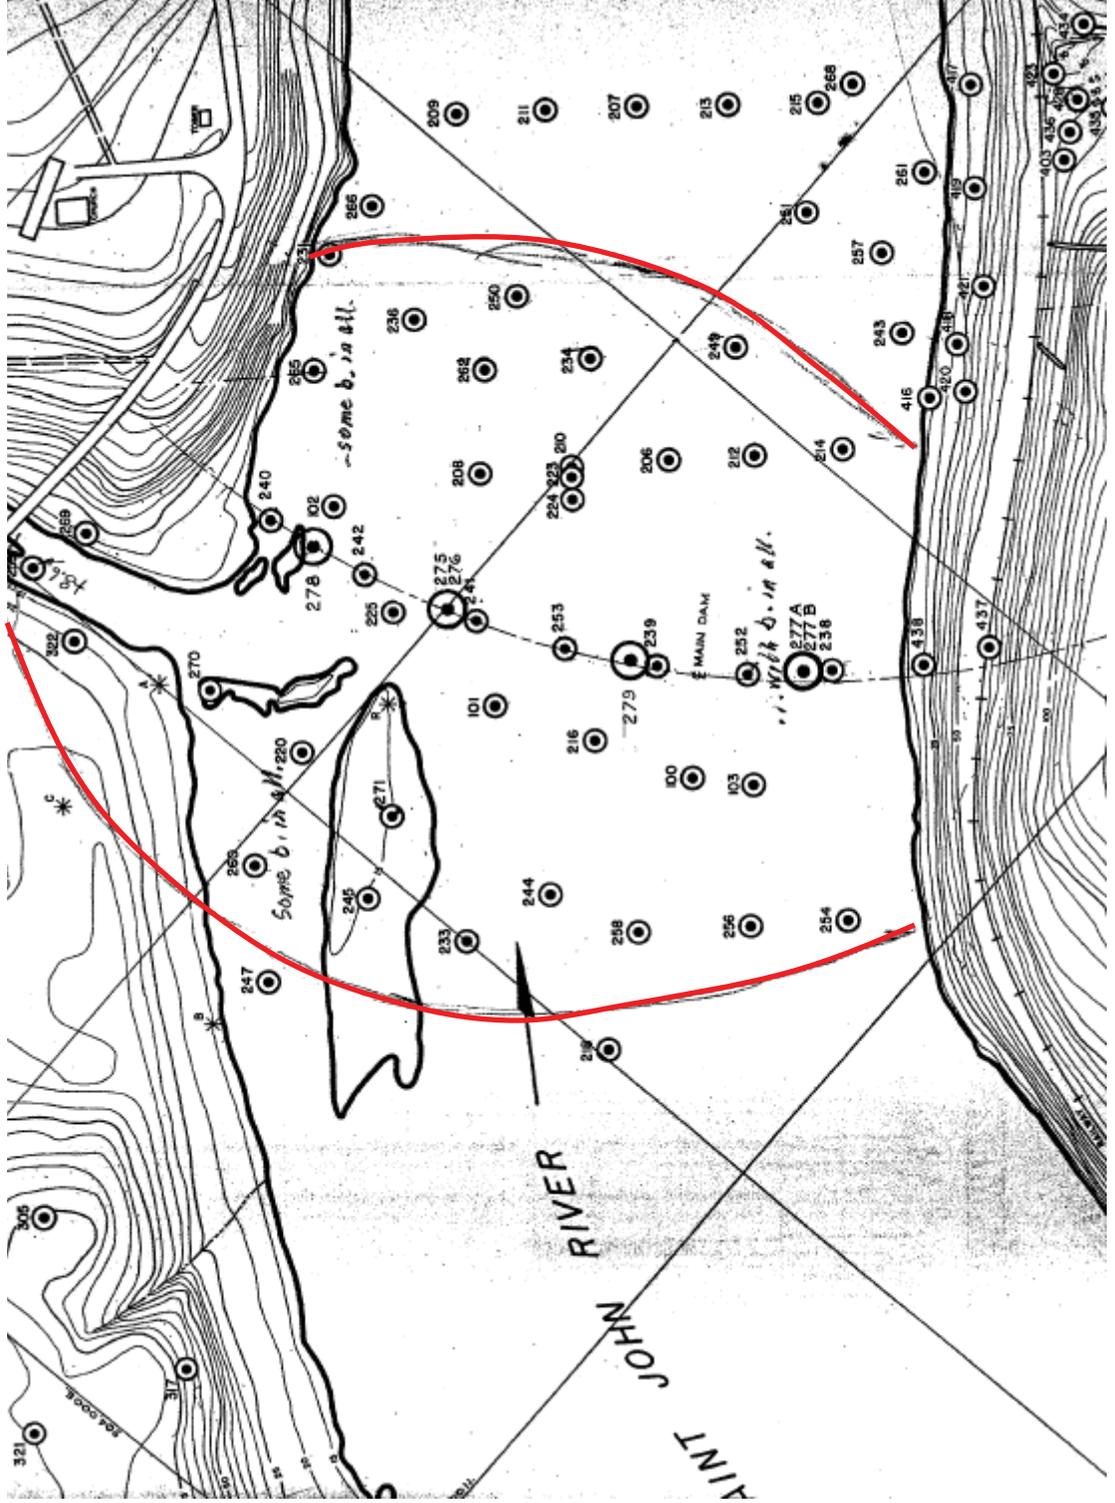
Fig.6 - Excerpt from Mactaquac dredging specifications

An excerpt from the dredging specifications is shown in Fig. 6. Again the amount of boulders is referred to as "occasional". The size of the boulders is not specifically stated, but the boulders referred to are described as being of a size that are "too large to be handled by the dredging equipment", the dredge having a cutter-suction head with a diameter of about 9 ft.

Before the dam area was dewatered, it was thought, as envisaged by the dredge specifications, that the dredge would leave a more or less undisturbed surface of stiff till partly covered with relatively large boulders too big to be picked up by the dredge. In reality, the dredging excavation left a substantial layer of remoulded till up to about 6 ft thick. The content of boulders in this disturbed till was not recorded. However, the size of the boulders that proved to cause problems with the dredging equipment was in the order of 8 to 12 inches. This size of boulders could be picked up by the suction of the dredge pump, but often these boulders damaged the pump impeller. The pump then had to be dismantled for repair, sometimes twice a day, and this of course caused delays.
