## Introduction by John Dunnycliff, Editor

## Automated MEMS-based In-place Inclino-meters

*Margaret M. Darrow*

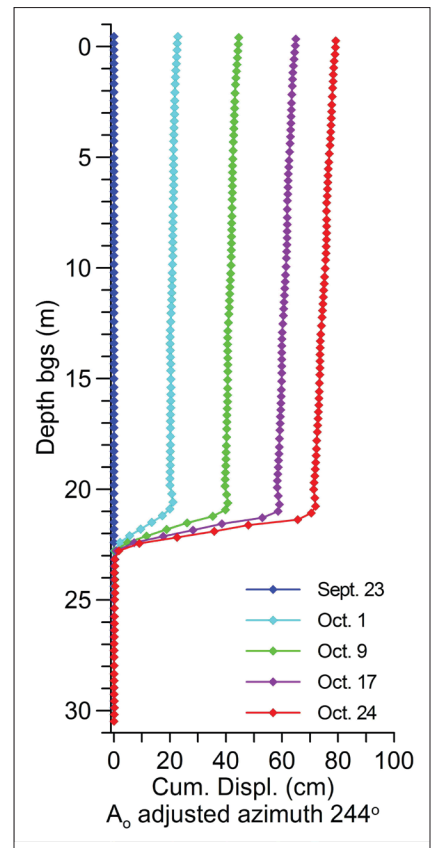
Figure 3. Cumulative displacement measurements for the boring through FDL-A until the INC500 began to demonstrate signs of failure.

Figure 3 contains plots of cumulative displacement from the M-IPI device. The data were corrected using vector summation (Cornforth, 2005), and for the cumulative change in depth of the sensors. Originally at 0.5 m above the ground surface, horizontal movement within the shear zone pulled the M-IPI down within the casing to 0.1 m bgs, correlating well with visual observations. These adjusted readings indicated movement within a well-developed shear zone between 20.2 m and 22.8 m bgs. The M-IPI device recorded at total of 79.2 cm at the surface in 31 days.

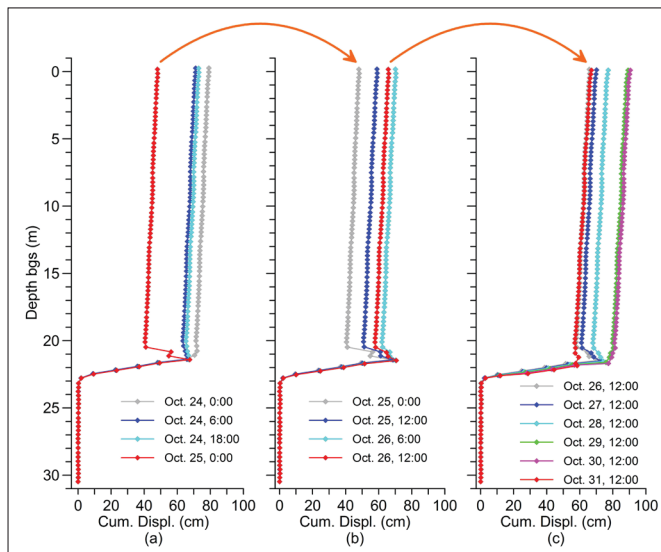
On October 24, the M-IPI began to record apparent “retrograde motion” upslope between 20.4 m and 21.4 m bgs (see Figure 4a). Considering the

Figure 4. Evidence of failure of the INC500 at FDL-A. (a) Apparent “retrograde motion” began at 6:00 on October 24, with major “retrograde motion” at 0:00 on October 25. (b) The lobe above the shear zone continued to move downslope, with another episode of “retrograde motion” on October 26 at 12:00. (c) Final readings of the INC500 until failure of the lower modules after October 31 at 12:00. For each plot, the set of readings in gray represents the last reading from the previous plot (for (a), this is the last reading shown in Figure 3). The sequence of readings is given the same color scheme, with red indicating “retrograde motion”.

failures of thermistors and a piezometer below this depth, we suspected that a few INC500 sensors were damaged in the shear zone. The manufacturer of the device agreed, indicating that the sensors “probably deformed or rotated within the housing” (J. Lemke, pers. comm., Nov. 2012). The M-IPI continued to record downslope motion above the shear zone, with episodes of “retrograde motion” intermixed (see Figures 4b and 4c). Then on October 31, the INC500 sensors below 20.2 m bgs ceased reporting data. The manufacturer suggested that either the cable was physically severed or that an underwater connector between modules pulled apart (J. Lemke, pers. comm., Dec. 2012). The sensors above the shear zone, however, continued to report movement and temperature data. Scheduling allowed the author and colleagues to return to the site every two to three weeks for manual inclinometer probe measurements. Considering the movement rate, only one or two additional sets of readings would have been obtained before the inclinometer probe could no longer pass the shear zone. Thus, the M-IPI device at this site delivered much more data than we otherwise would have collected.

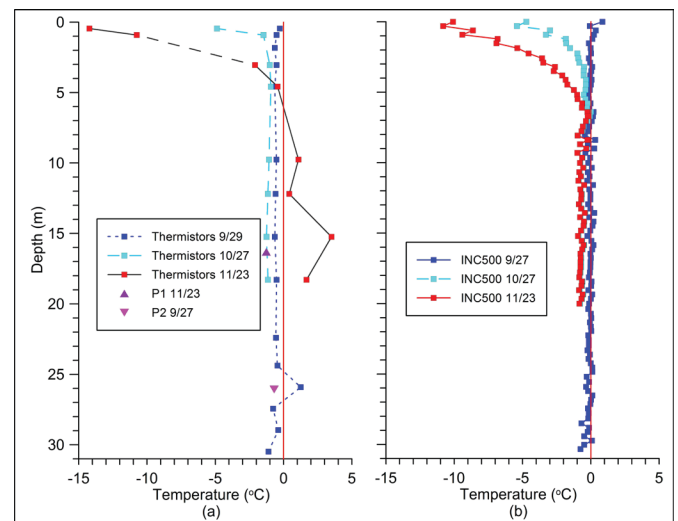
Figure 5. Temperature readings from the boring through FDL-A. (a) Temperature readings from the thermistor string and two VW piezometers attached to the outside of the casing; “P1” and “P2” are readings from the vibrating wire piezometers installed at 16.3 and 26.1 m bgs, respectively. (b) Temperature readings from the INC500. Nearest pairs of readings were averaged to reduce the scatter. For both plots, the phase-change temperature is indicated by the vertical red line.

The M-IPI device provided additional data in another way. Figure 5a contains a temperature profile of the boring. Thermistor measurements collected on September 29 demonstrated elevated temperatures due to the drilling process (having not yet reached a pseudo-equilibrium). Most of these temperatures, however, fit the trend

that developed with depth during the equilibrating process, with the exception of the malfunctioning thermistor at 25.9 m bgs. All thermistors and the VW piezometer below 18.3 m bgs failed on October 11 and October 26, respectively. Starting on November 9, the lowest remaining thermistors began reporting a steady increase in temperature resulting in above-freezing values, as indicated by the erratic temperature profile from November 23; yet the VW piezometer located at 16.3 m bgs (i.e., “PI”) measured  $-1.3^{\circ}\text{C}$ , matching the previous temperature trend. Figure 5b is a plot of temperatures obtained from the M-IPI device. The M-IPI stopped reporting accurate temperatures below 20.0 m bgs on October 24; however, the data above this depth are sufficient to indicate below freezing temperatures. Thus, the M-IPI data confirmed that the thermistors below 4.6 m bgs began to malfunction on November 9, likely the result of propylene glycol entering the cable and affecting the measured resistance.
