AN ENGINEER'S PROFESSIONAL LIABILITY “HORROR-STORY”

John L. Seychuk, P.Eng.
Geo-Engineering Consultant

Geo-Manitoba (2012)

The Project

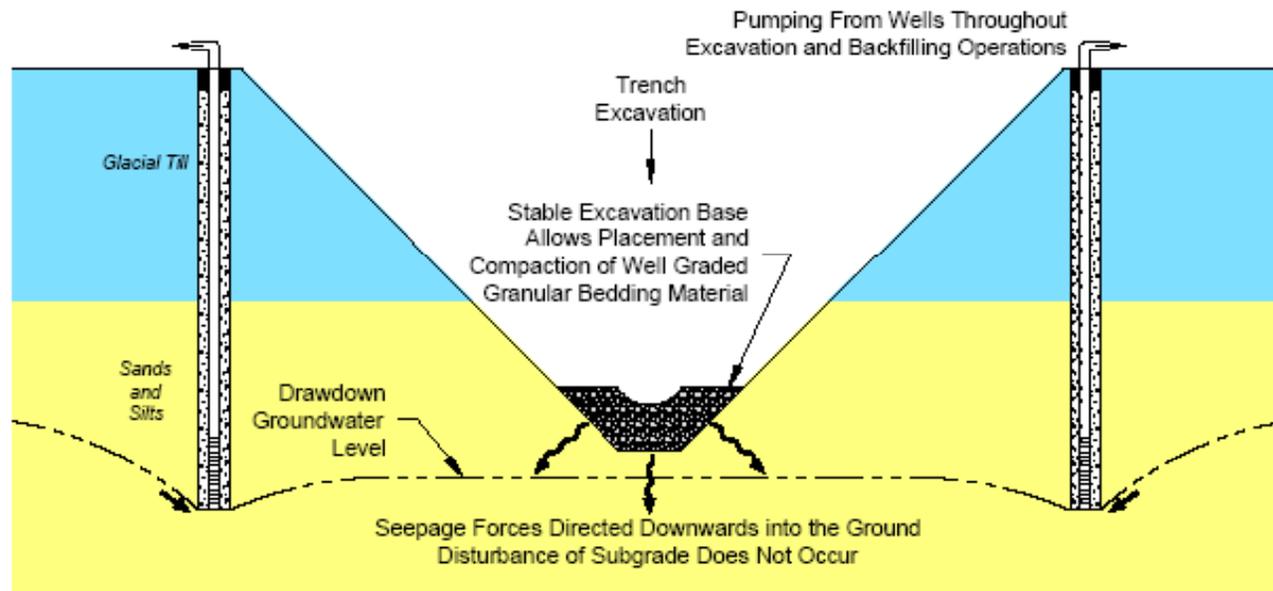
Figure 1

- The project under consideration involves the construction of a sewer system beneath a roadway in Canada.
- A preliminary site investigation along the route found a thin layer of glacial till underlain by water bearing sands and silts.
- Open cut trench excavation by the Contractor proceeded without any “prior” dewatering
- (i.e., the groundwater level in the sands and silts was not lowered to below invert level prior to excavation activities as illustrated in Figure 1).

Illustration of "Prior" Dewatering Excavation Conditions

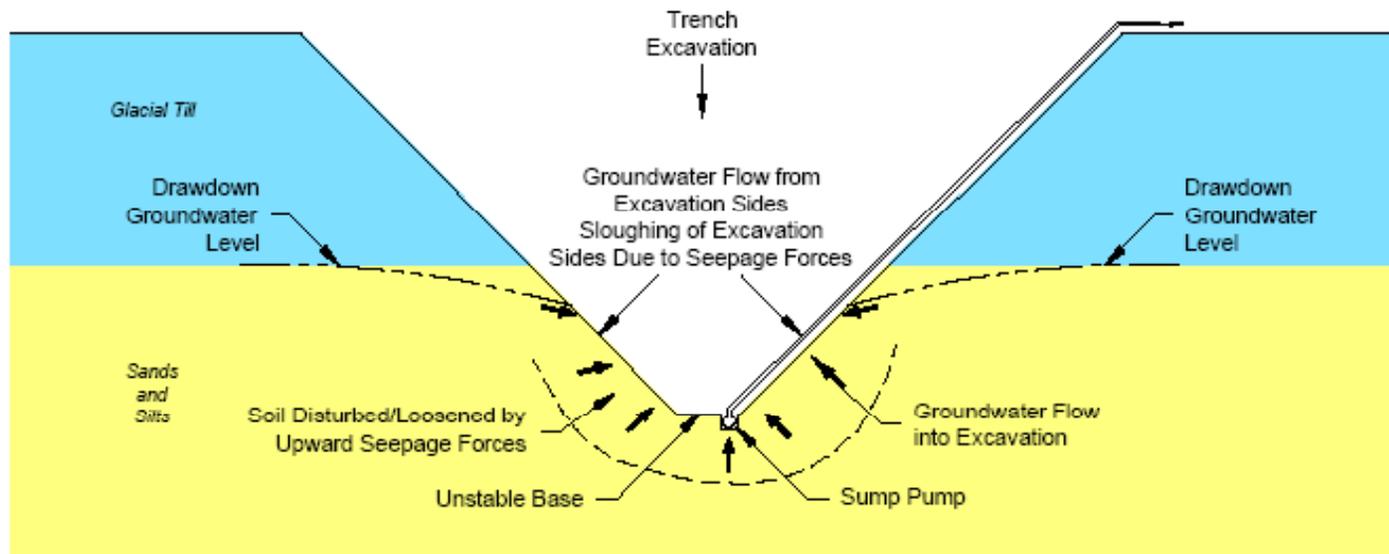
Figure 2

- Needless to say, without “prior” dewatering, water inundated the trench before the excavation reached sewer invert level, and
- groundwater inflow could not be controlled by sump pumping alone.
- The negative effects of sump pumping (which is referred to as “post” dewatering) on the
- stability of the excavation sides and bottom are shown in the “Engineering Cartoon” in Figure 2.

Illustration of "Post" Dewatering Excavation Conditions

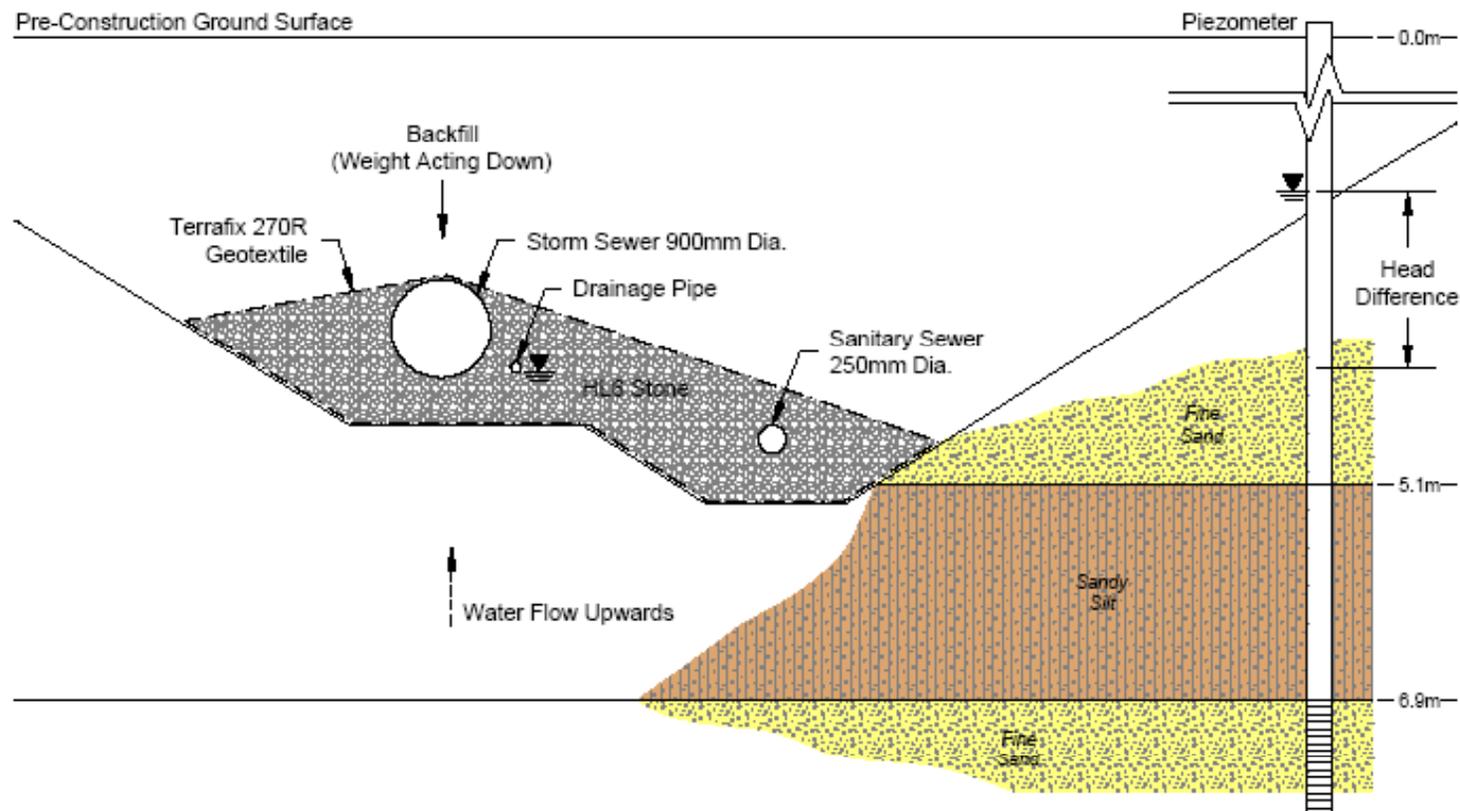
Figure 3

- The Contractor objected to the use of granular “A” on the basis of cost and workability issues and insisted on using clear stone.
- The Geo-Consultant recognized this approach to be a “recipe for disaster” because of the potential of a “piping failure” – (i.e., ingress of the fine grained soil into the clear stone void spaces)
- resulting in settlement of the surrounding ground and consequent deformation of the sewer pipes.

- Based on a suggestion by the Prime Consultant, a compromise solution was reached
 - with the use of a geotextile wrapped around the clear stone bedding,
 - to act as a protective filter median (as per the design arrangement shown on Figure 3).

Schematic Cross-Section of Compromise Sewer Design System Clear Stone Bedding with Filter Fabric Surround

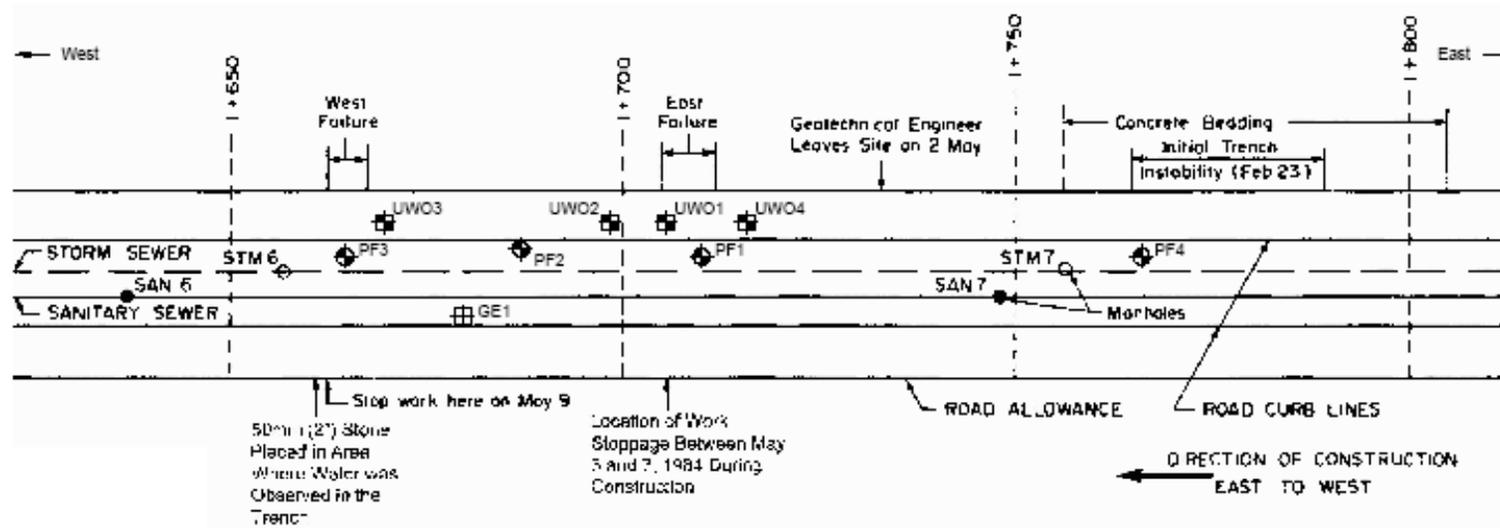
Figure 4

- One year following completion of sewer construction, two (2) separate shallow cave-in failures of the roadway surface occurred
 - along the section of sewer where clear stone with geotextile wrapping was used.
- Significantly, these failures took place in the area where the Geo-Consultant
 - was not involved in installation monitoring activities (Figure 4).

Site Plan Showing Failure Areas and Borehole Locations

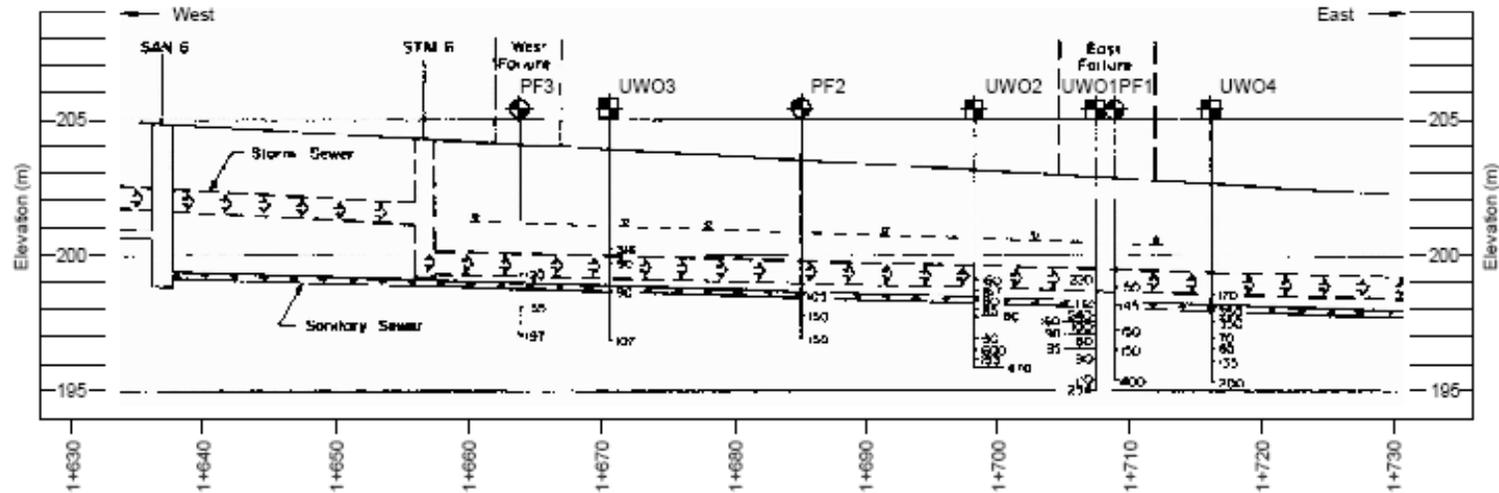
Figure 5

- The three boreholes put down at, and between, the failure areas - encountered silty fine sand at and below pipe invert level.
- At the first (easterly) failure location - the minimum d_{85} of the soil at invert level was found to be 145 microns.

- A minimum d_{85} (grain size) of 120 microns was found at the second (westerly) failure location.
- Significantly, at the third borehole located in a non-failure area, the d_{85} of the soil was 105 microns – i.e., the soil was finer grained here than at both failure locations (Figure 5).

Longitudinal Section Along Sewers Showing the Post-Failure Borehole Locations and D85 Laboratory Gradation Test Results
