# The September 19<sup>th</sup> 1889 rock slide along Champlain Street in Québec City, a catastrophe foretold by Charles Baillargé

Jacques Locat,  
*Department of Geology and Geological Engineering,  
Université Laval, Québec, Qc, Canada, G1A 0A6*

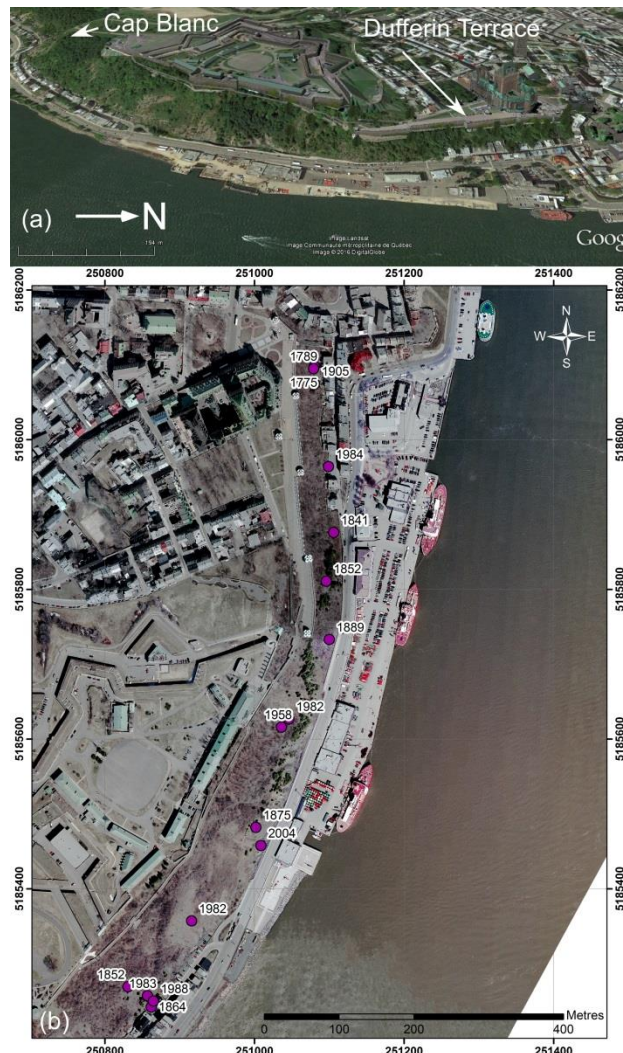
Figure 1. (a) Oblique view of the Champlain Cliff and (b) location and year of slide events in this sector along the St. Lawrence River.

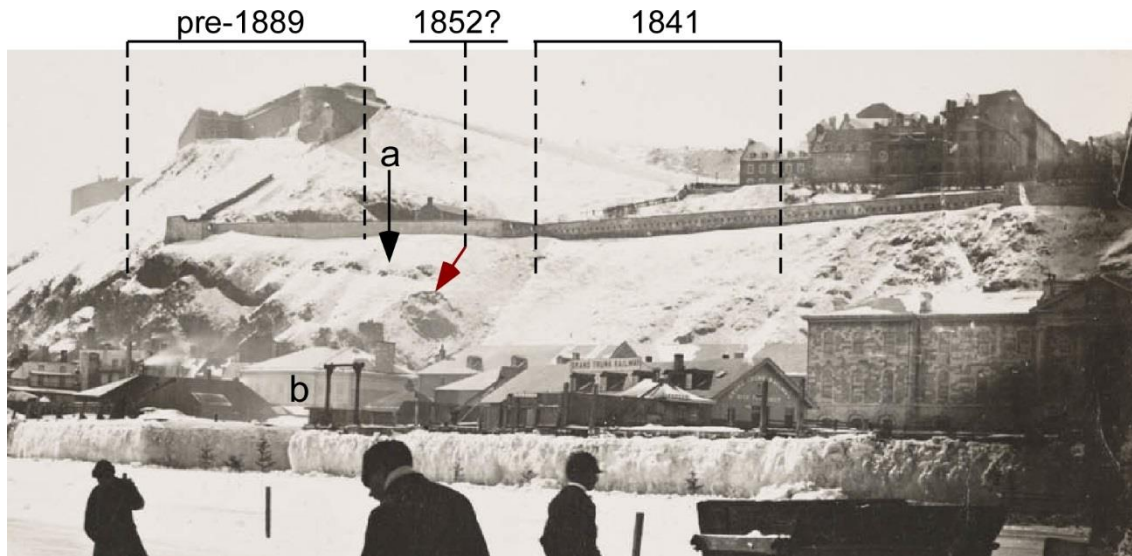
Figure 2. Extract from a photograph of the Champlain Cliff taken in 1870 from which we can see the reworked slope of the 1841 slide, the likely position of the 1852 slide (red arrow) and the slope in the pre-1889 slide area (a). Also shown is a possible fissure along 'a', evidenced by absence of snow likely due to heat being expelled along it. In 'b' is the government building seen in Fig. 3. See text for explanations. (modified after a photo taken by Livernois in 1870).

On July 14<sup>th</sup> 1852, following an intense storm, three slides were reported along the Champlain Cliff with a major one approximately located on Figures 1 and 2 which destroyed a house killing 9 people. If the semi-circular feature in Figure 2 is the head of the scarp of the 1852 slide, it would indicate that it stopped half way up in the slope.

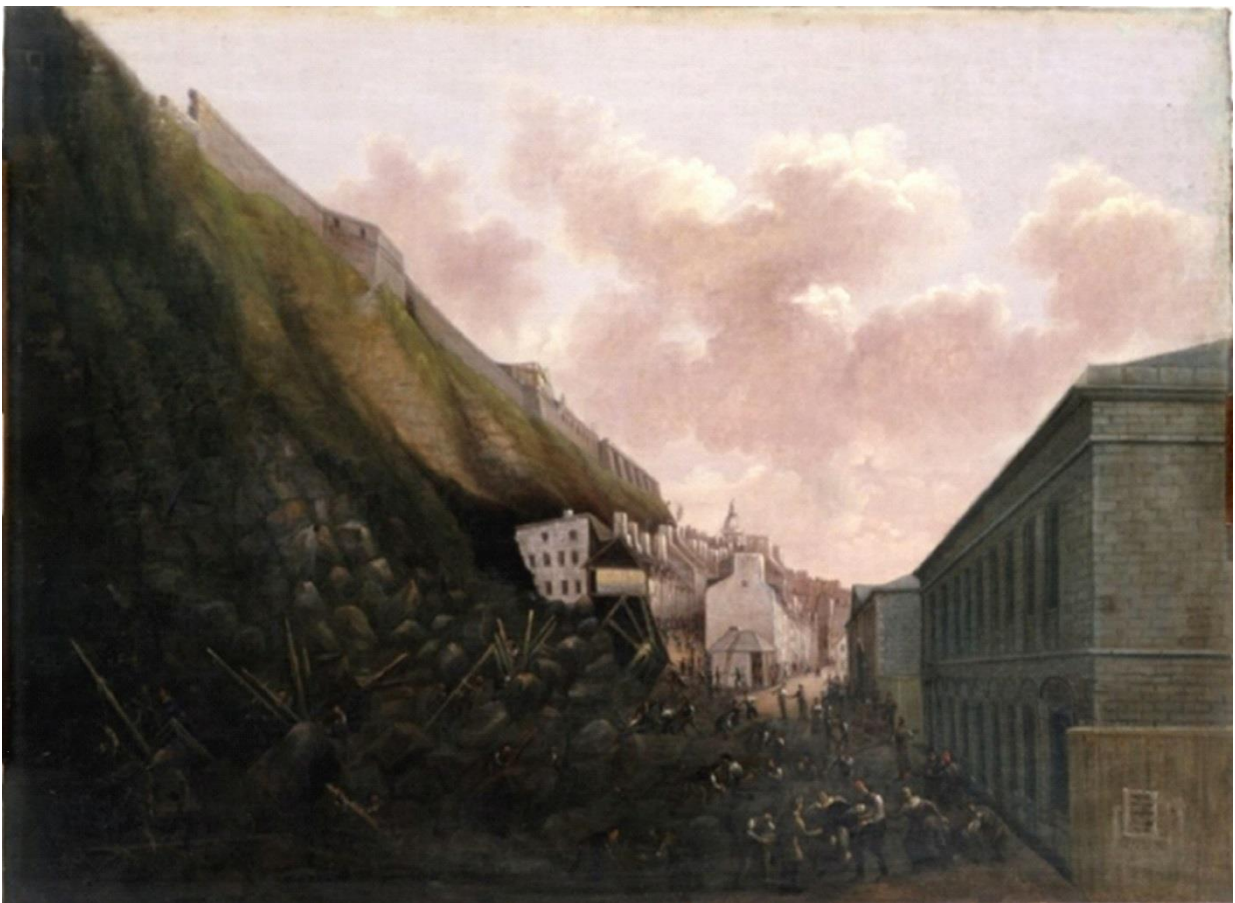
Figure 3. The 1841 slide along Champlain Street shown in a painting by Joseph Légaré. The large government building in the foreground is shown in Figure 2 with the letter 'b' (source: Le Devoir, Musée du Séminaire de Québec).

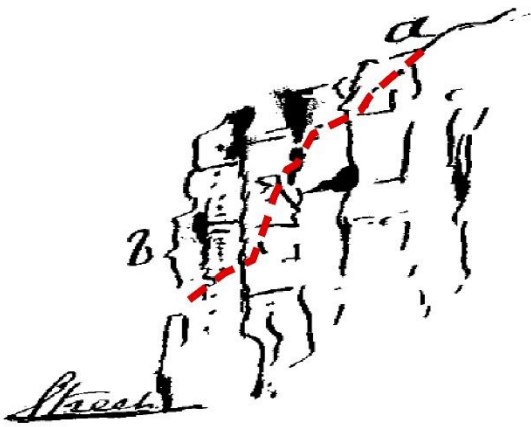
Figure 4. Sketch of the cliff west of the 1841 slide and along Champlain Street (Street on the figure). Scaling was recommended along the dashed line between 'a' and 'b'. The red dashed line is interpreted by the Author (modified after Cole 1842).

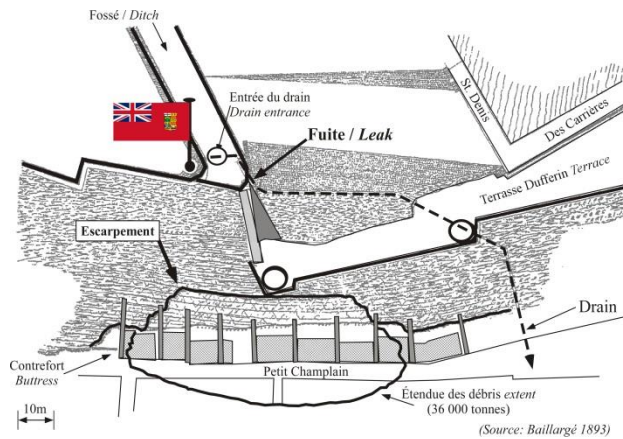
Figure 6. Plane view of the 1889 slide area also showing the remedial measures (buttresses) proposed by Baillargé in 1880. The broken drain was only identified in 1889. (modified after Baillargé 1893).

This local groundwater recharge would have been caused by a defective drain constructed around 1830 (see Fig. 6). At first, this drain was installed to divert water from cracks but it was eventually forgotten! Baillargé had noticed that, even before the slide event, water would often accumulates in deep cracks during rainfall and it could take many days for the cracks to be fully drained (see an example of these large fissures in Fig. 8).

By looking at Figure 6, it is clear that Baillargé had rightly understood the situation and proposed remedial measures that were only partly followed.

It is striking to see that the place where he suggested to put the buttresses was exactly along the final head-scarp of the slide which took place 10 years later.

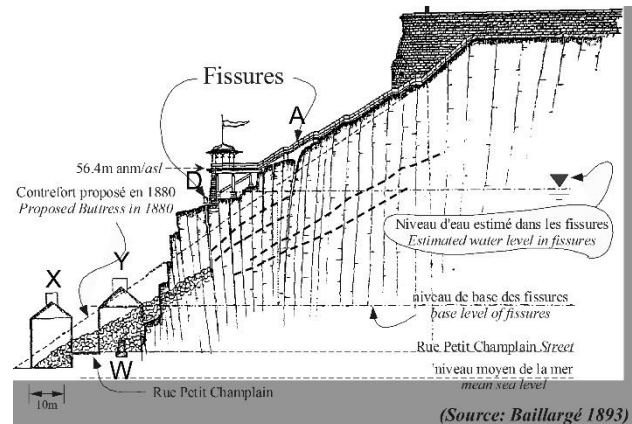
Following the investigation by Baillargé, the Federal government decided to take action but carried out only parts of Baillargé's recommendations. The Government bought and removed the houses below the Champlain Cliff (Y in Fig. 7), but not those across the street (X in Fig. 7), and built a small retaining wall (W in Fig. 7) put in such a way as to also increase the width of Champlain Street in that sector.

Figure 7. Section more or less perpendicular to the King's bastion at the top which is almost in the middle of the 1889 slide. Black inclined dashed lines were inserted by the Author according to the drawing of Baillargé (1889). (modified after Baillargé 1893). A and D are fissures.

The slide parted along crevasse 'D' in Figure 7 (B in Fig. 9) and fell has a toppling failure on the houses on the other side of the street (X in Fig. 7) which had not been removed, contrary to the recommendation of Baillargé in 1880. In his 1893 paper, Baillargé noted that the fissure A (Fig. 9) had opened by 15.3 cm (6 inches) between 1879 and 1889.

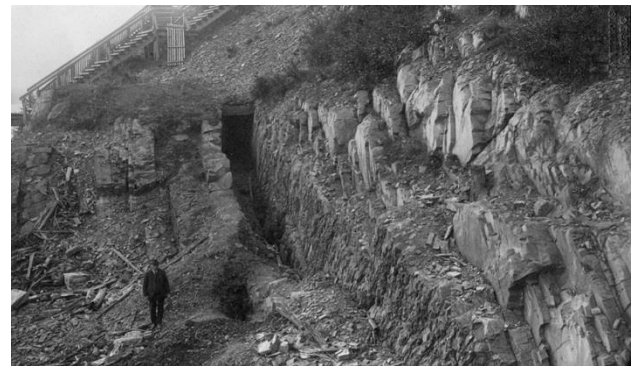
Figure 8. Example of one of the large fissures (fissure A located in Figs. 7 and 9) mapped by Baillargé in 1879 and partly filled by debris. Note the wood cover near the top. Photograph likely taken while the slope was being repaired after the 1889 slide. (Source: archive of the City of Québec).

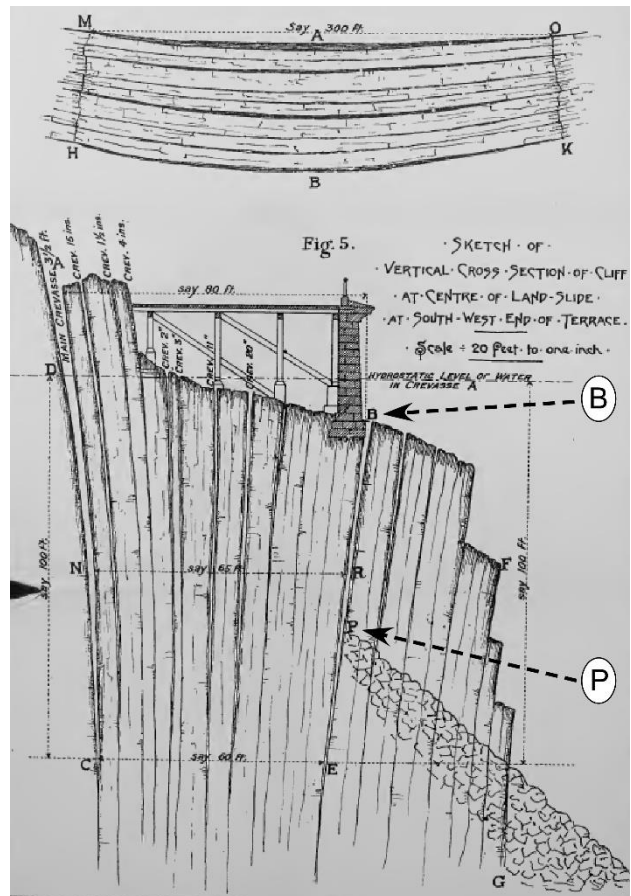
mould, grasses and other growths at B (at the scarp, Fig. 9) would have been found at the P (the base, Fig. 9) while, on the contrary, they were found at the extreme outer edge of the fallen debris, showing that, as testified by several witnesses, the cliff actually fell toward from the top". From this, the 1889 Quebec slide should be considered as a toppling failure.

Figure 9 Detailed 1879 analysis of the main crevasses near the center line of the 1889 slide (modified after Baillargé 1893),

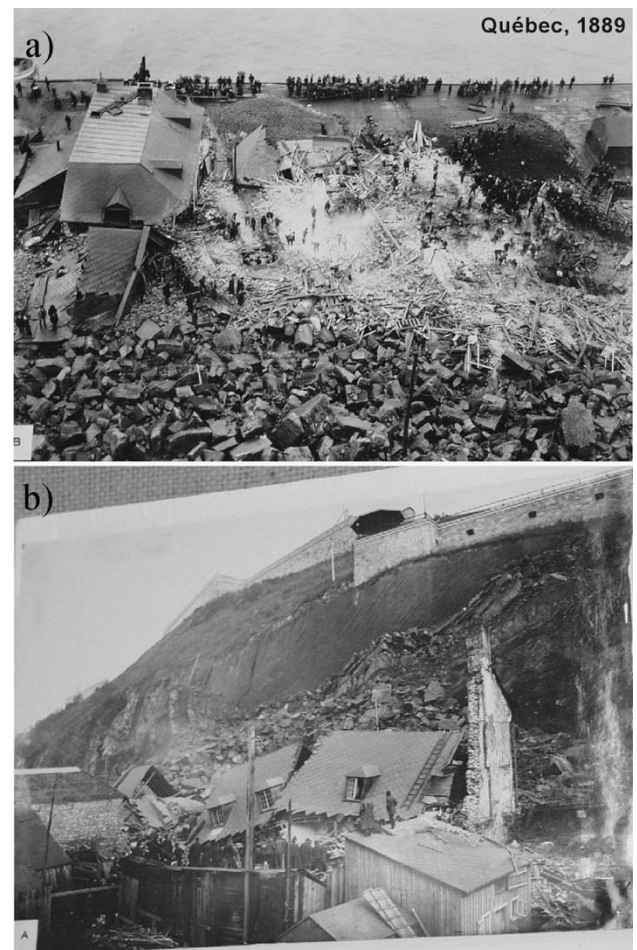
slope unable to sustain the water pressure exerted in the major cracks. The amount of slide debris was estimated at 36 000 tons (Baillargé 1893, Fig. 10a).

Figure 10. . Photographs of the Québec 1889 rock slide with a view in a) showing the debris over Champlain Street and in b) of the head scarp controlled by fissure 'D' in Figure 7. (source Québec City archives, photographs by Topley).
