**The 65th
Canadian Geotechnical Conference
September 30 – October 3, 2012
Winnipeg, Manitoba**

**Alternate Dispute Resolution by Reverse
Engineering – A Case History**

Carman G.A. Fielding,
Carman Construction Inc., Lively, Ontario, Canada
Randy W. Donato,
Vale Canada Ltd., Copper Cliff, Ontario, Canada
M.A.J. (Fred) Matich,
MAJM Corporation Ltd., Toronto, Ontario, Canada

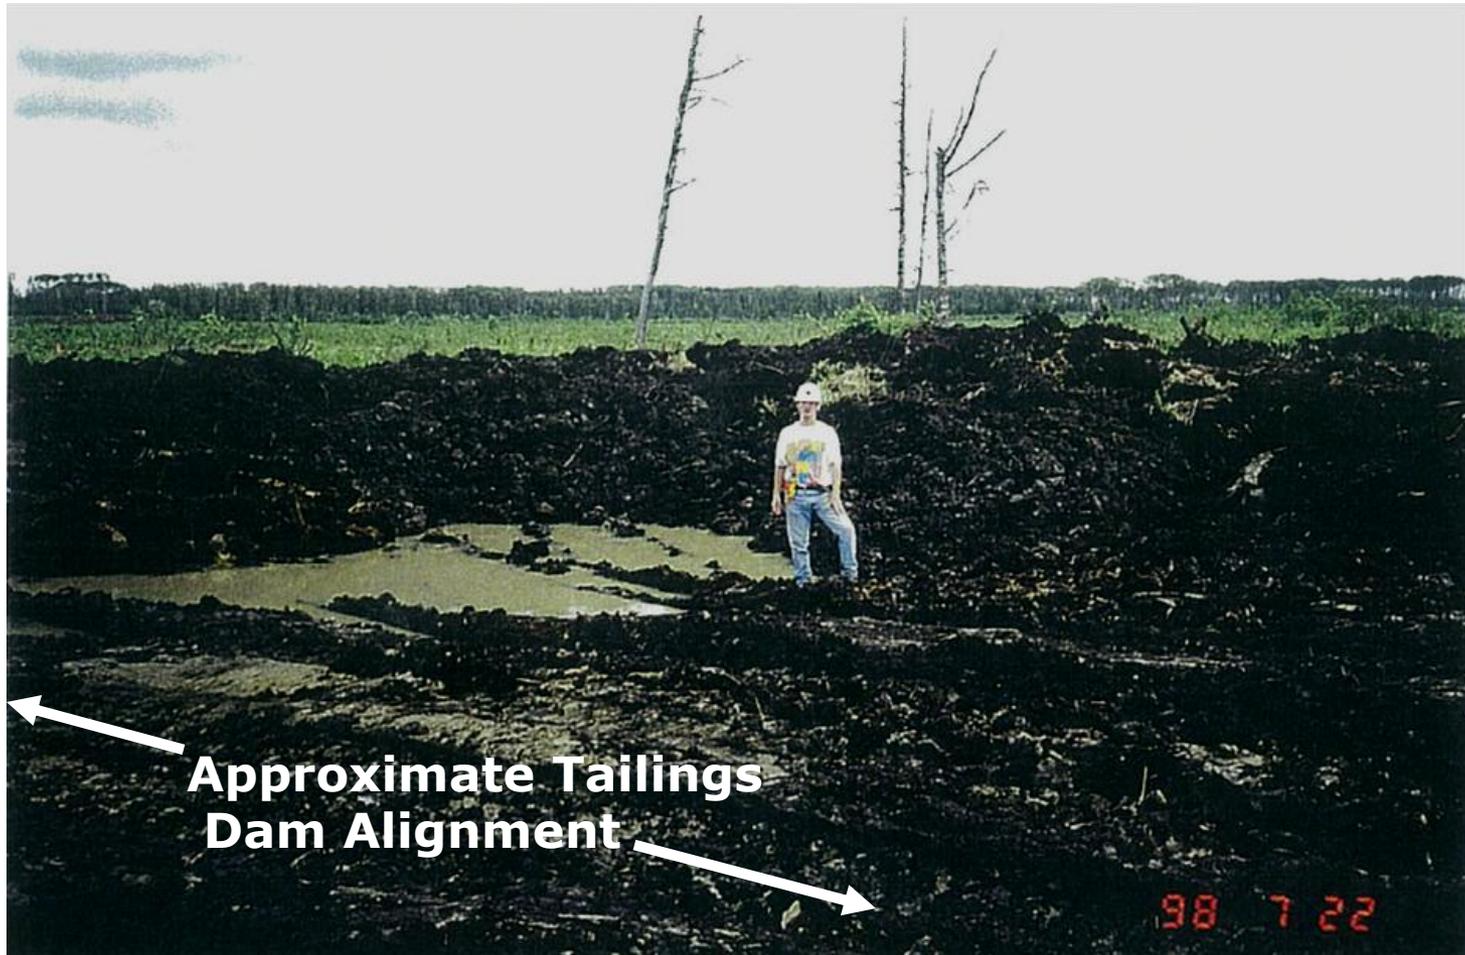
Peat Formation During Excavation

- **Increased depth of topsoil/peat**

Instead of 0.3m to 0.5m, with some areas up to 1.2m deep, depths encountered were up to 3m with an average of 1.8m.

The Tendered quantity was 24,000m³. In practice, about 142,000m³ had to be excavated.

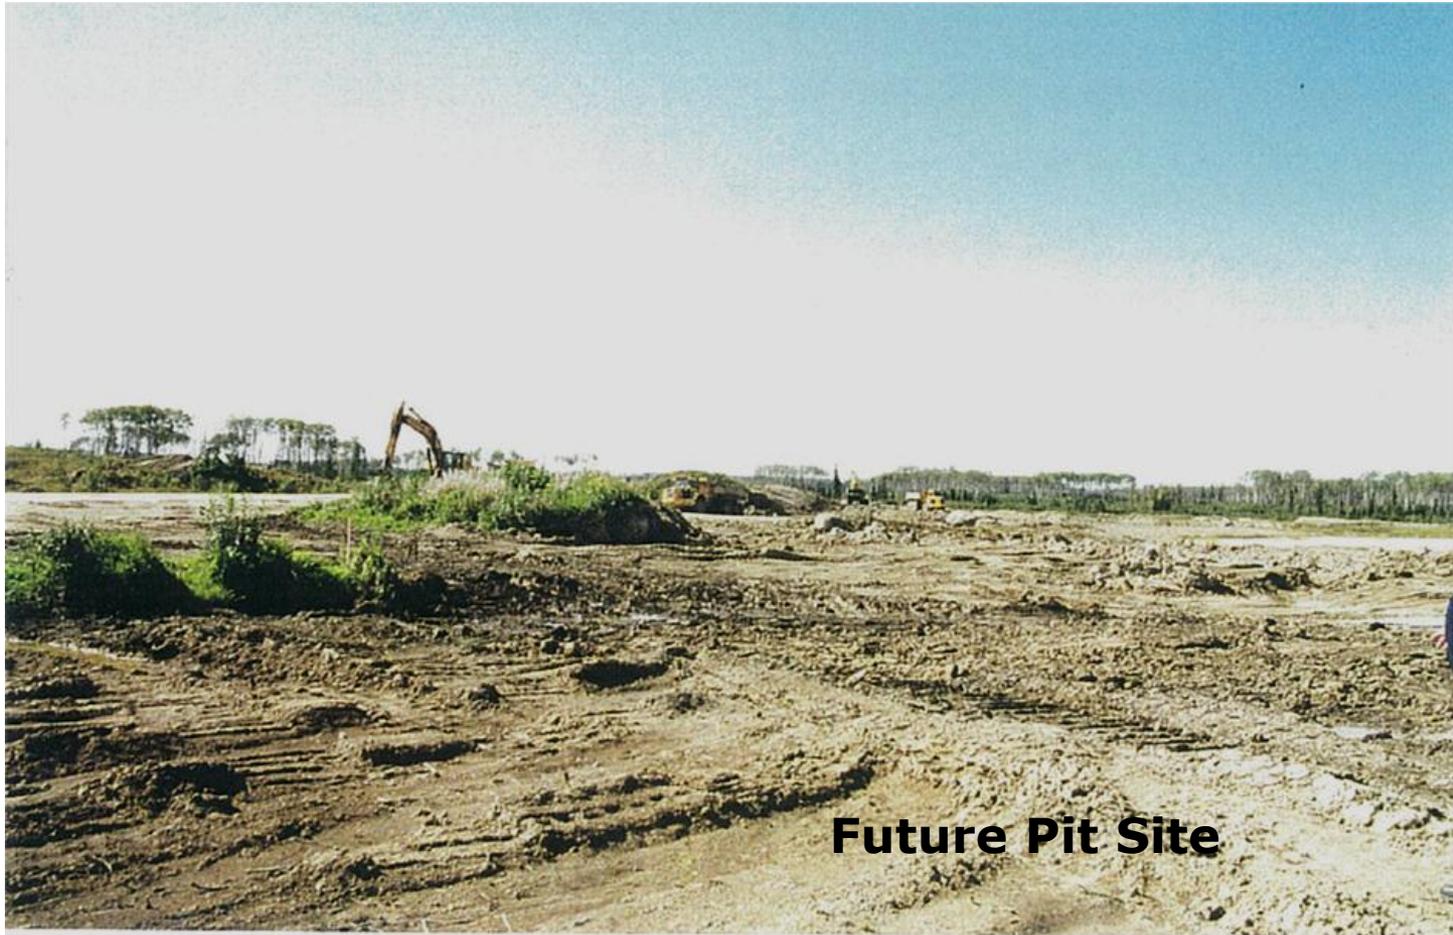
Clay Formation After Stripping the Peat at the Pit

The designated borrow area at the Open Pit proved to be unsuitable. Only one metre of the two to three metres of upper clay met specifications. Borrow areas elsewhere had to be investigated and utilized, resulting in further delays.

The high moisture content of the surficial clay not only affected its suitability for dam construction, its description as desiccated suggested more favourable trafficability characteristics than encountered in practice. This had a considerable impact on the efficiency of hauling units (despite use of off-road articulated haulers), and the number of dozers required.

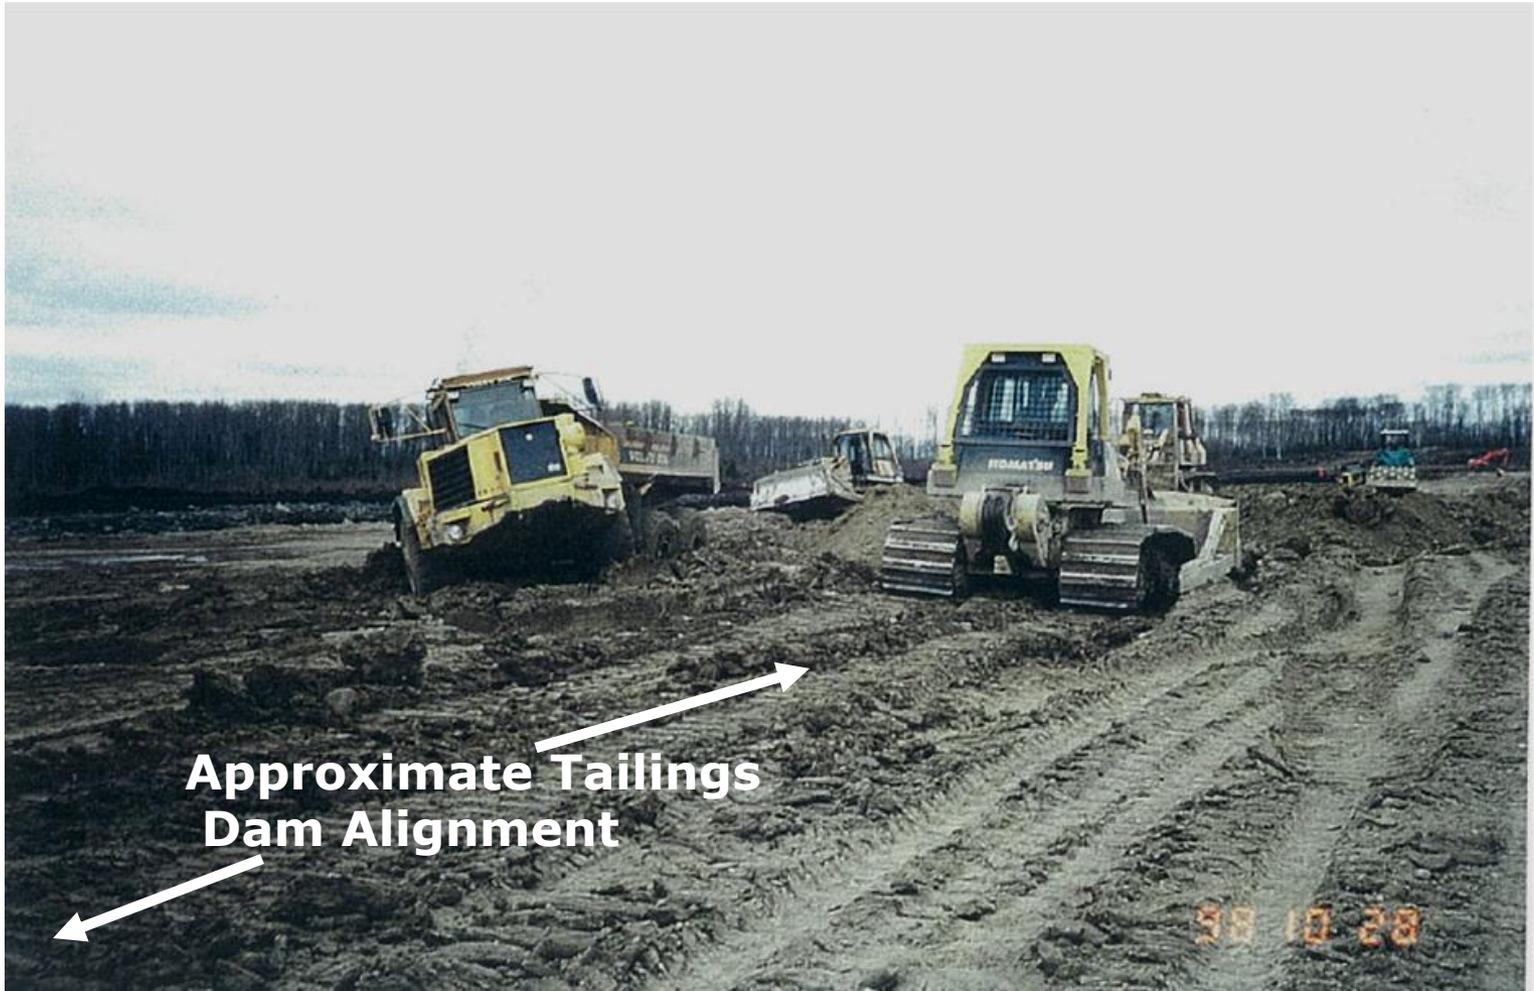
Clay Placement for Dam Construction

The large increase in topsoil/peat excavation from the Tailings Dam foundation required a corresponding increase in clay fill – from 113,700m³ tendered to 328,314m³ actual, also instrumental in delaying construction into inclement weather.

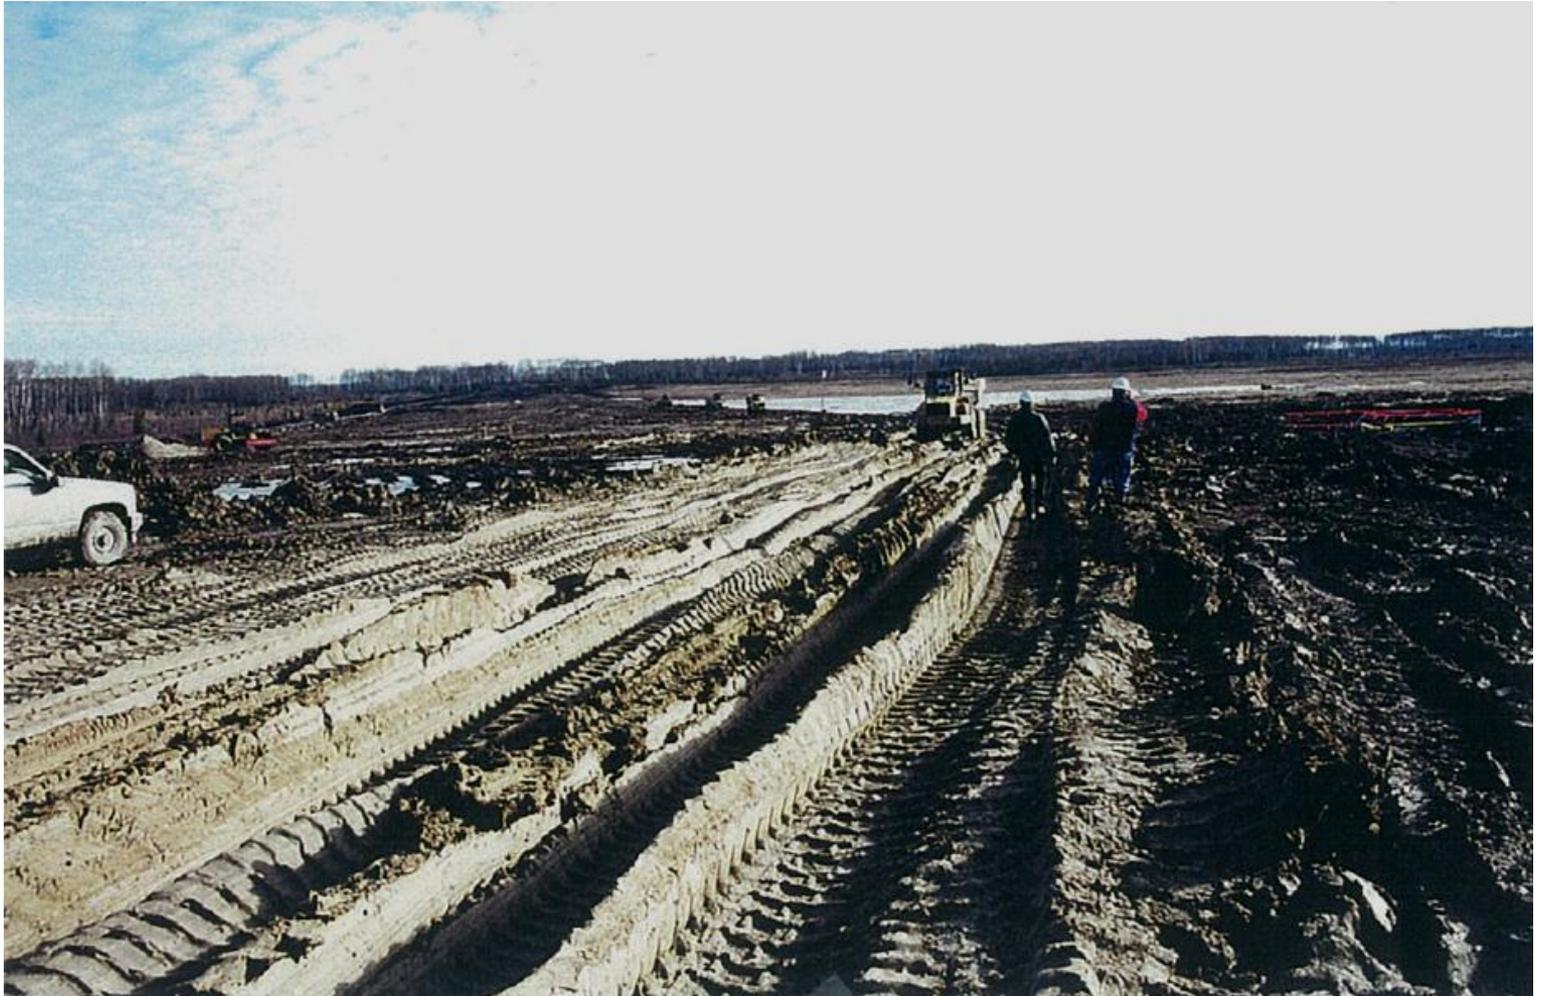
Difficult Trafficability on Roads to the Dam
