CATASTROPHIC ROCK AVALANCHES, WEST-CENTRAL BRITISH COLUMBIA

James W. Schwab, BC Forest Service, Smithers, B.C.
Marten Geertsema, BC Forest Service, Prince George, B.C.
Stephen G. Evans, Geological Survey of Canada, Ottawa, Ont.

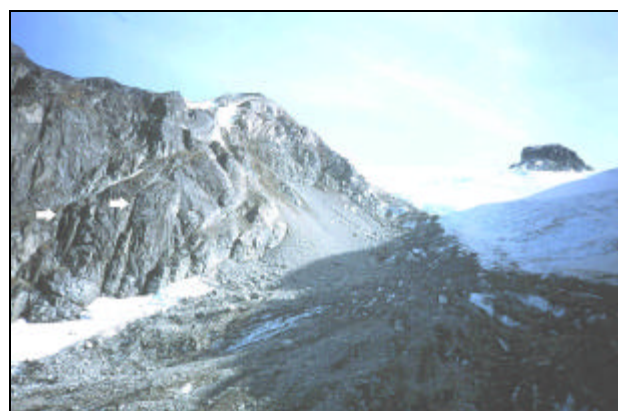
Figure 3. Howson rock avalanche, view toward head scarp. Note near vertical joints (September 16, 1999).

The rock avalanche originated as a topple of about $0.9 \times 10^6 \text{ m}^3$ from a bedrock ridge at 1923 m.a.s.l. The rock toppled and slid on a 48° slope for 150 m on to glacial ice. The rock avalanche expanded to cover the glacier to a width of 300 m spreading out on a 10° slope (Figure 3). Rubble hurtled over the ice along an ever-increasing slope gradient, dropping into Limonite Creek valley over a slope of close to 40° . Travel through the forest was along

Steep granodiorite cliffs rise above the glacier. The bedrock is steeply jointed and highly fractured. Preliminary analysis shows no clear relationship between discontinuities and the apparent failure.

The thinning of the Howson glaciers has likely resulted in debuttressing and destabilization of the steeply jointed and near vertical rock slopes. Toppling features observed along ridge crests provide evidence of destabilization and indicate the most likely mechanism for the initial stage of landslide movement.

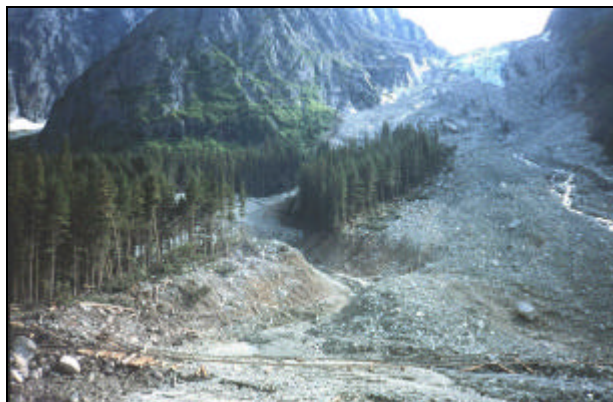
Figure 4. Howson rock avalanche, view upslope toward glacier ice. Note temporary gas line in fore ground.

The slide path through mature forest covered an area 1,200 m long and up to 400 m wide (Figure 4). Scour along the slide path through the forest, incorporated colluvial and morainal material. Trees were blown over by the resultant air blast along the sides and front margin. Landslide debris dammed Limonite Creek, creating a lake that filled within a few days. The avalanche was contained along the west and east boundary, below the glacier, by lateral moraines and a gully. Flow features appear in the zone of accumulation, issuing from the gully along the east boundary of the avalanche—these flow features possibly indicate that a debris flow, from the gully, occurred shortly after the initial avalanche. The gully was filled with landslide debris, which remobilized as a debris flow. Despite the large forest area contained in the avalanche path, few trees are visible in the landslide debris. A few large boulders, some up to 10 m diameter, were strewn along the landslide path. Howson rock avalanche appears to have involved an estimated 1.5×10^6 m³ of material.

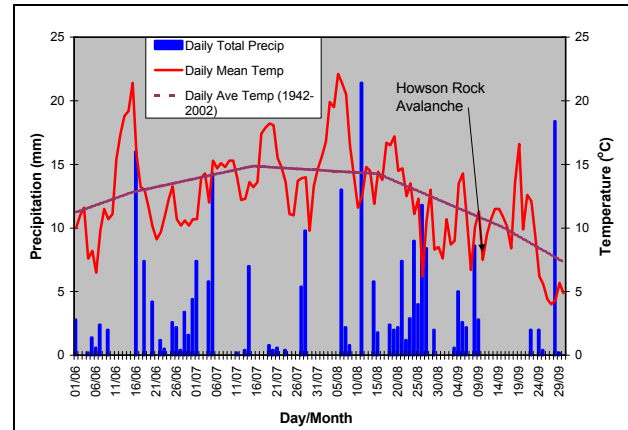
Figure 5. Precipitation and temperature, Terrace airport August-September 1999.

Figure 5. Precipitation during the months of May to September 1999, was 2 times normal for the Terrace airport at 217 m.a.s.l. Temperature was below normal. Similar conditions, with even cooler temperatures, were reflected at the airport in Smithers at 522 m.a.s.l. Conditions were generally clear and cool at the time with freezing temperatures at the higher elevations in Howson Range.

Above normal precipitation, recorded during the preceding summer months, may have created excessive joint water pressures. In addition, a greater incidence of freezing night temperatures—frost wedging, may have been the trigger.

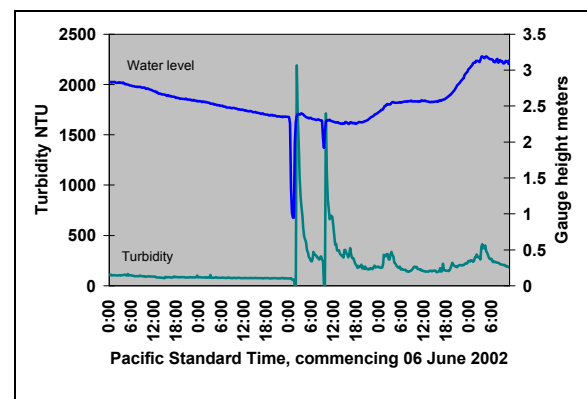
Figure 6. Water level and turbidity recorded for Zymoetz River at Water Survey of Canada station, 3km down stream of the Zymoetz rock avalanche.

On Saturday morning approximately 01:15 to 01:30 hours PDT June 8, 2002, Pacific Northern Gas (PNG) pipeline was severed at 15.5 km on Copper River Road. An intense fire at the break could be seen by residents along Highway 16 near the bridge crossing of the Zymoetz River. Water Survey of Canada station (08EF005) situated 3 km down stream recorded the blocking of the river, over topping of the dam and a smaller debris flow observed by PNG personnel at 10:15 hours PDT (Figure 6).

The snow pack in the Bulkley and Babine Mountains in June 2002 was about 200% of normal. This was reflected in above normal precipitation and slightly below normal temperature in the preceding months. The Tsai Creek snow pillow station situated at 1360 m.a.s.l in the Telkwa River watershed, Bulkley Range, west of Smithers, recorded a snow water equivalent of 1909 mm on May 15. Precipitation and temperature conditions leading up to the Zymoetz landslide are presented in Figure 10. The days prior to the landslide were cool with snow falling at higher elevations. On the morning after the Zymoetz landslide, a rapid temperature rise is reflected in a rise in the Zymoetz River hydrograph (Figure 6).

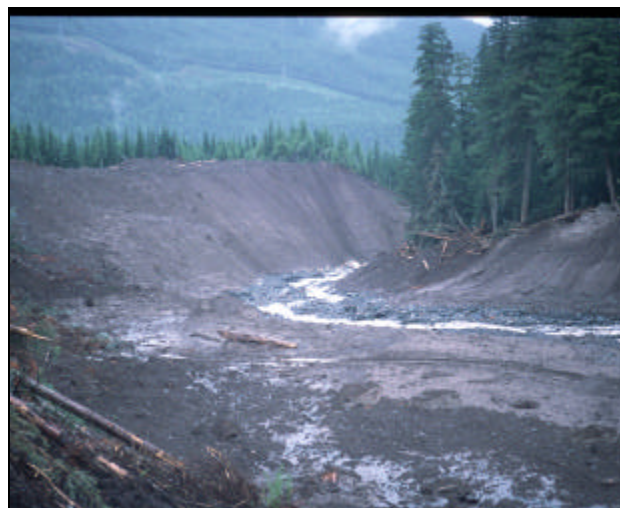
Figure 8. Super-elevated curve, lower section, above the canyon (June, 2002).

Velocity calculations used the formulas as present by Cruden and Lu (1992). Run up observed in the upper basin was estimated by $(2gh)^{1/2} = 34$ m/s, where g is equal to the acceleration of gravity, and h is maximum vertical run up. Velocity was estimated at super elevated curves by $(Rg \tan P)^{1/2}$, where R is the radius of the curve in the bend and P is the tilt of flow surface at the bend (Figure 8). Preliminary velocity calculations provide estimates of 18 to 26 m/s along the debris flow. Mud splatter was observed at one location to have reached 13 m above the trim line, a total distance of about 33 m above the base of the stream channel.

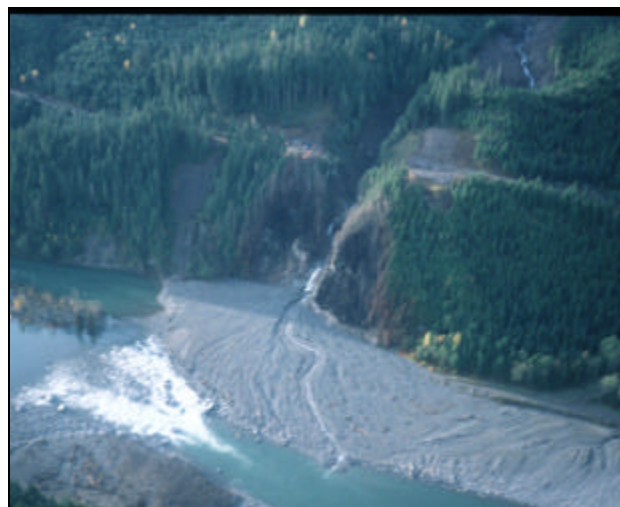
Figure 9. Debris fan in Zymoetz River. Note, the narrow canyon and large boulders in river (October, 2002).

Along the lower reach, the debris flow travelled at high speed through a narrow canyon 300 m long (Figure 9). Debris exploded onto the Zymoetz floodplain, extending across the river a distance of 250 m, to a depth of 10 to 12 m. An estimated $0.5 \times 10^6 \text{ m}^3$ of debris, some rocks up to 7 m in diameter, dammed Zymoetz River. Water was backed up on the floodplain 1.5 km. An unknown volume of debris was transported down river. The dam was overtopped within 30 to 45 minutes. The river down cut a 5 x 60 m channel through the dam during high waters of June

The rock avalanche-debris flow travelled a distance of 4.3 km. The drop in elevation from the headscarp to the river is 1,255 m. The total volume entrained, transported and deposited through various zones approaches $1.6 \times 10^6 \text{ m}^3$. About 30% of the total volume is contained within the dam on the Zymoetz River (Figure 9).

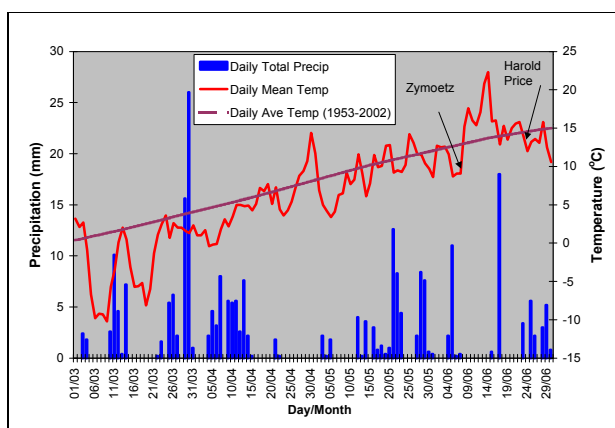
Figure 10. Precipitation and temperature, Terrace airport, March-June 2002.

High discharge in local streams followed the rise to above normal temperatures recorded at the airport in Smithers. The same trend is evident at the Terrace airport (Figure 10). However, temperatures appear to have cooled prior to the landslide. Rain squalls were observed in the vicinity of Harold Price valley during the weekend of June 22-23, 2002.

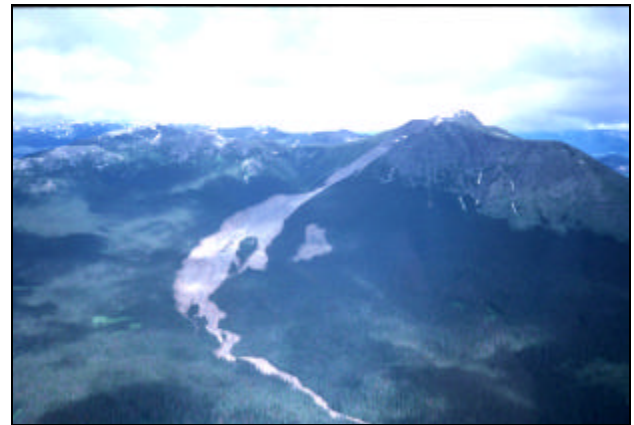
Figure 11. Harold Price rock avalanche-debris flow (June 28, 2002).

The Harold Price rock avalanche is believed to have occurred some time between June 22 to 24, 2002. It was first observed on the morning of 24 June, 2002 by a forestry crew doing helicopter reconnaissance in the area (Figure 11). It was raining hard at the time and high water flow was observed in streams on the morning of June 24. The rock avalanche originated at 1723 m.a.s.l. on the lip of a south west facing cirque occupied by a rock glacier. Interstitial ice was observed in the scarp face. The hillslope below the cirque basin is concave shaped—a result of valley glaciation. A deep till blanket covers the Harold Price valley below 1450 m.a.s.l.

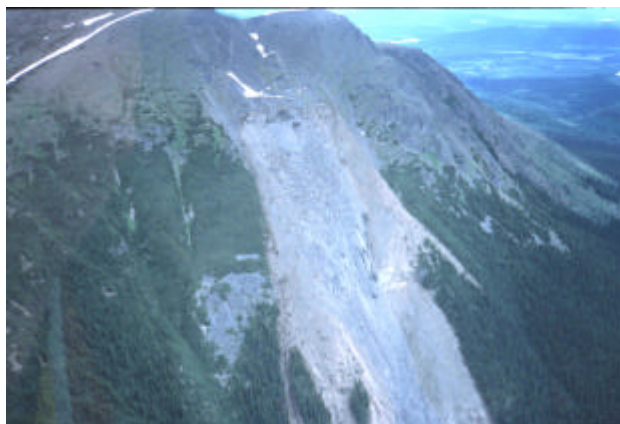
Figure 12. Rock glacier, above the displacement zone.

Catastrophic failure occurred in deeply weathered and highly jointed volcanic bedrock/rubble and ice of the rock glacier above a steep concave slope. Volume² from the upper displacement zone is estimated at 0.7×10^6 m³ across a scarp face of 175 m wide by 30 m deep (Figure 12). In addition, an 8 ha area of rubble within the basin exhibited post slide tension cracks and showed downward and lateral displacement. The estimated displaced volume of rock and ice that remained in the basin is in the order of 2×10^6 m³. The rock avalanche dropped 300 m onto the open valley expanding to a width of about 360 m while moving at a rapid speed across a basal till surface. Unique features composed of disintegrating rock “molards” are present in the main landslide track extending from the base of the mountain for about 850 m (Figure 13). The landslide, at 1.3 km, transformed into a debris flow transporting mainly forest debris. Debris entered an incised stream channel at 2.2 km and carried down to Harold Price Creek a further 1.8 km. Debris jammed over a 150 m stretch of Harold Price Creek and resulted in re-routing of the stream. A debris flood carried logs an additional 3.5 km down stream to a sharp corner leaving a debris pile inundation about 100 m onto the floodplain. Only a minor amount of rock and debris from the initial landslide appears to have been transported to Harold Price Creek. The main constituents of the

Rock glacier movement, with debris streaming over the lip of the cirque basin, is visible on the pre-landslide aerial photographs. In addition, debris from a previous landslide is evident on the adjacent slope. Initial movement may have occurred below the lip of the cirque, on a portion of the over steepened convex slope. This area of active movement is visible on air photographs. Degradation of interstitial ice may have played a role in catastrophic failure of the slope.

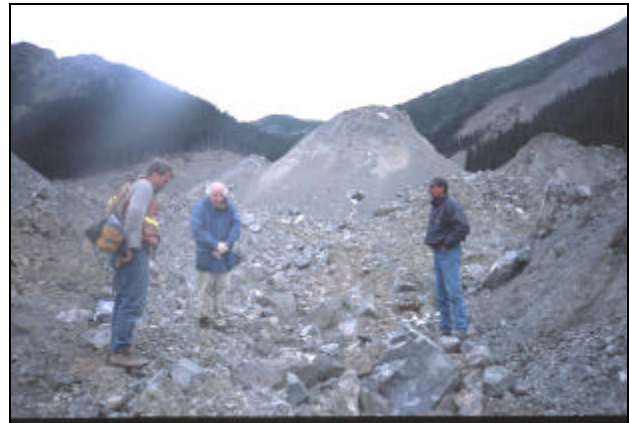
Figure 13. Disintegrated rock, “molards” (August, 2002).

Bedrock involved in the landslide is composed of highly weathered and heavily jointed volcanic rocks. The rocks show considerable hydrothermal alteration. Smaller rocks left along the main track were easily crumbled by hand or shattered with a rock hammer. We found at the base of the zone of depletion a hard volcanic rock, striated and polished by valley glaciation. We were only able to chip small fragments after repeated blows with a rock hammer. A deep till blanket in the valley is characteristic of Bulkley Valley till (Clague, 1984). Till samples collected contained 41.8% sand; 31.0% silt; and, 27.2% clay. Atterberg limits were: liquid limit 33.5; plastic limit 12.1; and plasticity index of 21.4. Bulk density for the till samples averaged 1.85 Mg/m^3 .
