# Charles Creek Debris Flow Mitigation Structure

## Why a Canadian geotechnical achievement?

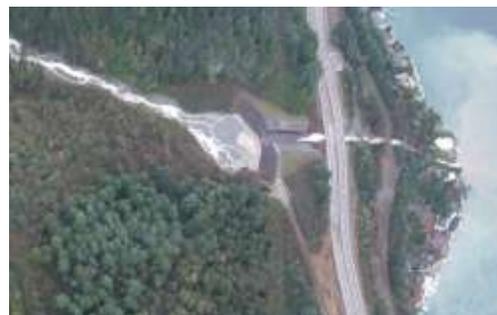
Aerial view of Charles Creek mitigation structure.

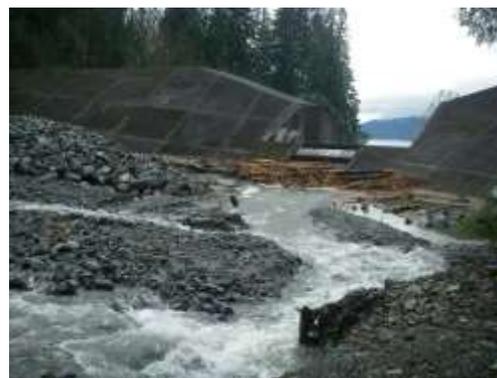
Structure after 2009 debris flow, and before debris was removed (for scale, the width of spillway opening is ~8 m).

Subsequent debris flows occurred in 1990, 1991, 1995, 2005, 2007, 2009, 2010, with volumes estimated up to 25,000 m<sup>3</sup>. After each major debris flow, as intended, the debris was physically removed from behind the structure.
