## Introduction by John Dunnycliff, Editor

## Automated MEMS-based In-place Inclino-meters

*Margaret M. Darrow*

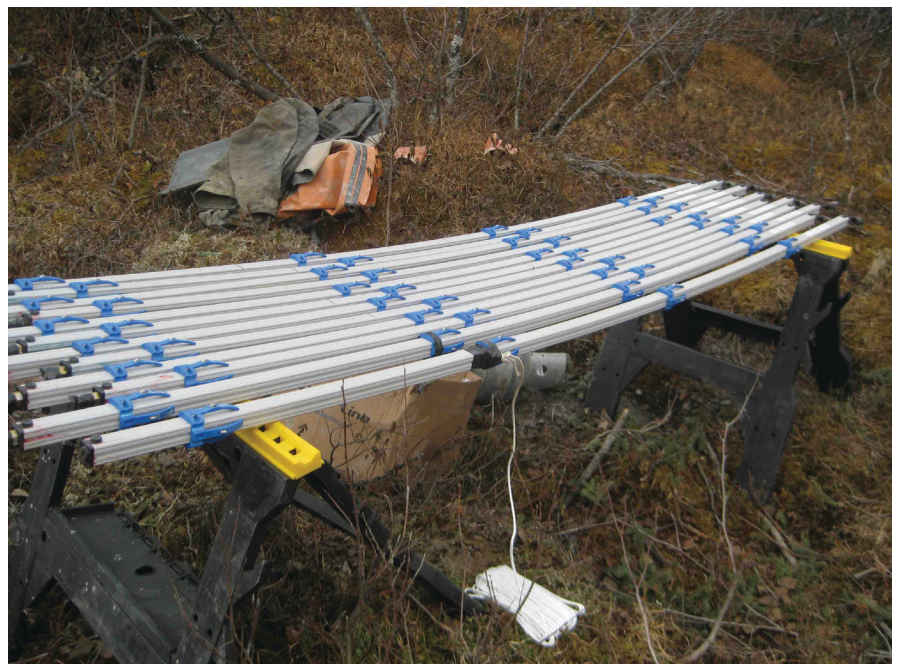
Figure 1. INC500 modules, staged with centralizers attached and ready for installation.

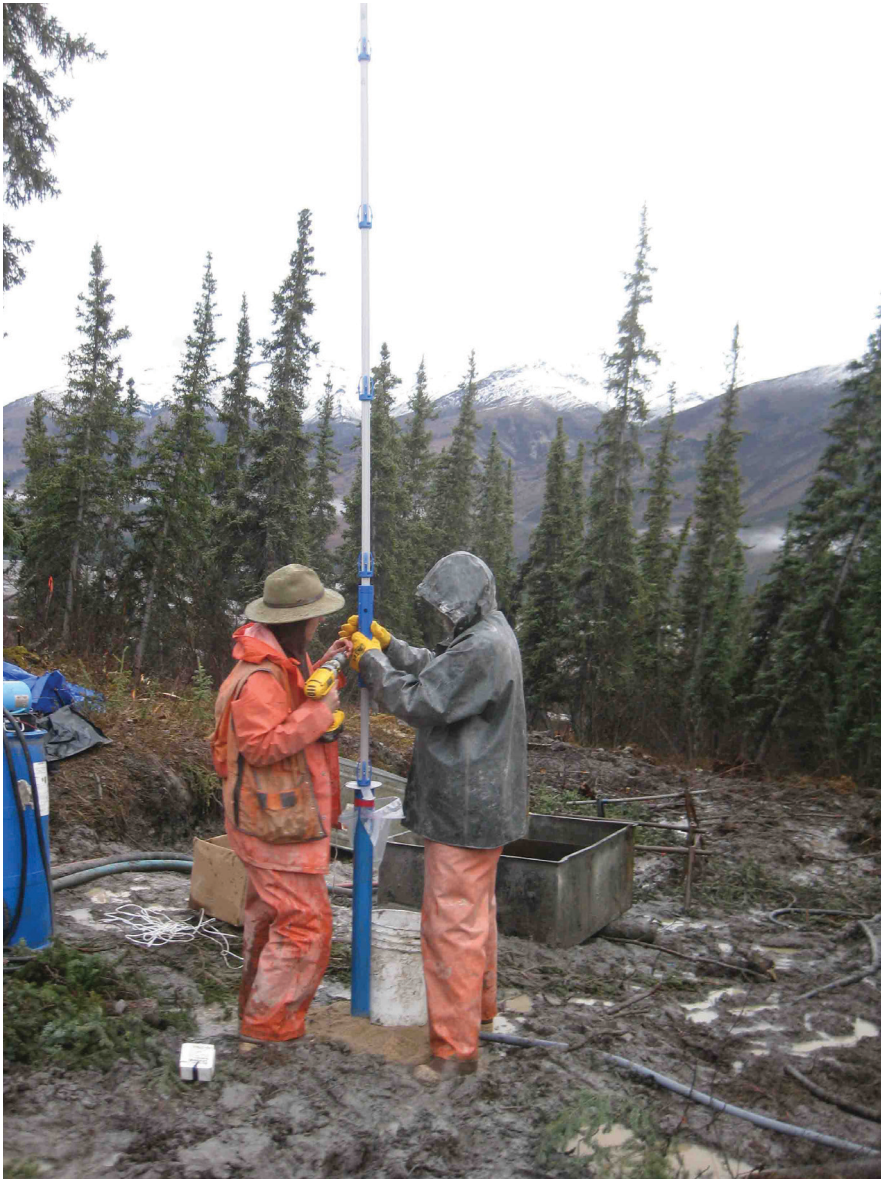
Figure 2. Installing the INC500 within the guide casing (photograph courtesy of J. Simpson).

For this installation, the INC500 device consisted of 12 modules and was installed to 30.5 m bgs (see Figure 2). Due to the difference between the casing and assembled M-IPI lengths, approximately 0.5 m of the uppermost INC500 module was above the ground surface within the casing. The guide casing was filled with propylene glycol to prevent freezing of any
