THE FAILURE AND RIGHTING OF THE TRANSCONA GRAIN ELEVATOR

THE FAILURE OF THE TRANSCONA GRAIN ELEVATOR

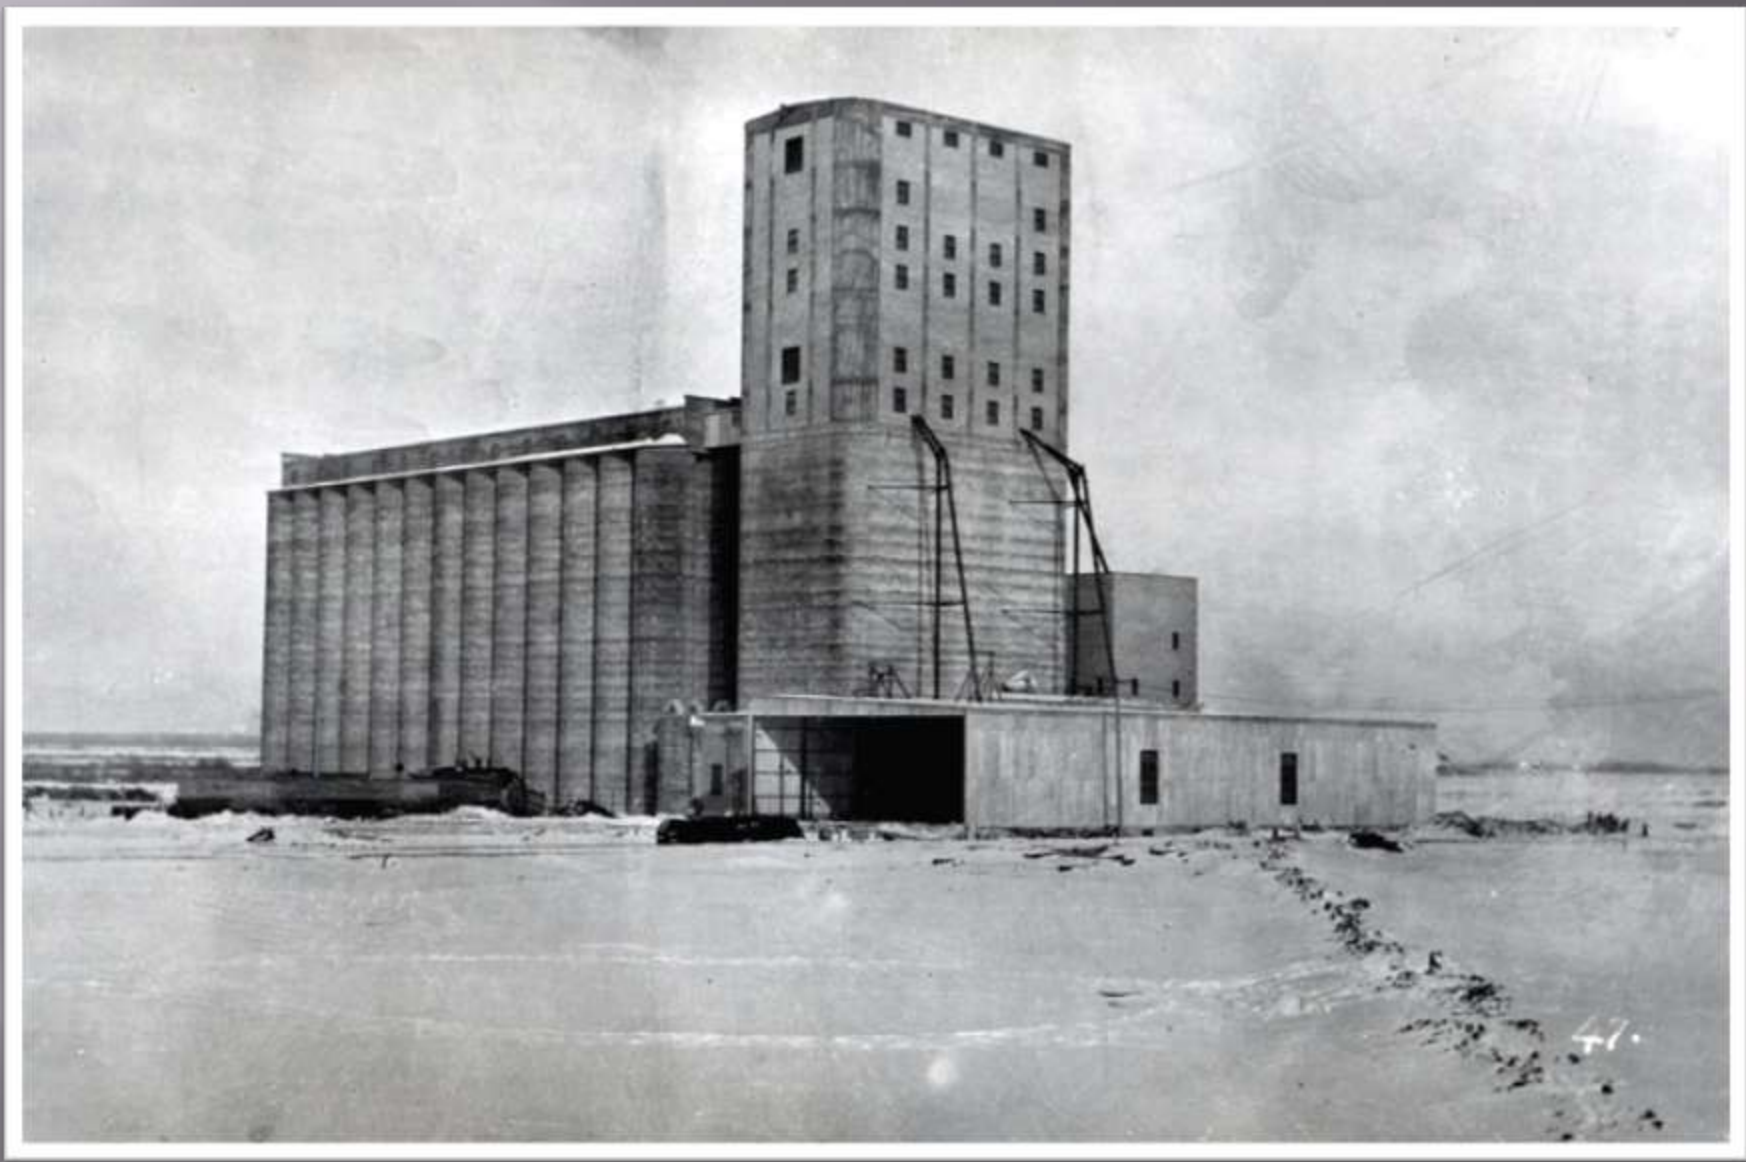
Elevator Before Failure Looking NE

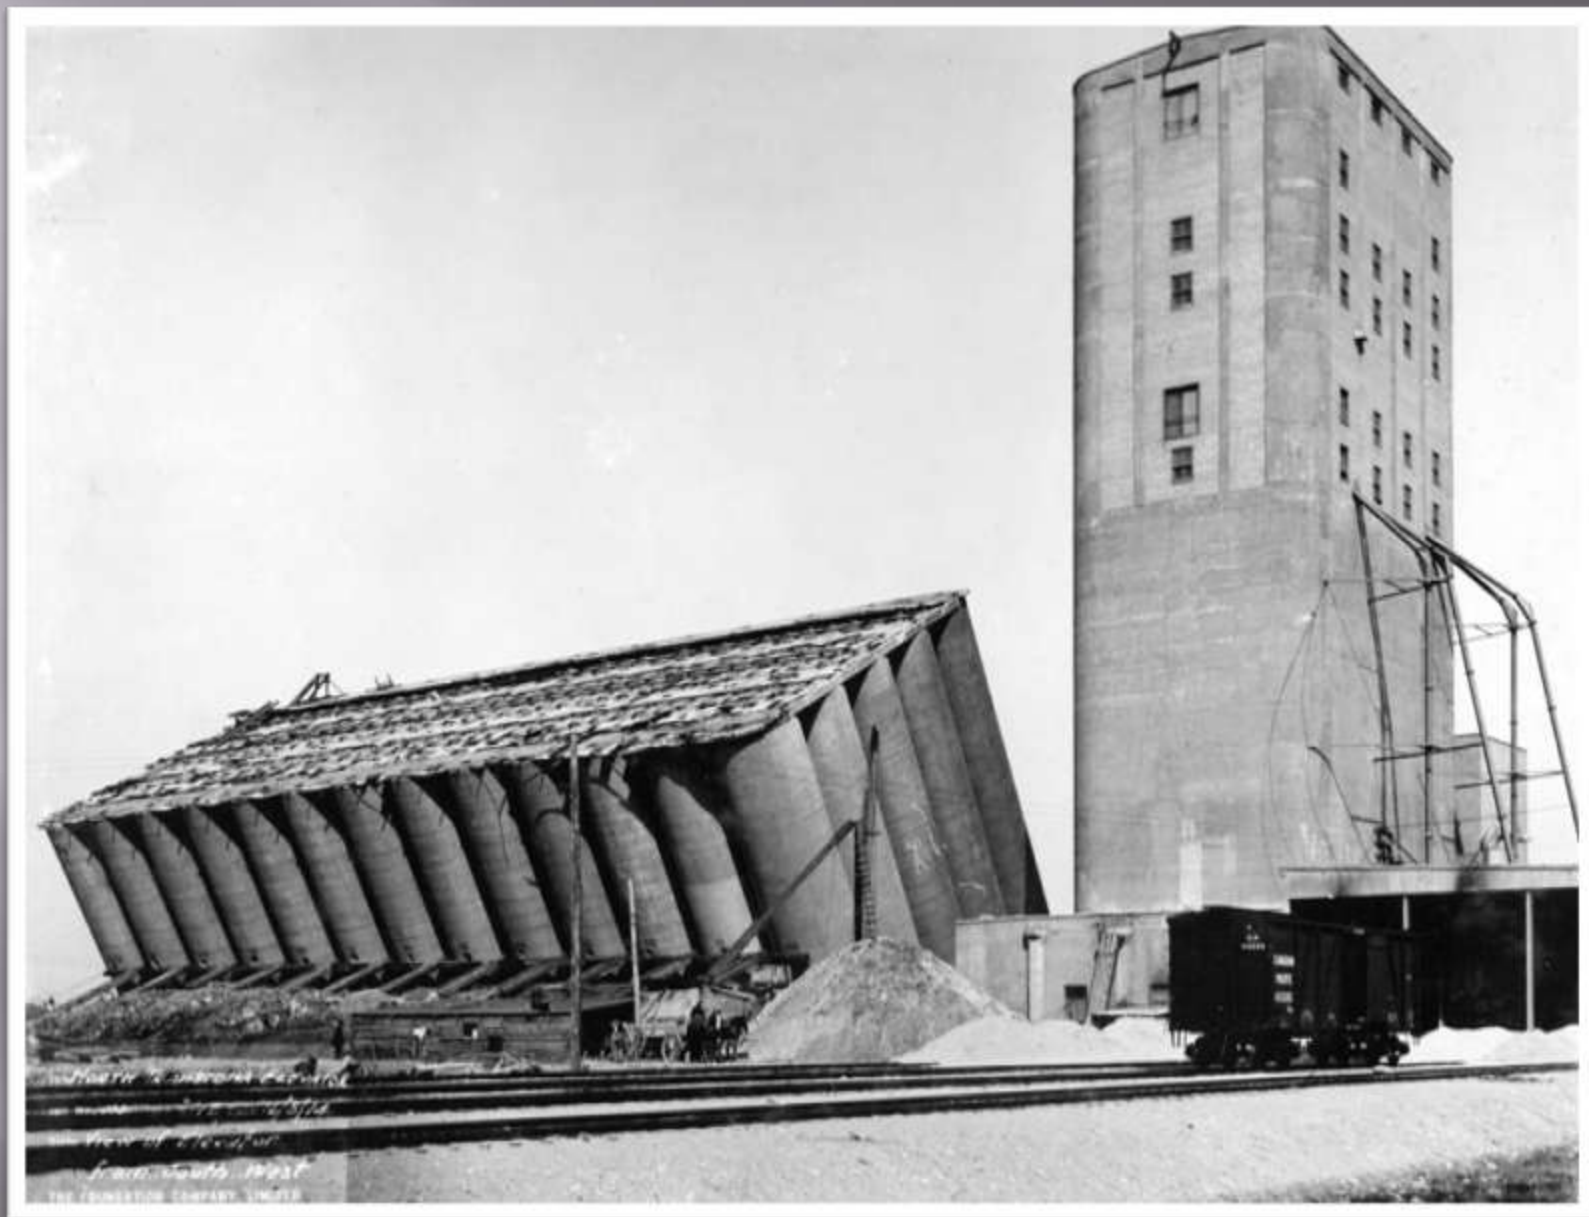
View of Elevator From South West

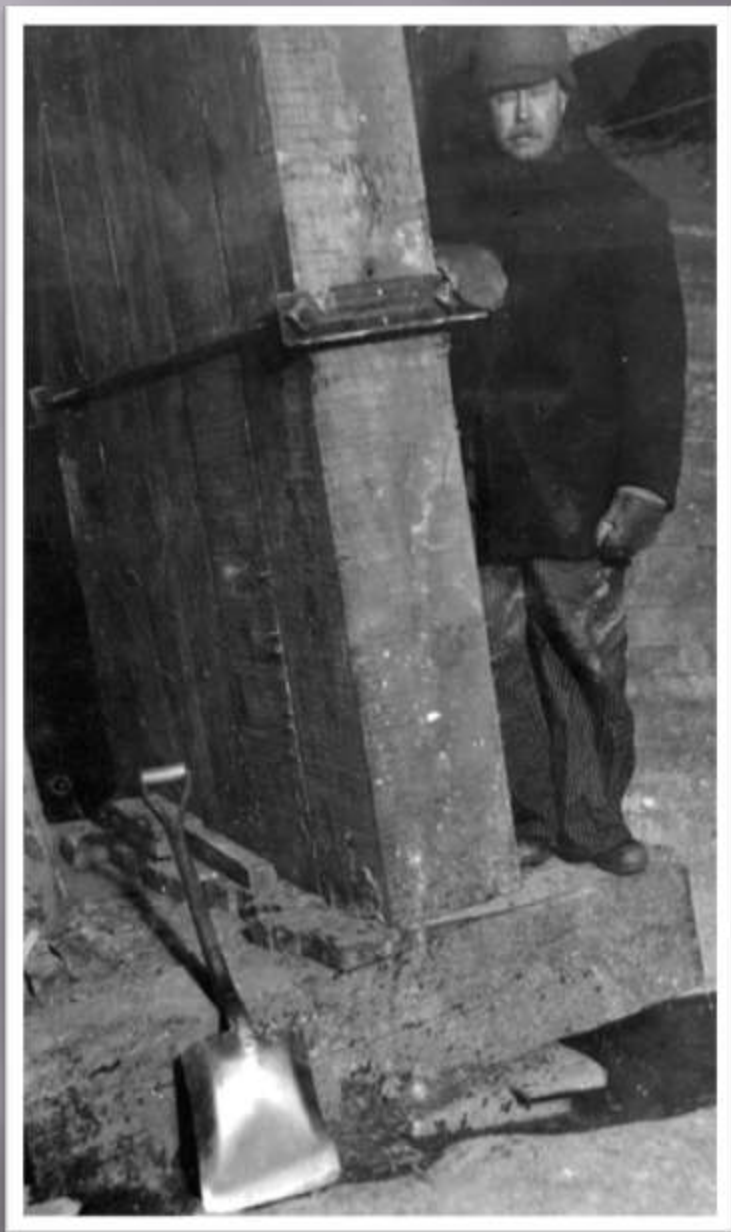
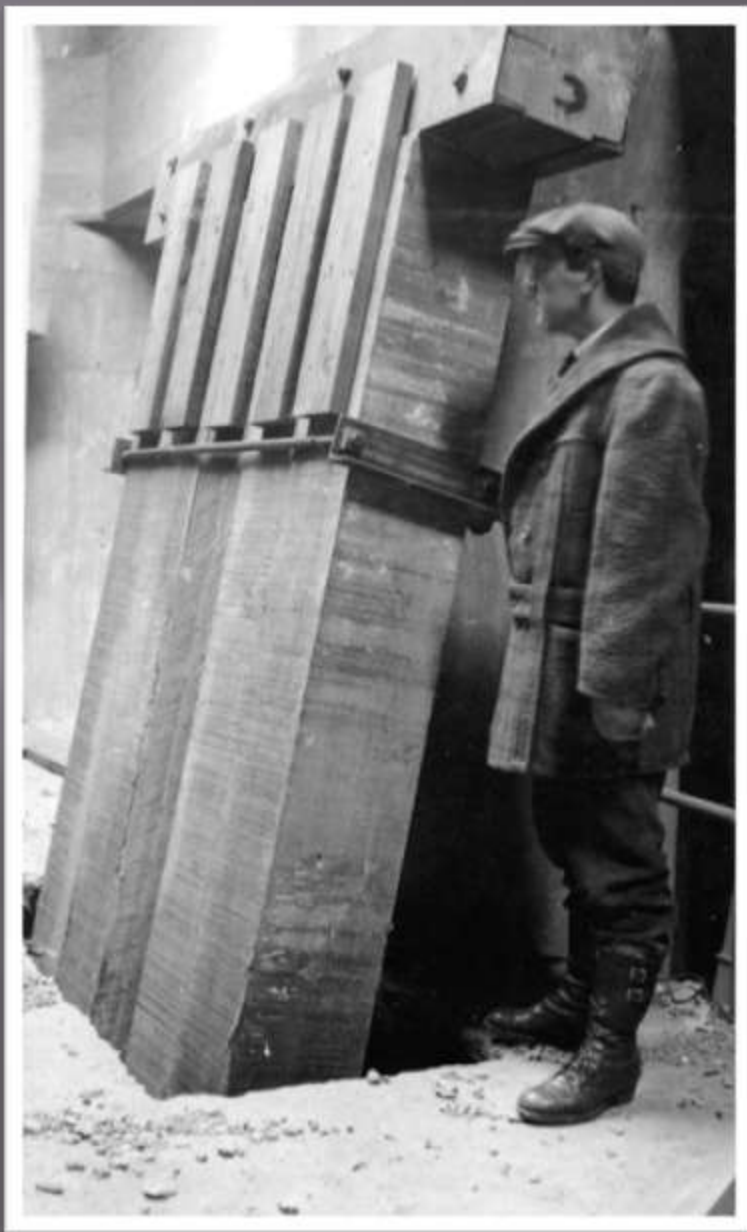
Foot and Top of Shores in Workhouse

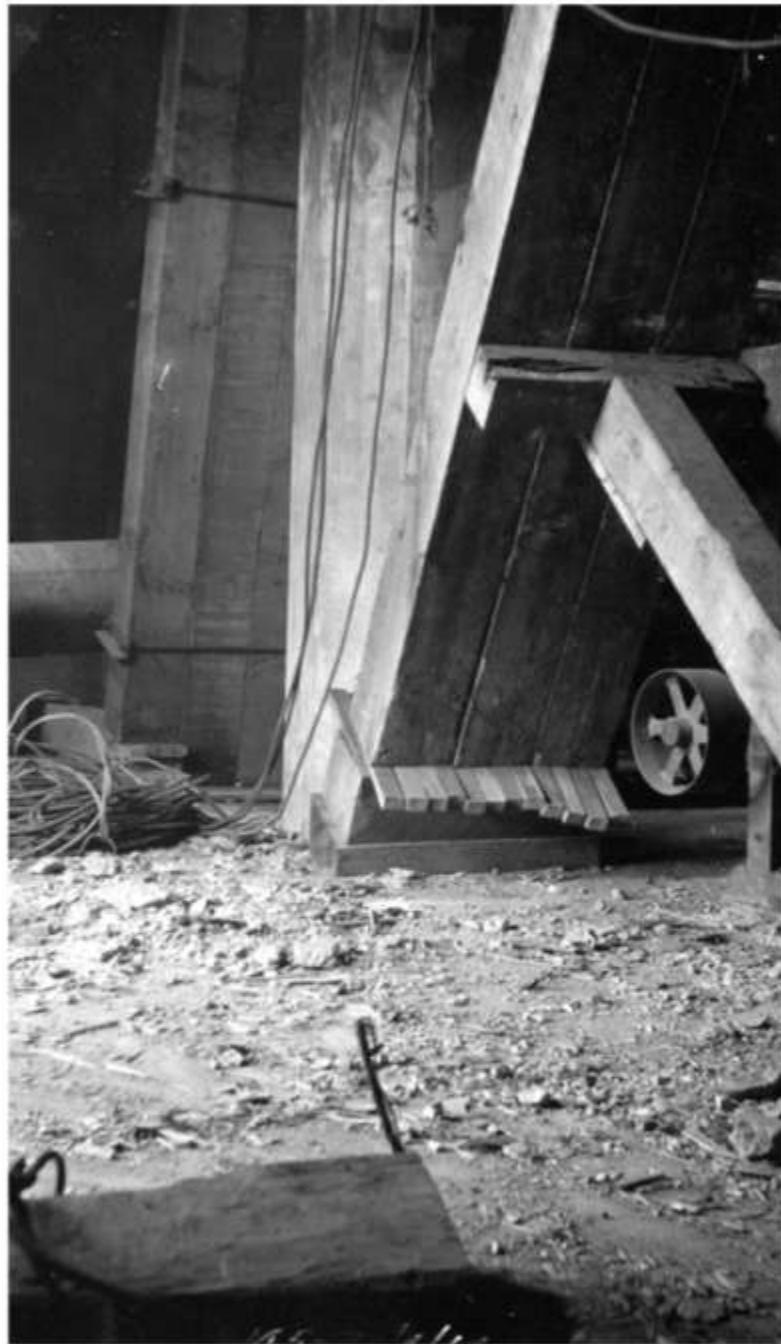
Secondary Shores
in 2nd Floor of
Workhouse

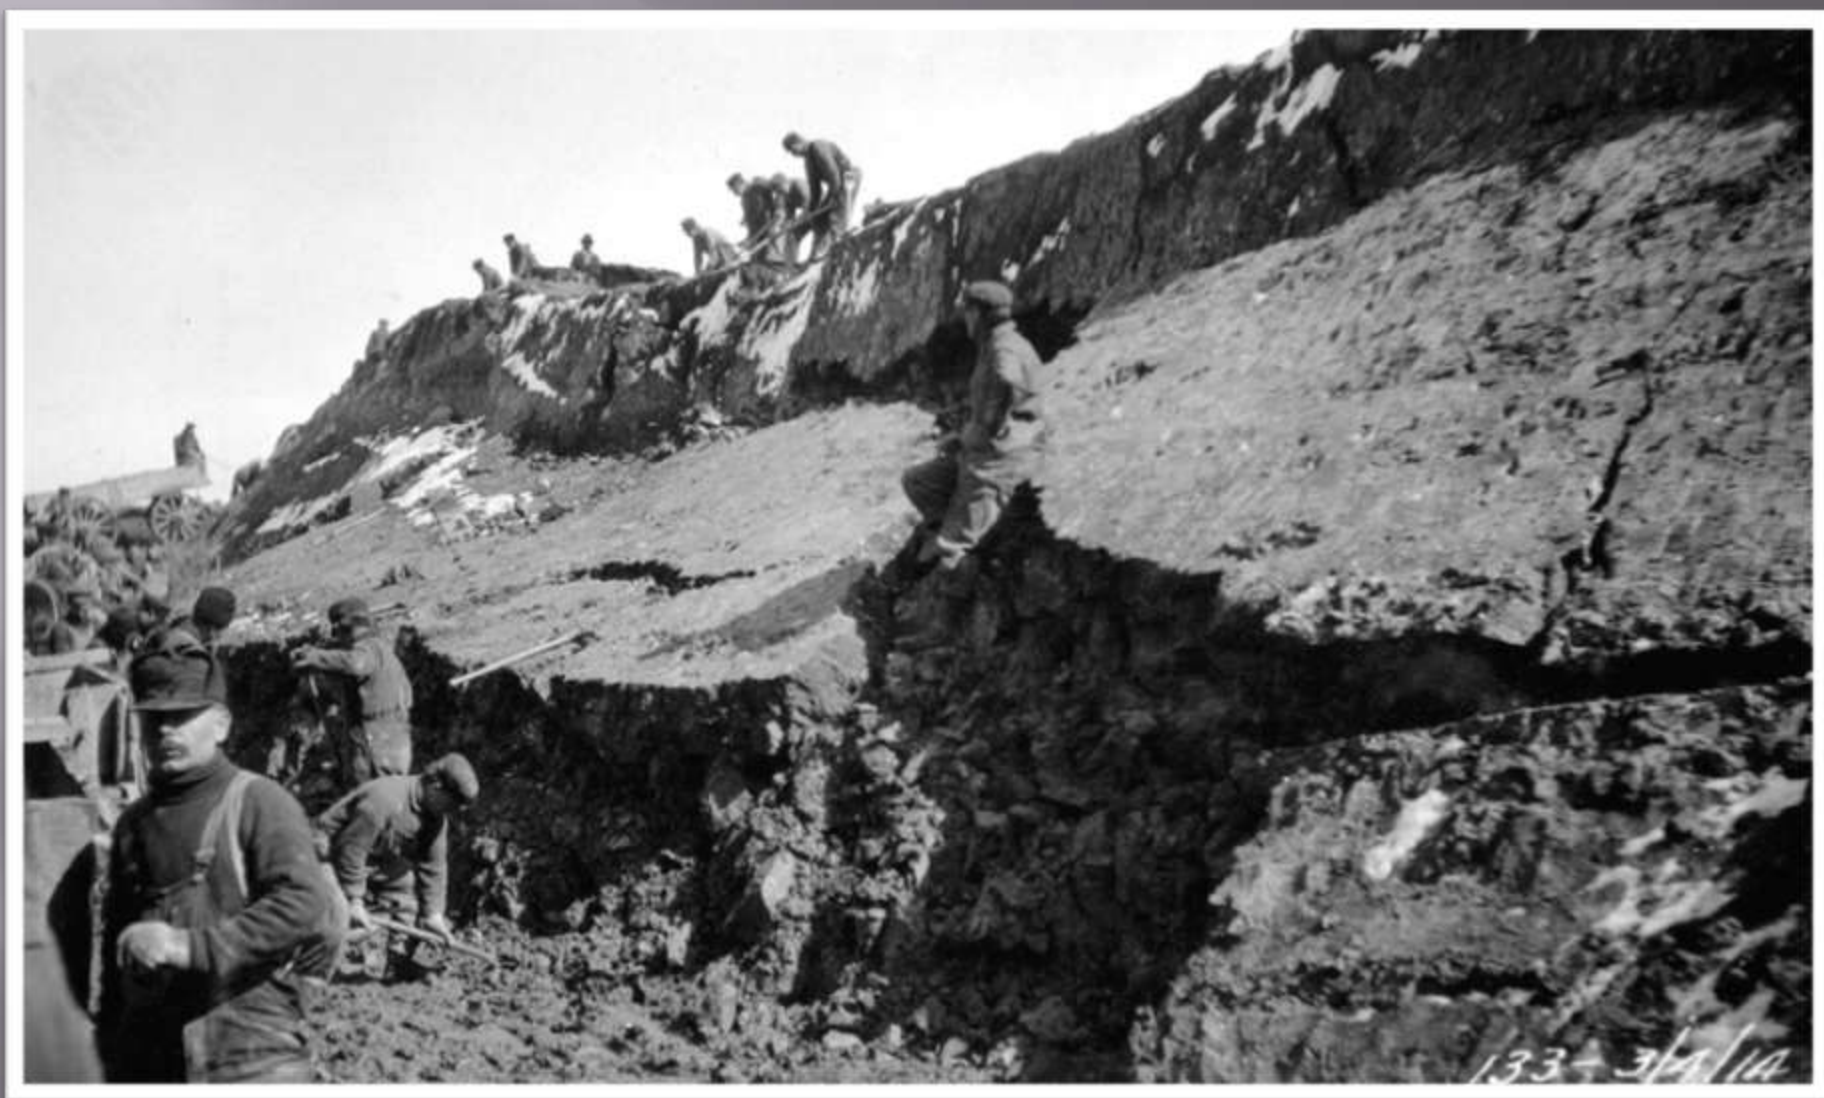
Slide in East Side Trench

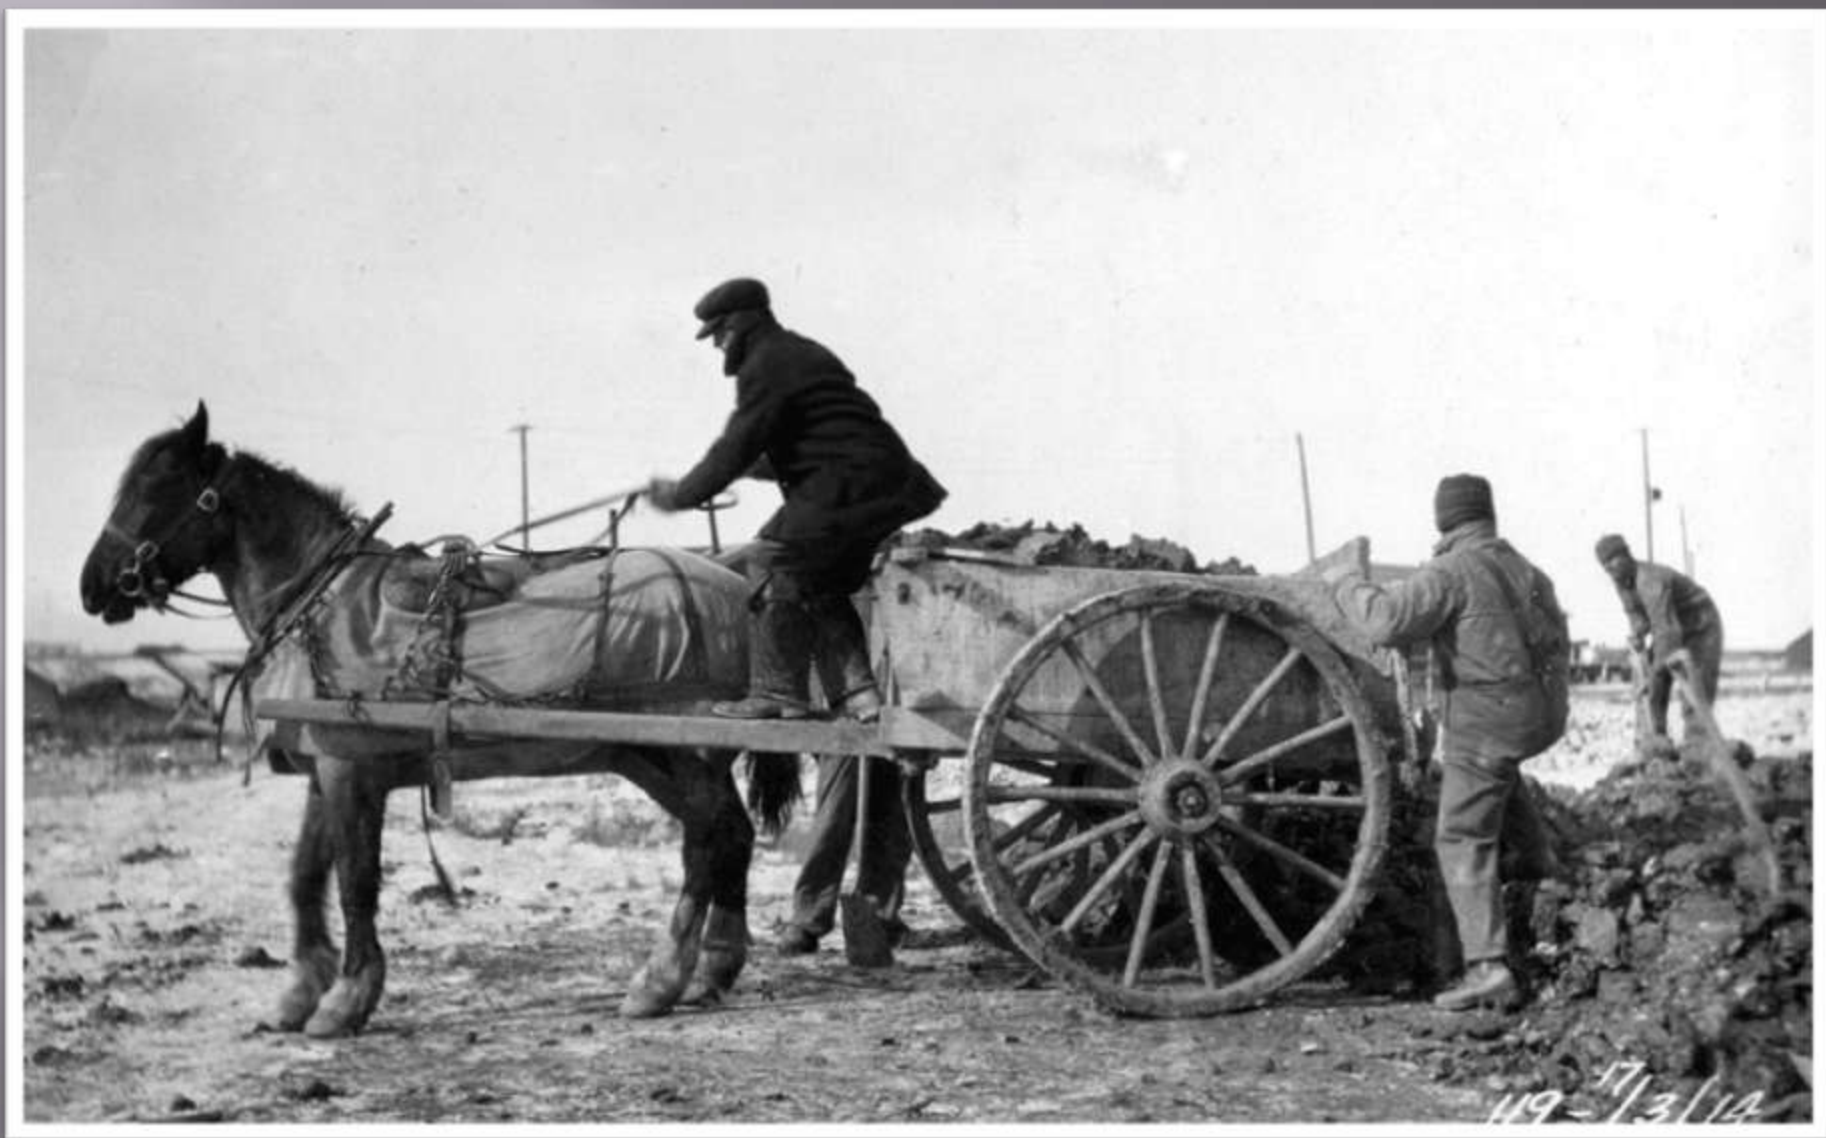
Disposal of Earth From East Excavation

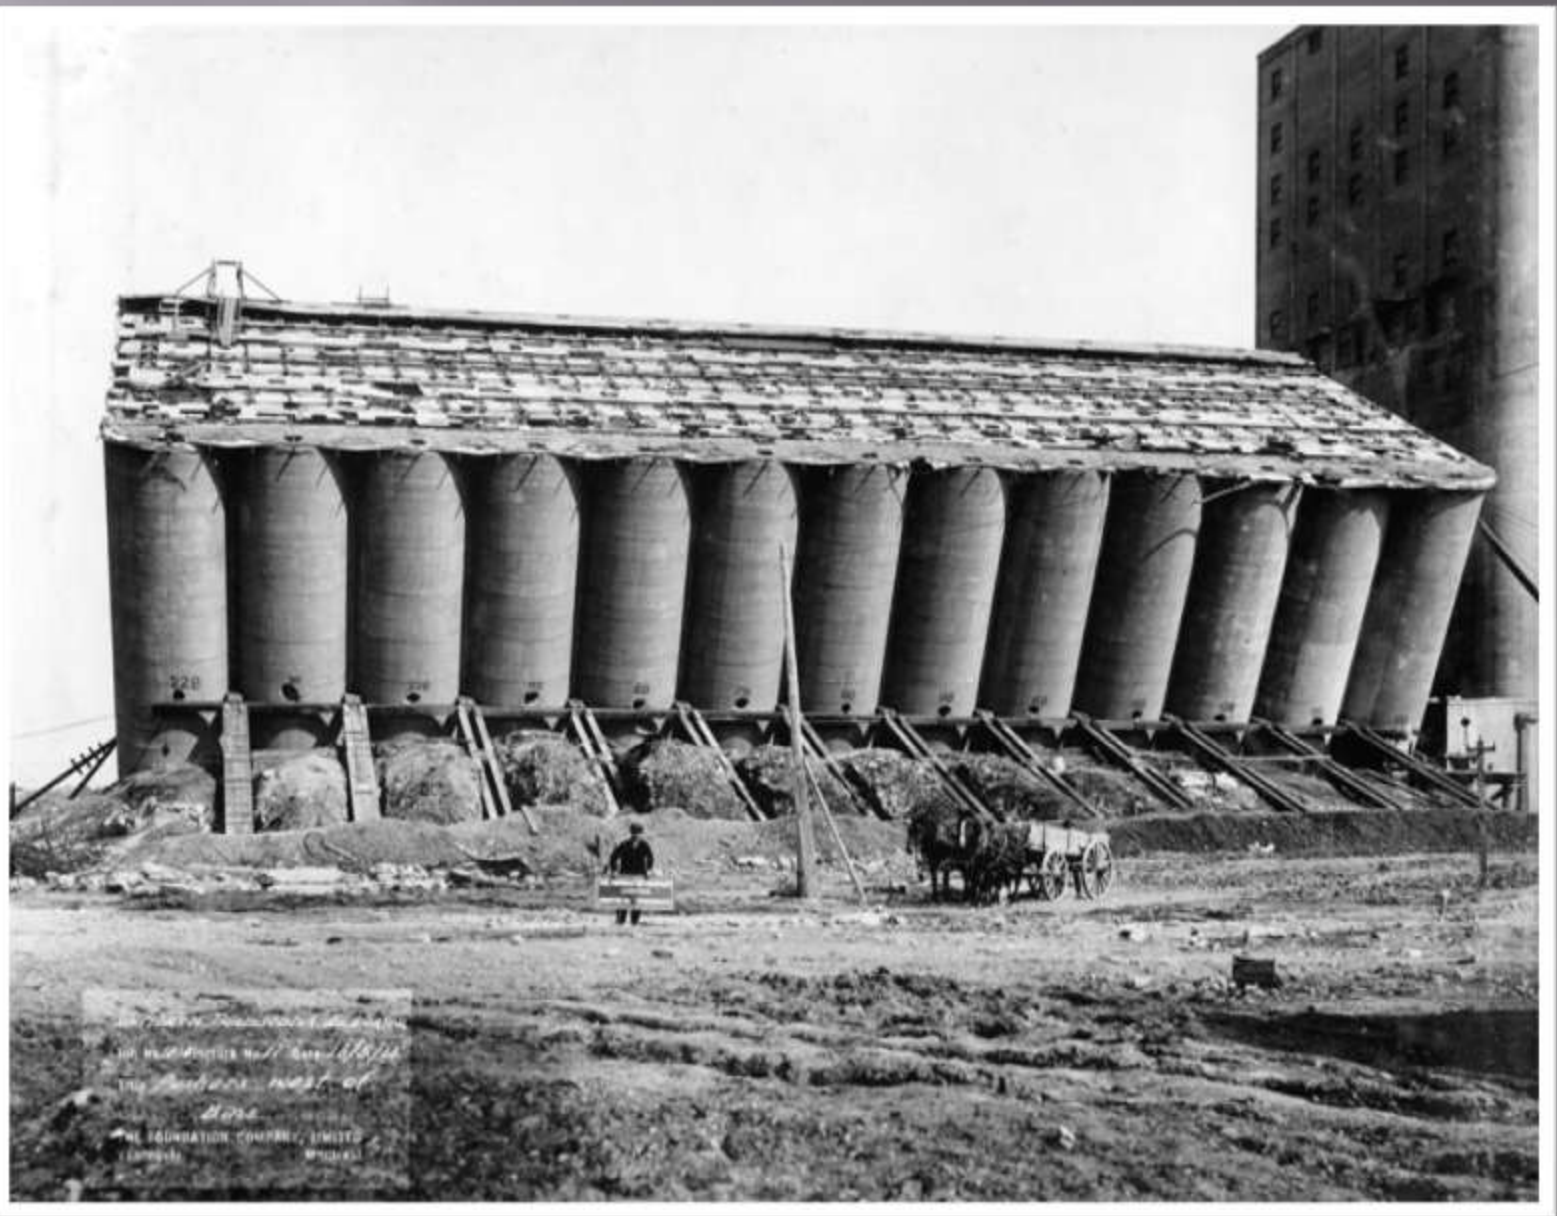
Pushers West of Bins

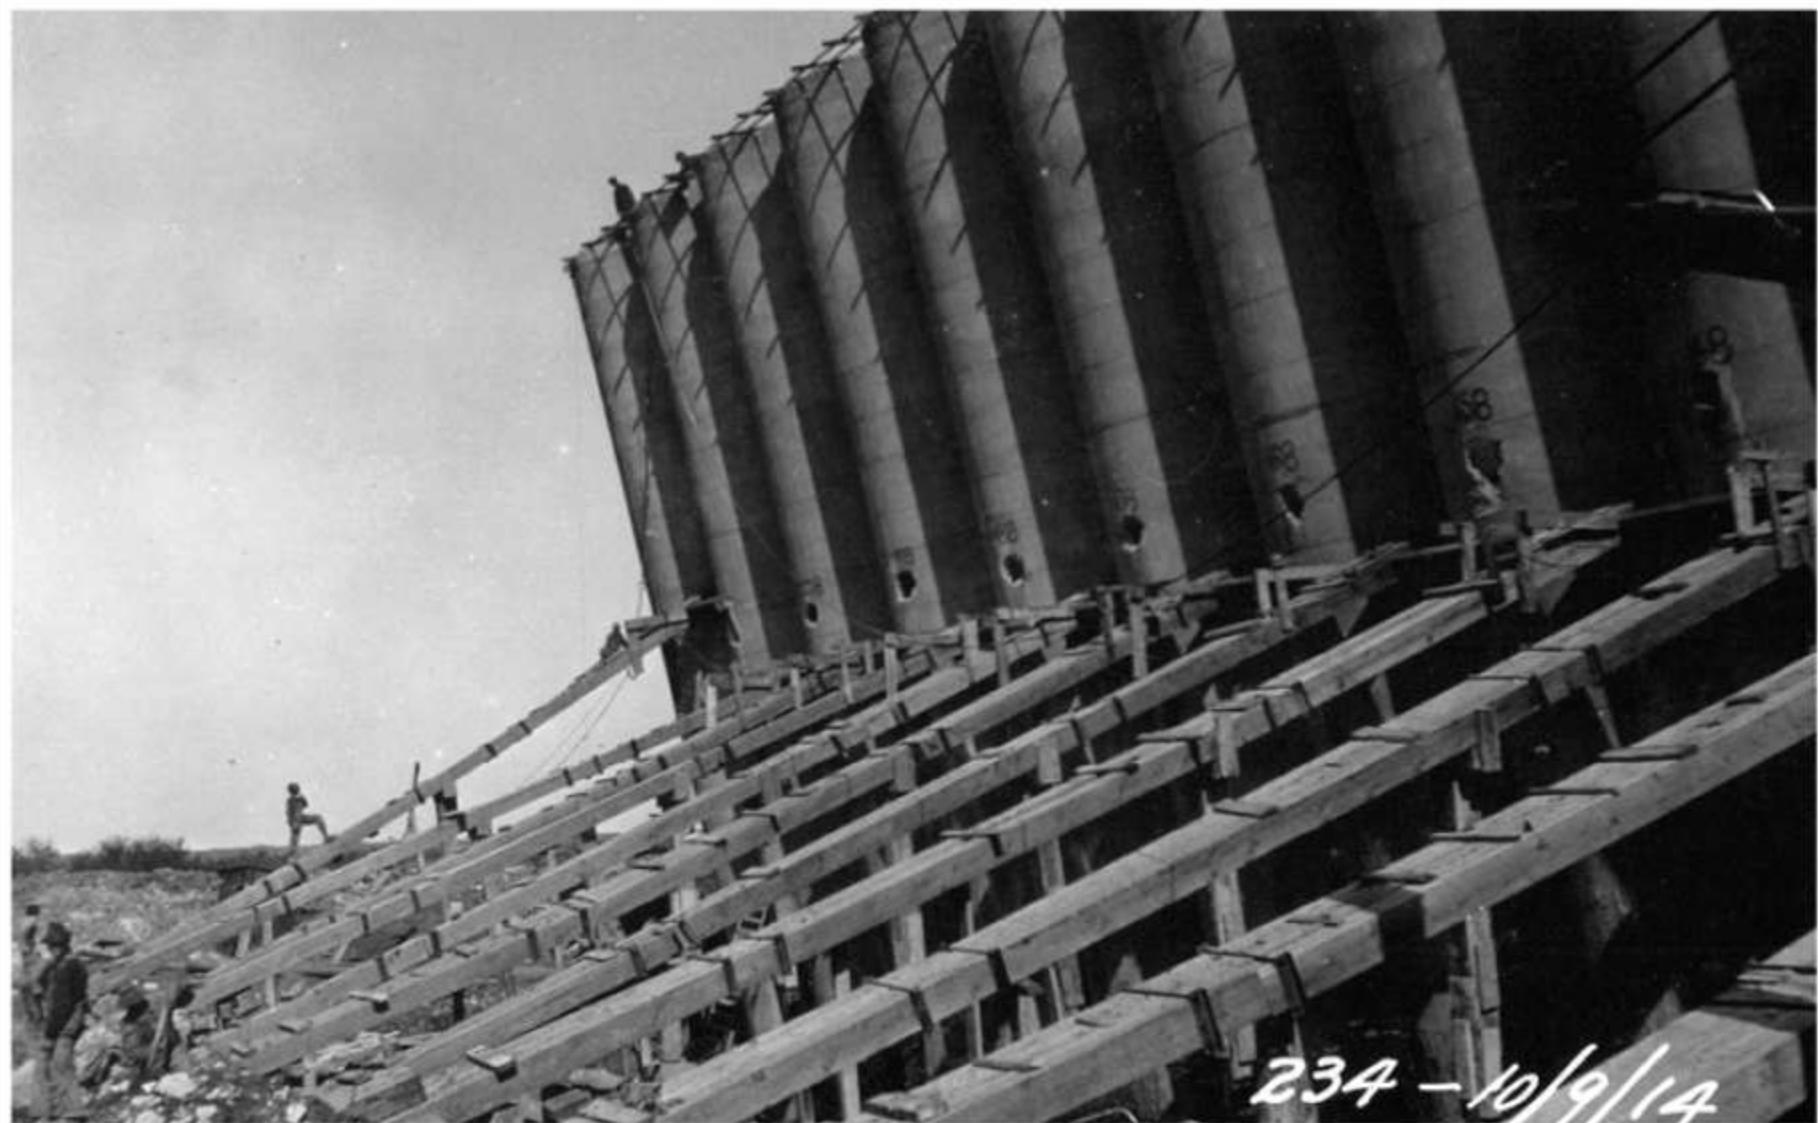
West Side Pushers – Note Holes in Side of Bins to Tap Grain

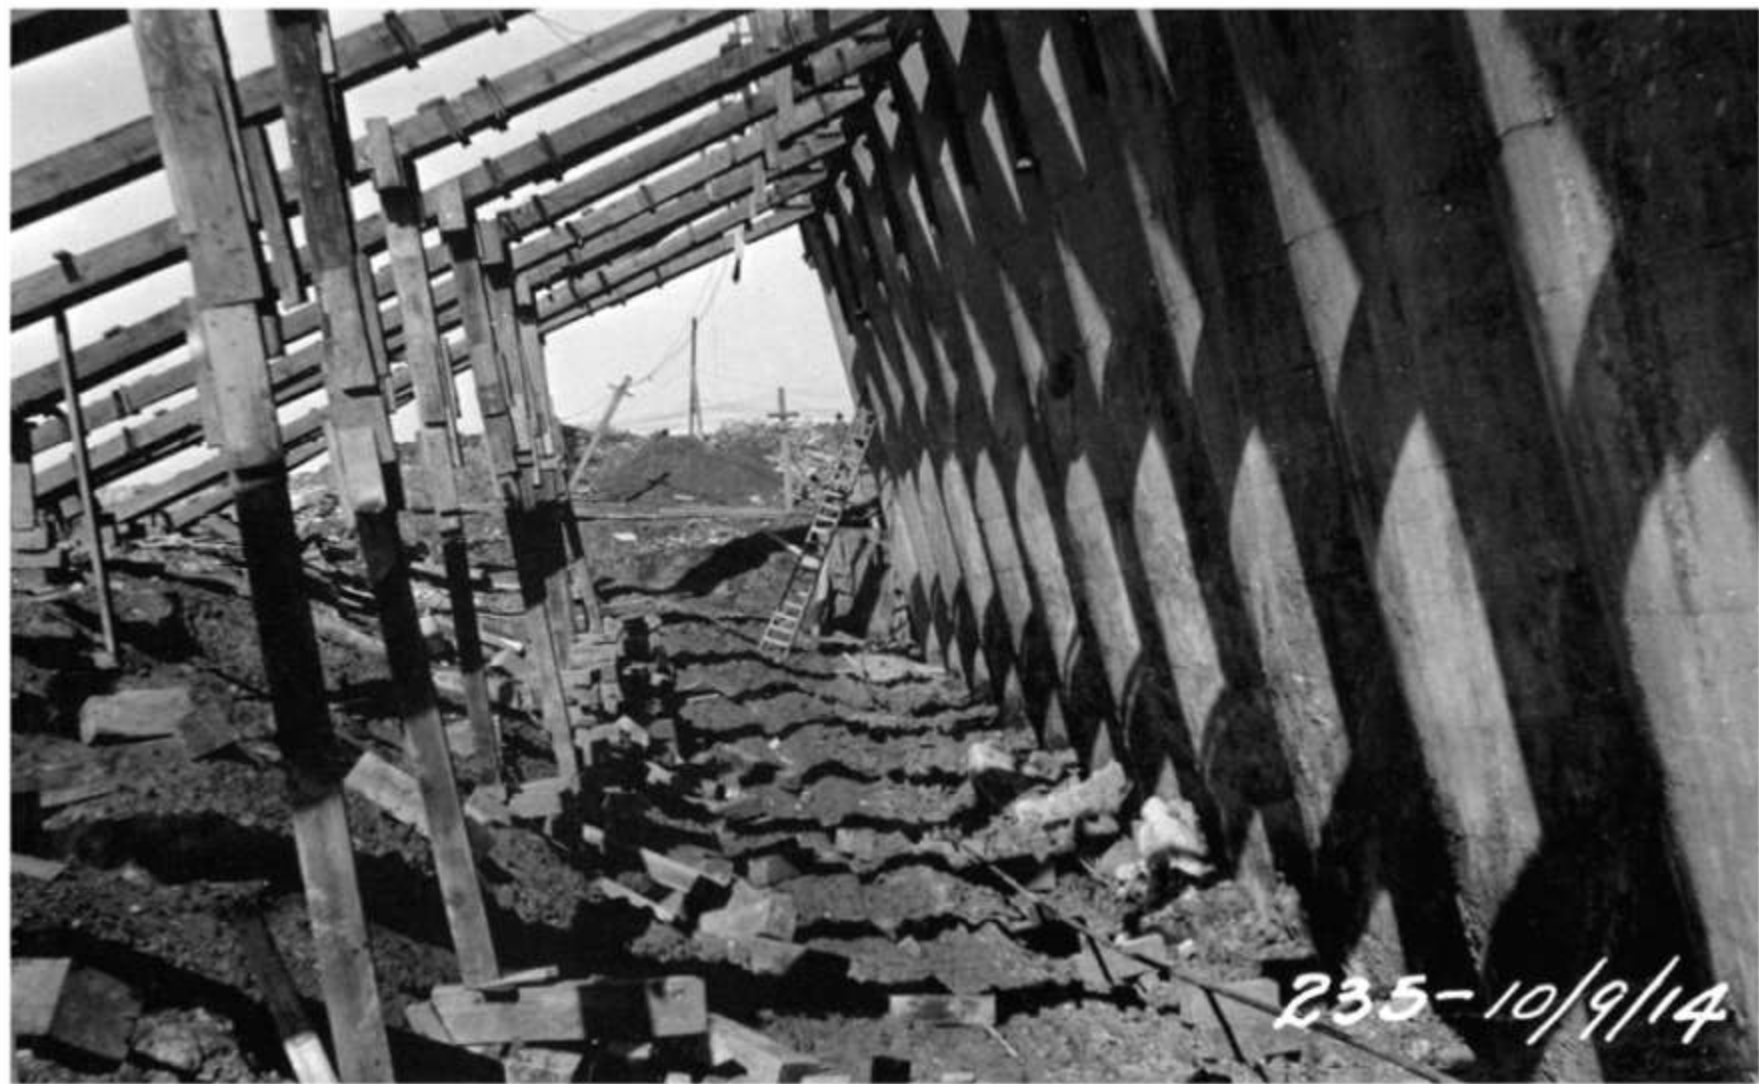
West Side Pushers

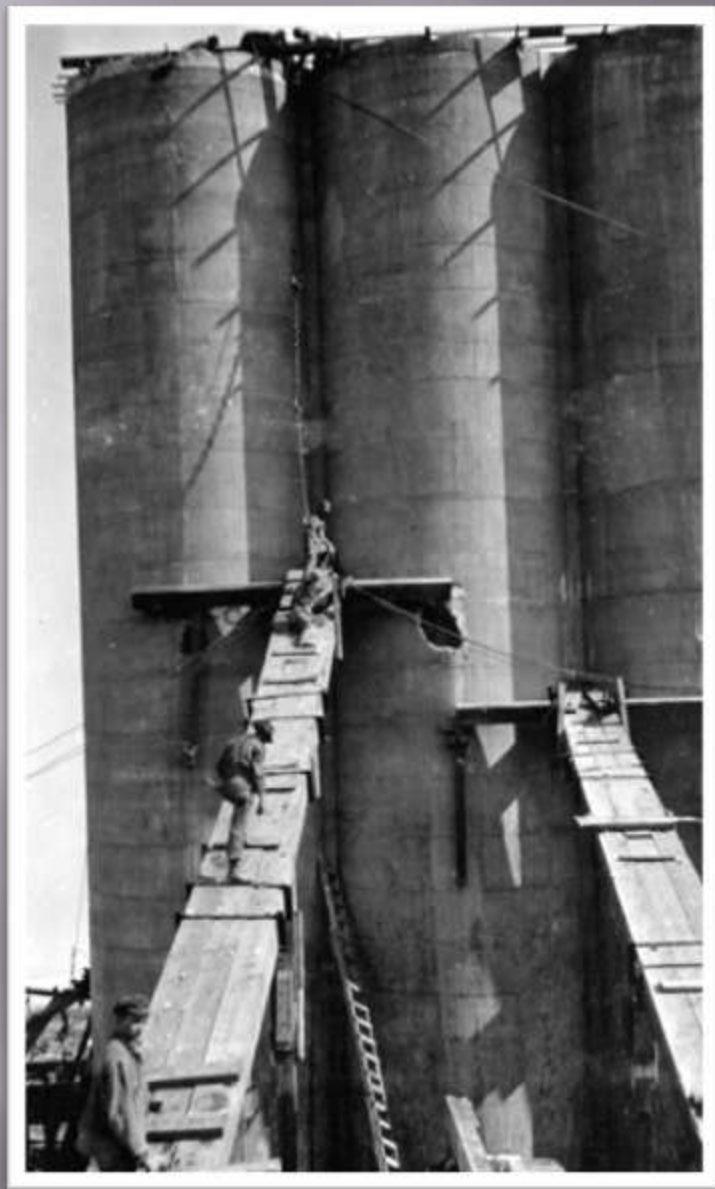
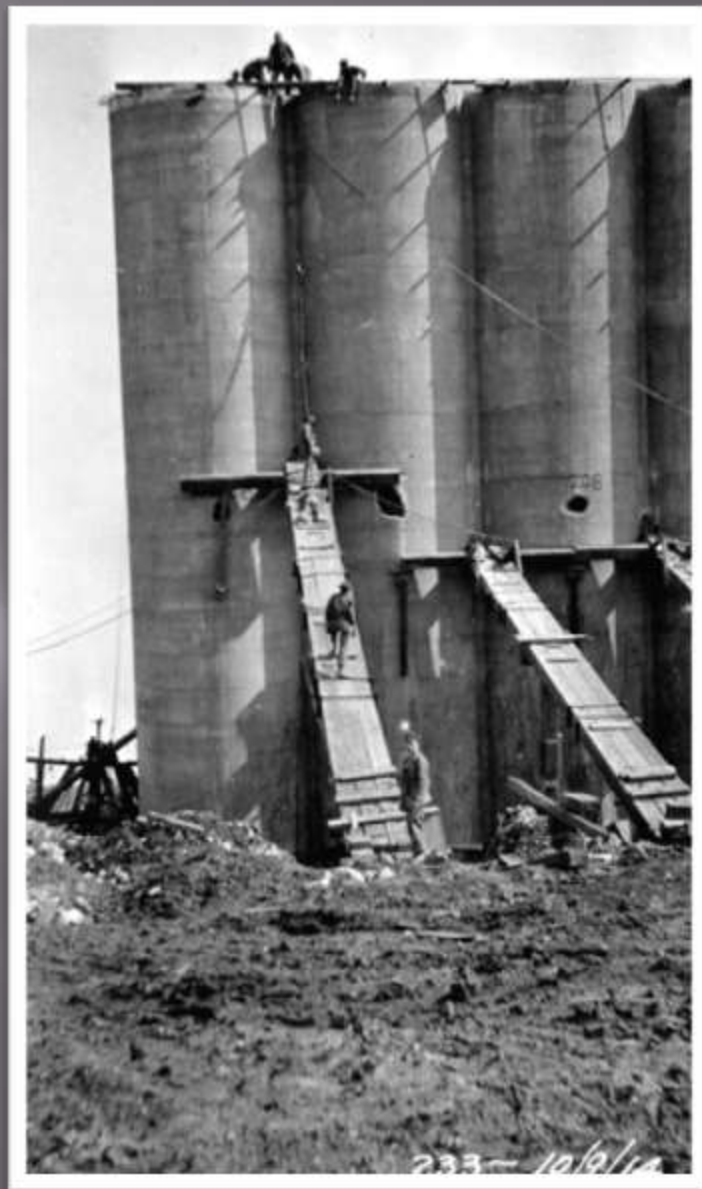
Lowering Pushers on West Side of Bins

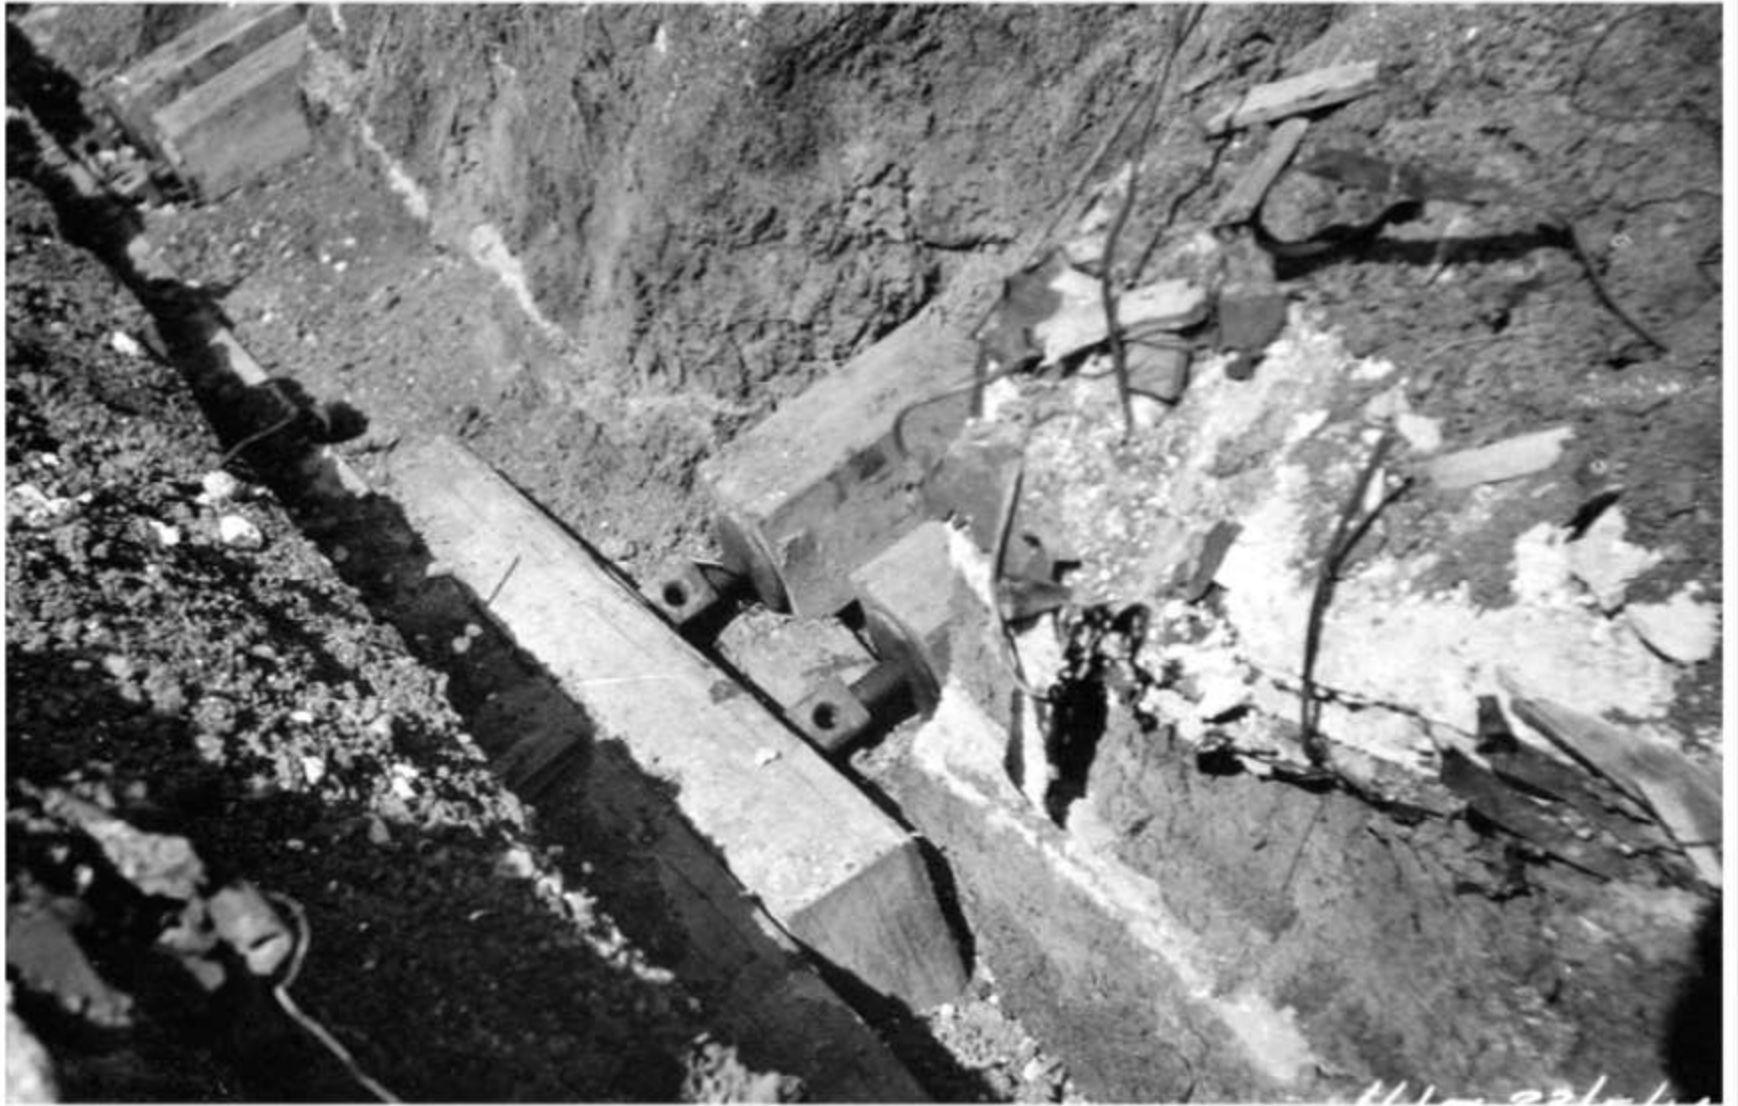
Shoring Screws at Foot of Pushers

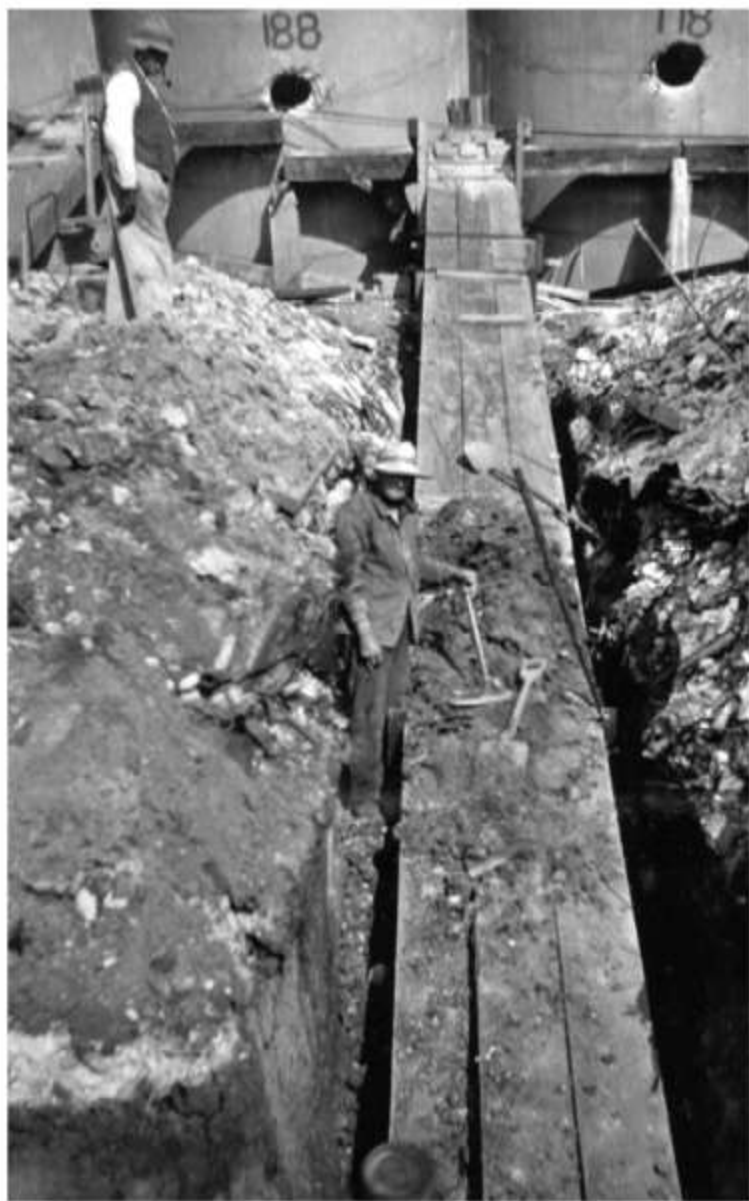
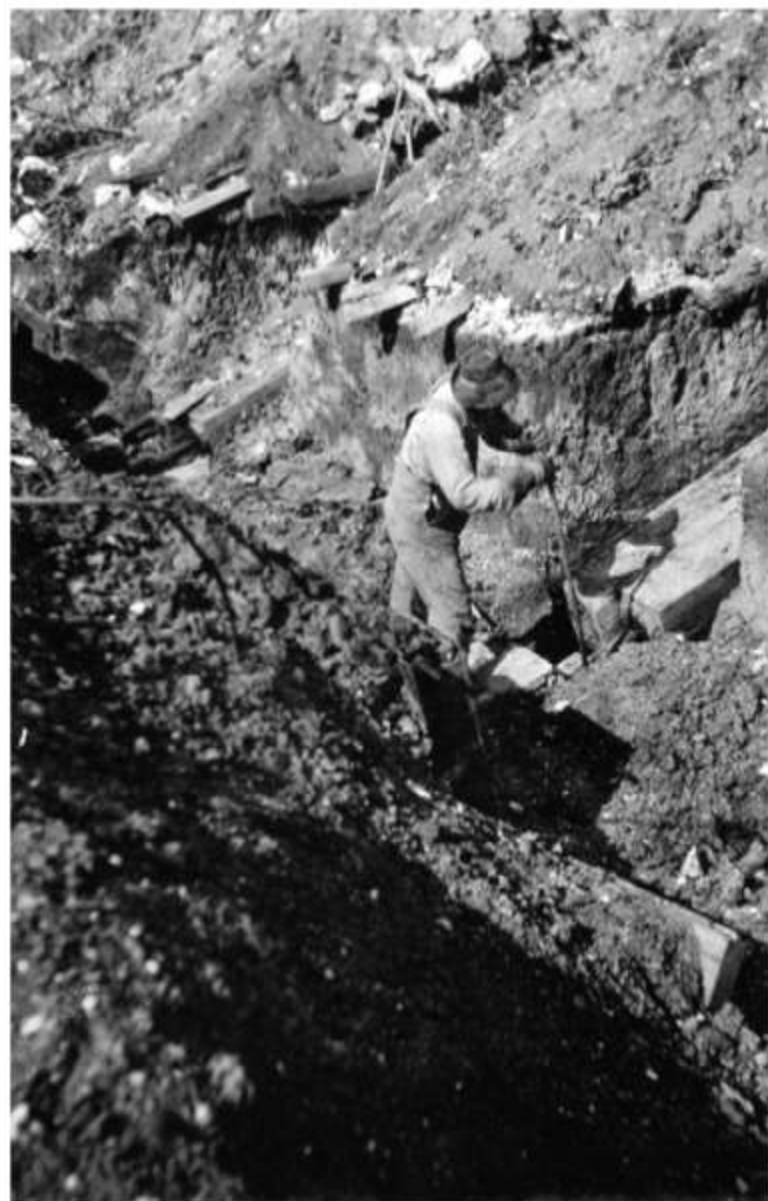
Timber Pushers on West Side of Bins
