THE FAILURE AND RIGHTING OF THE TRANSCONA GRAIN ELEVATOR

THE FAILURE OF THE TRANSCONA GRAIN ELEVATOR

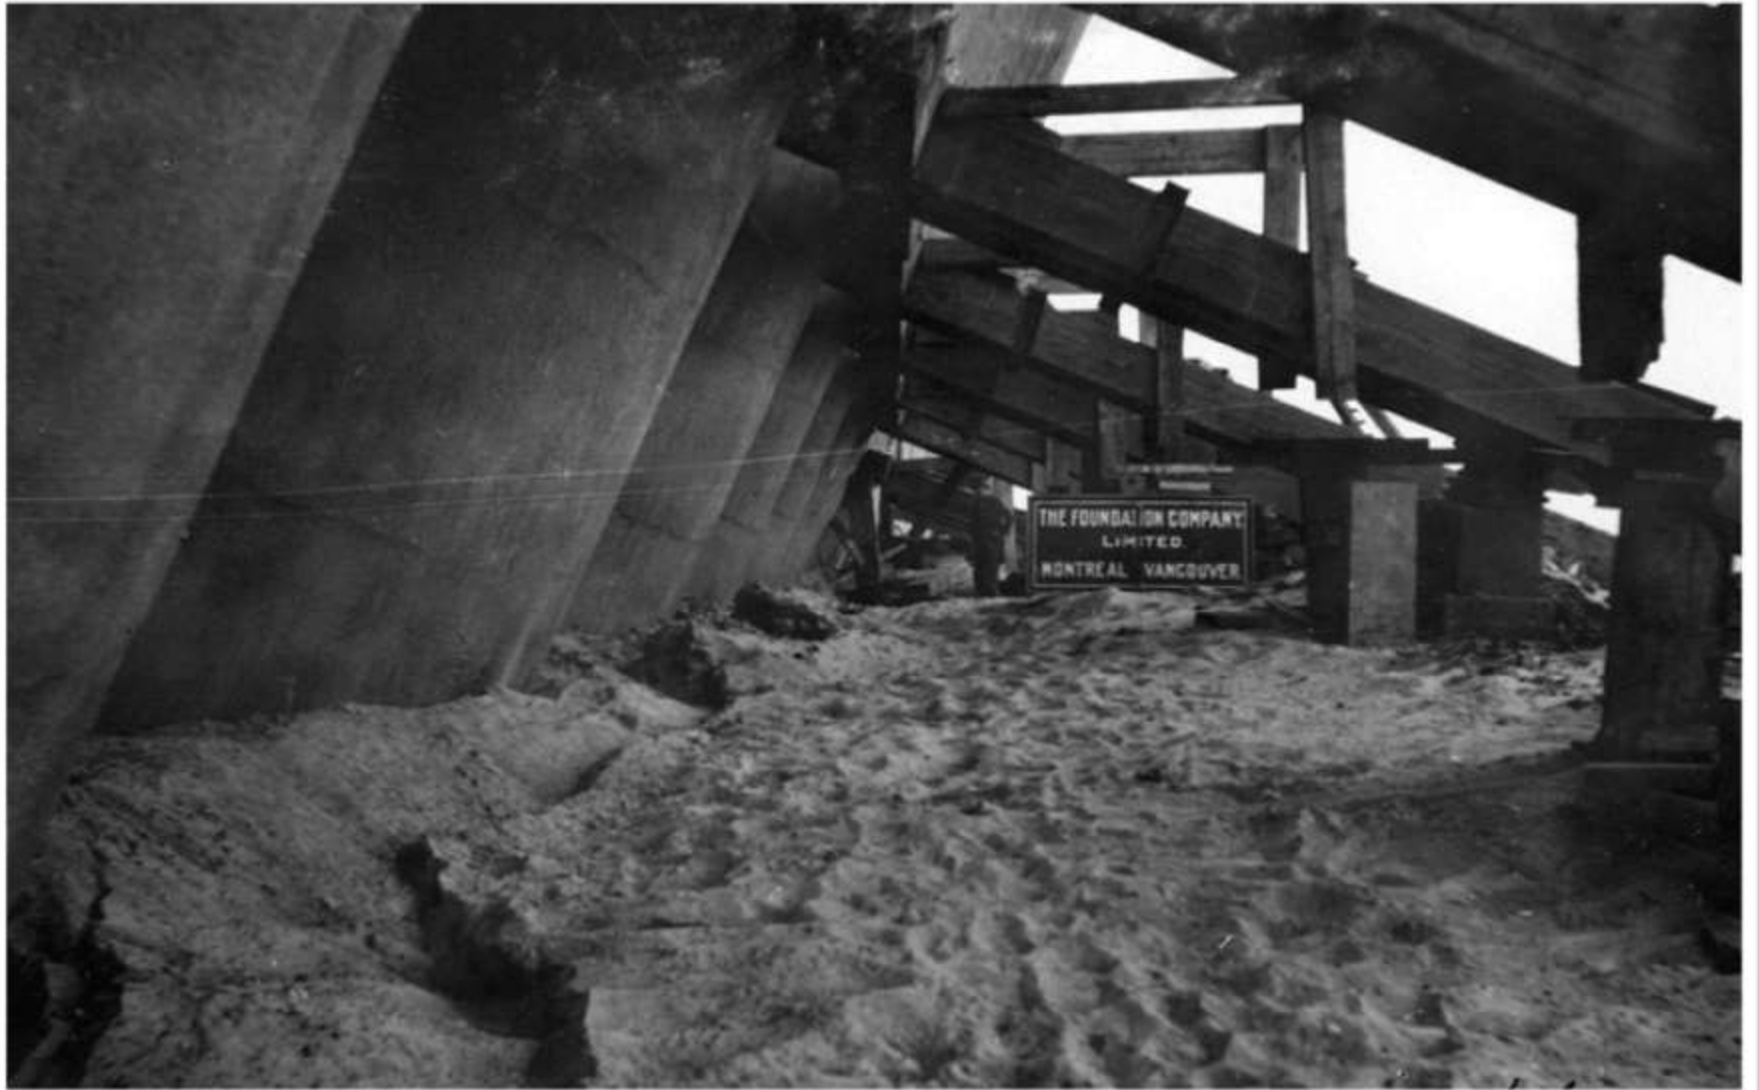
Sand in Crevice West of Bins

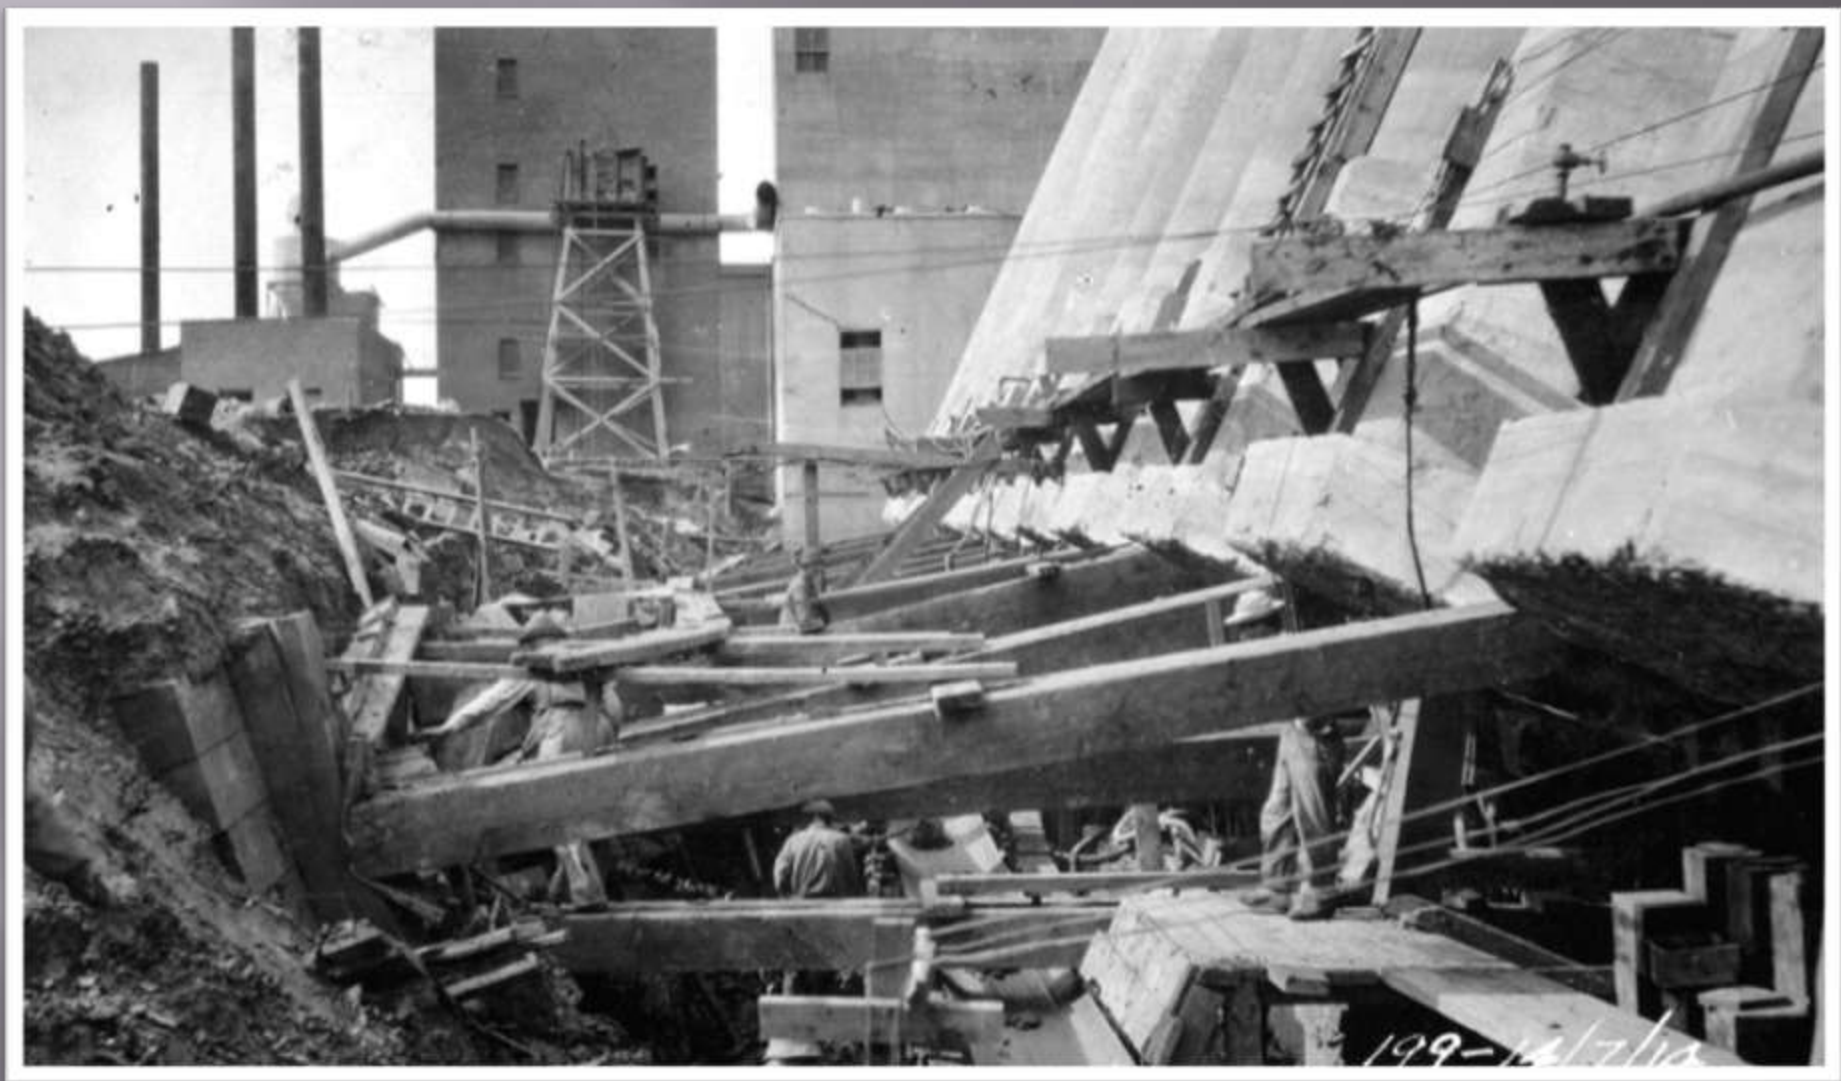
Kicking Braces in East Trench

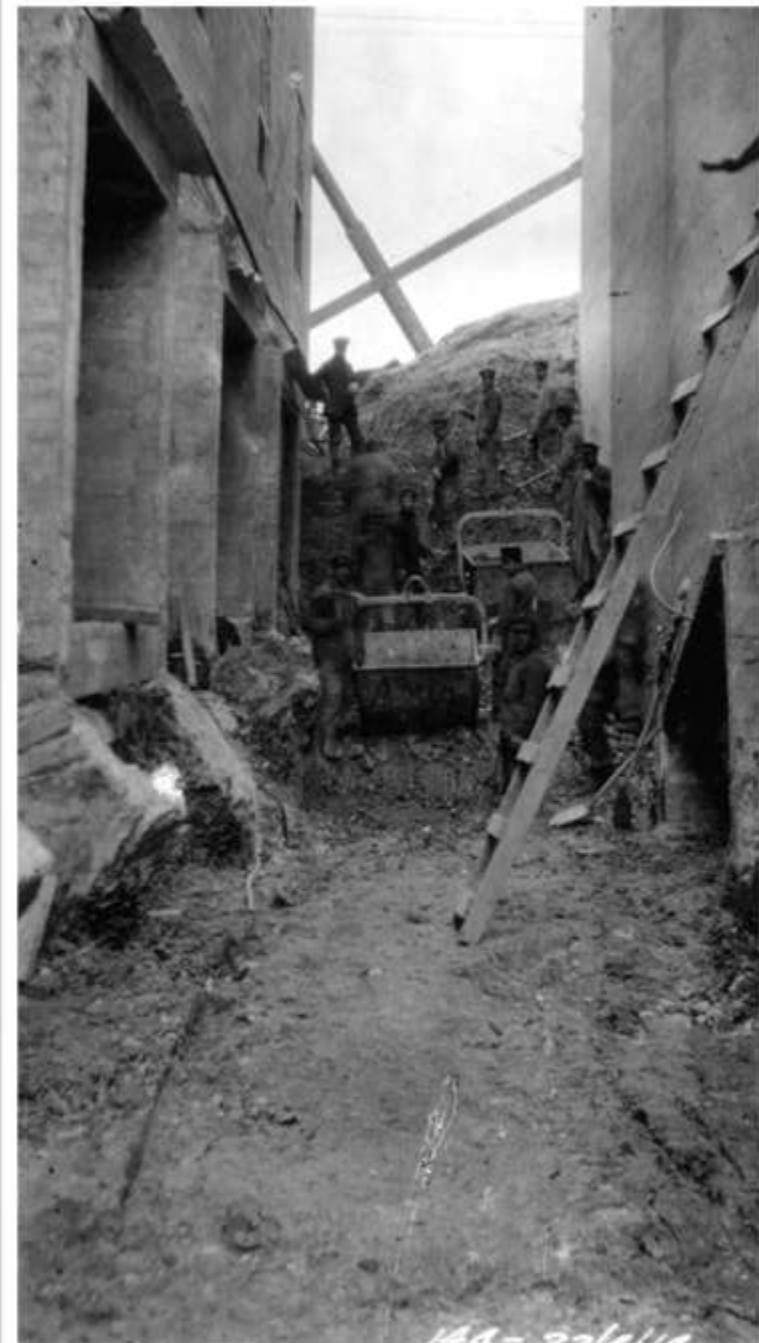
Excavating
Between
Workhouse and
Bins

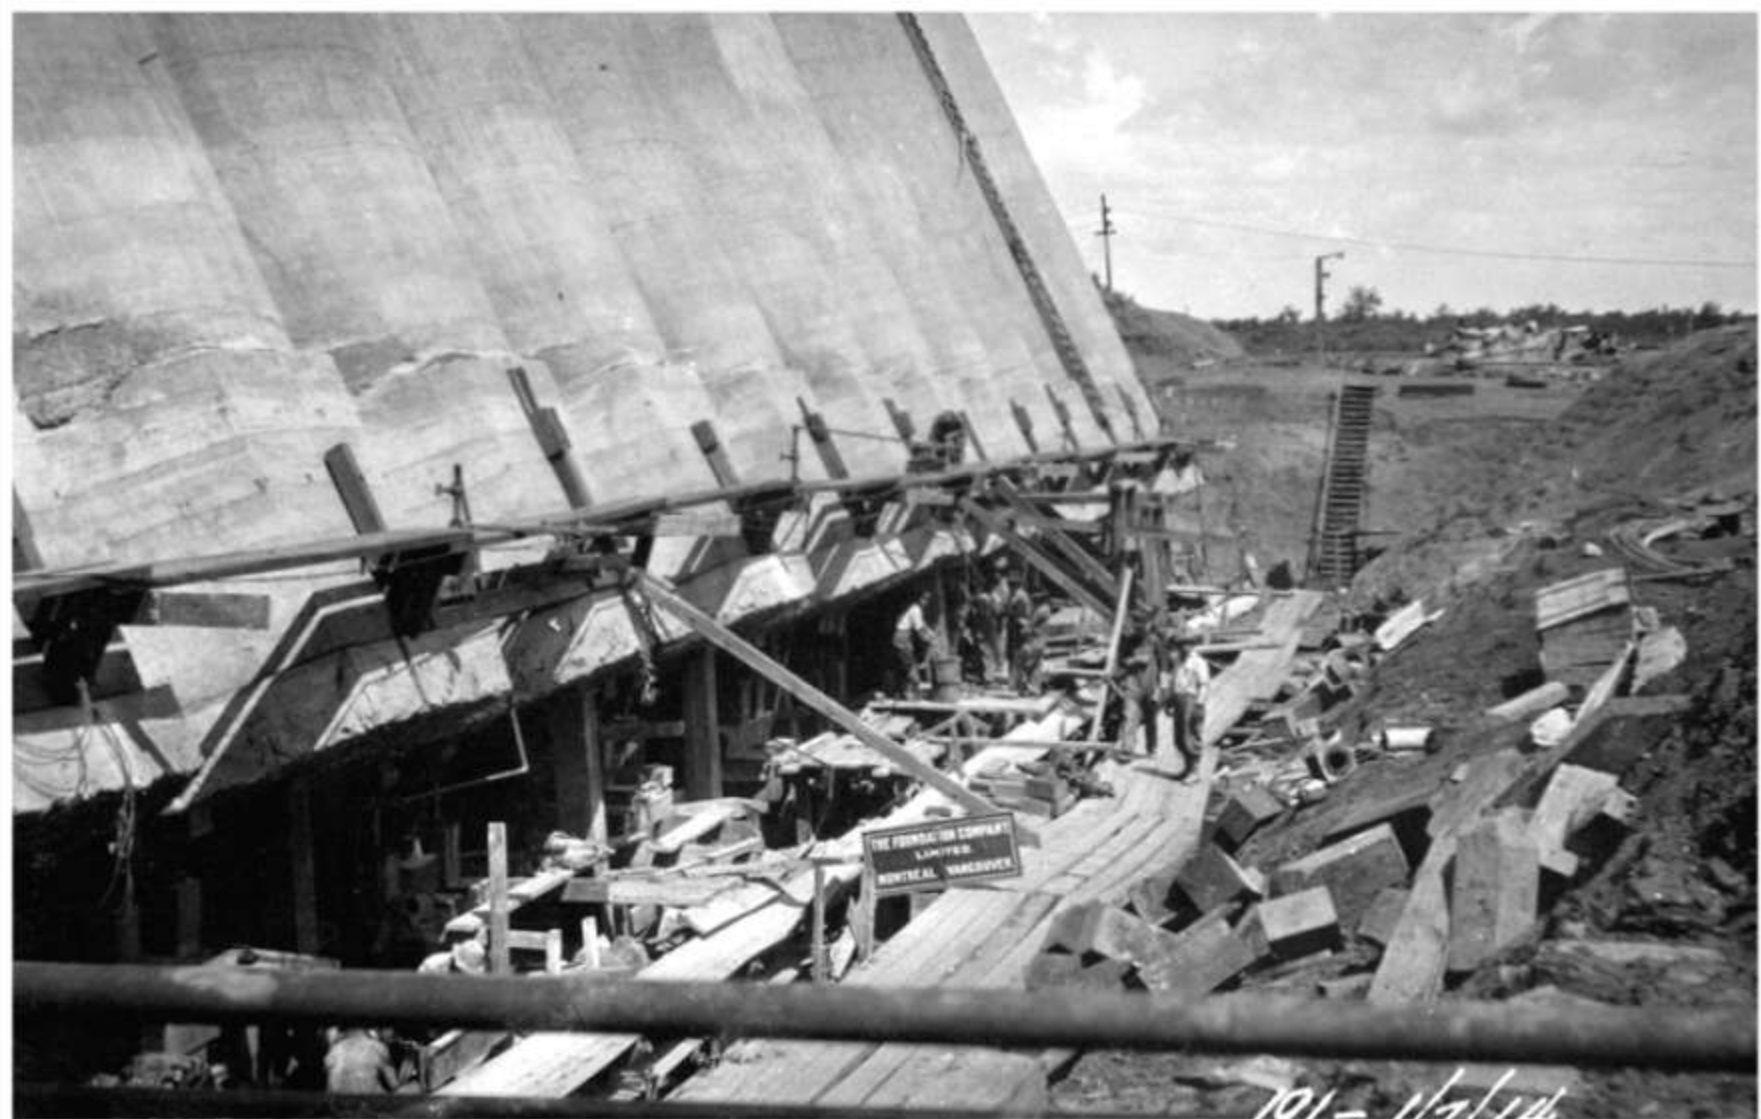
East Side of Mat Supported on Posts & Screws

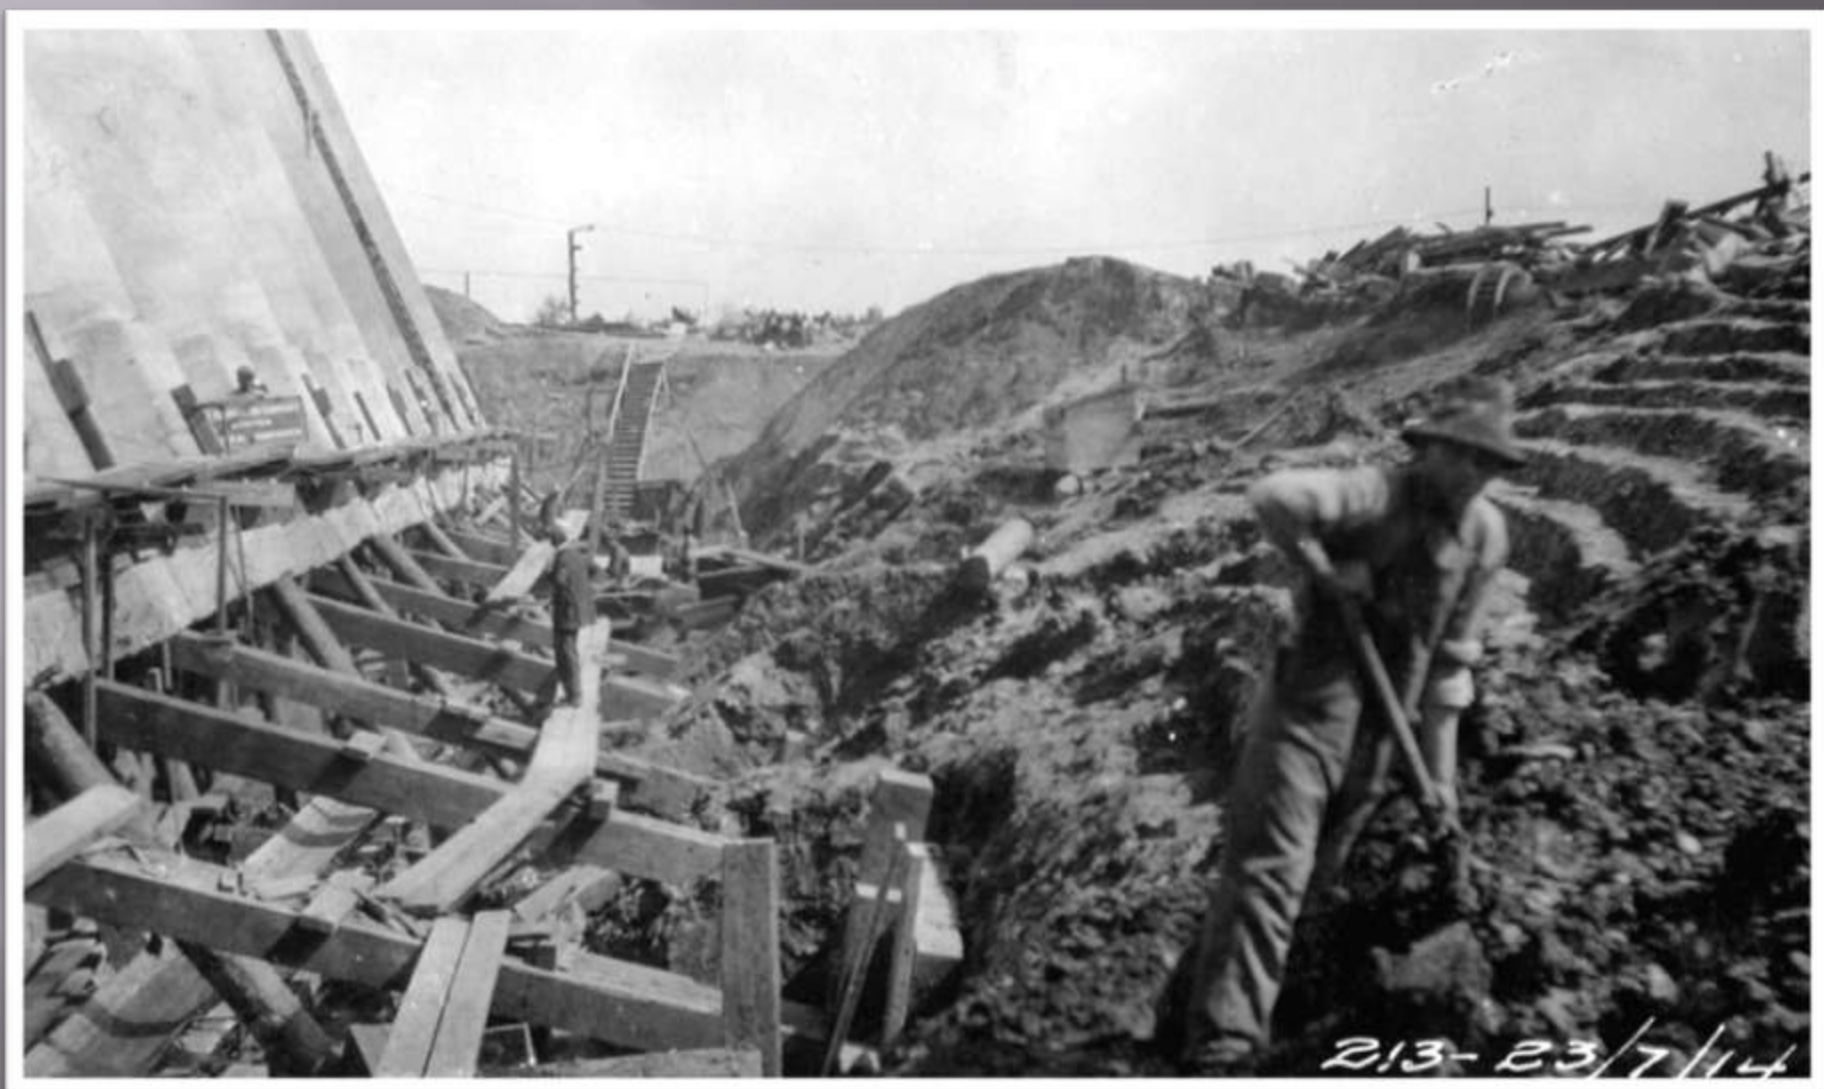
Bracing in East Trench

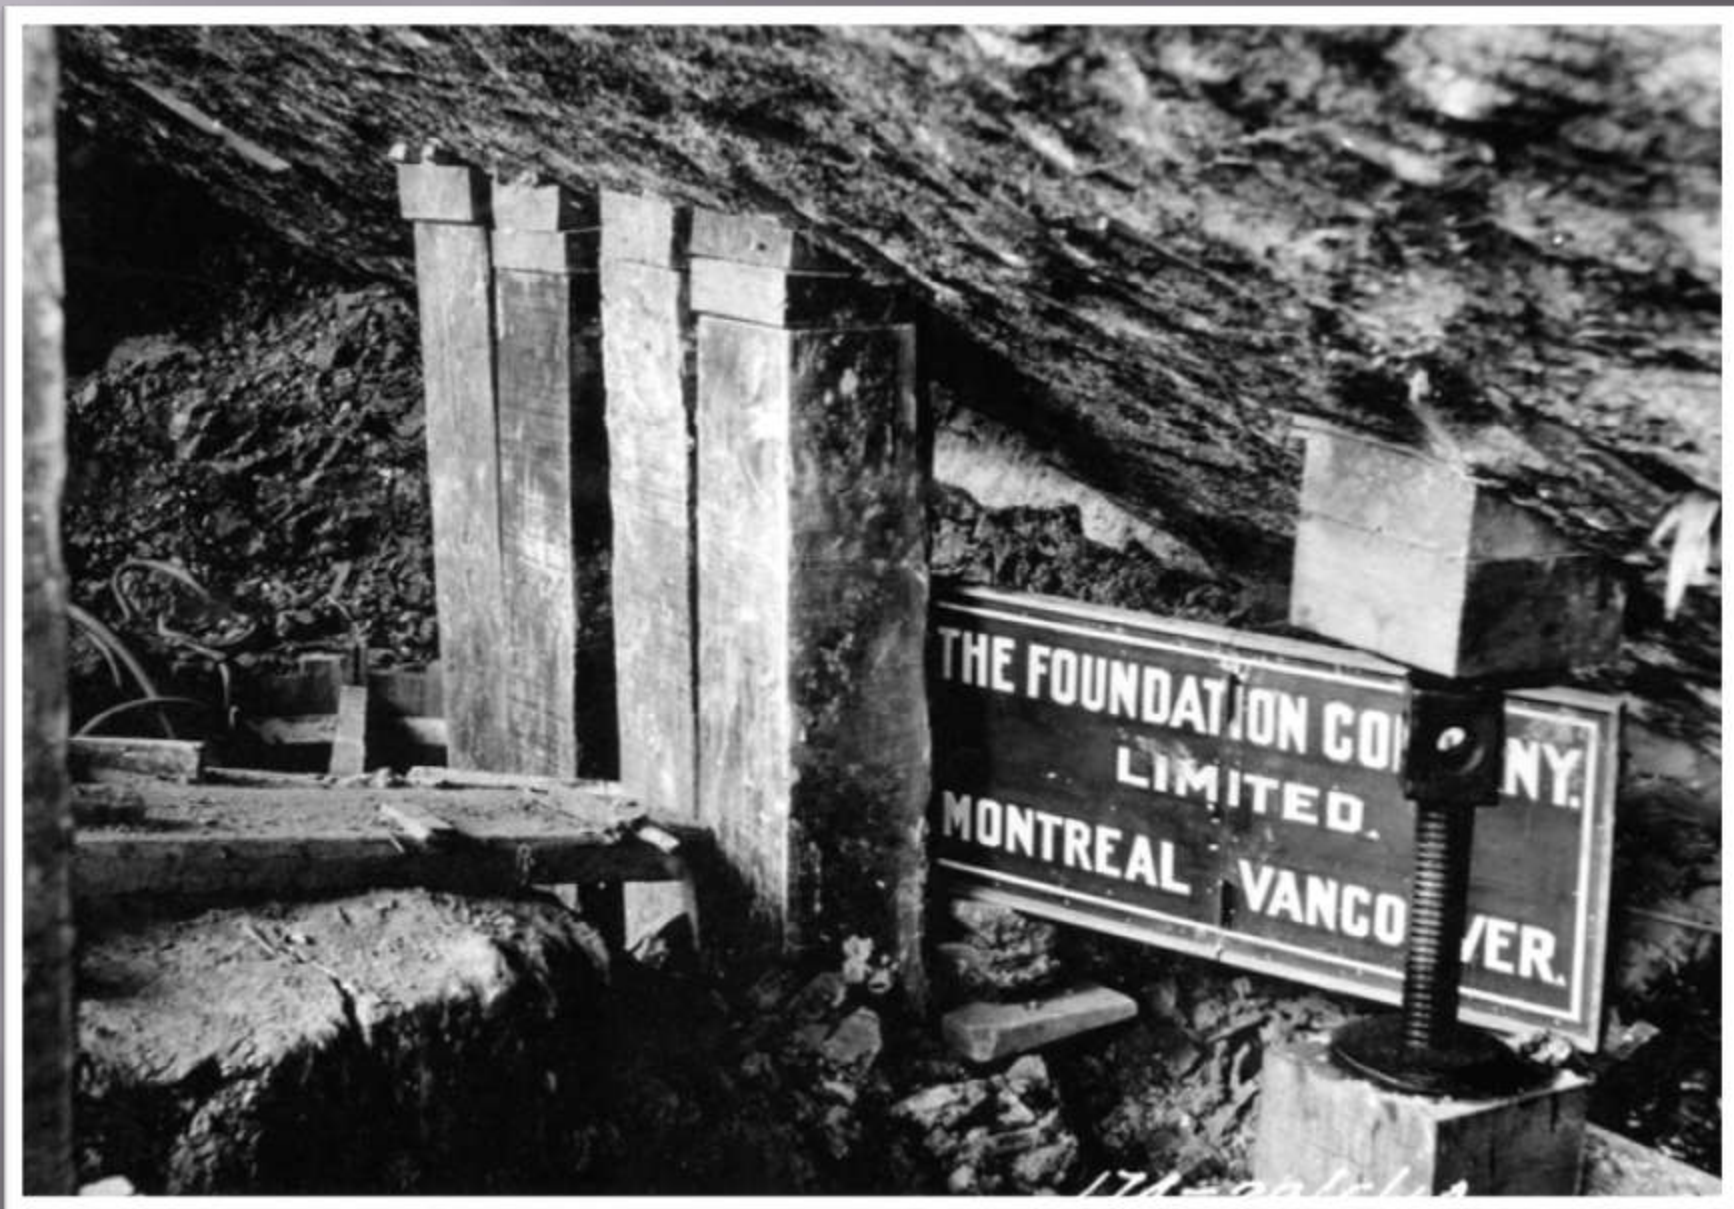
Controlling Movement Before Setting Jacks

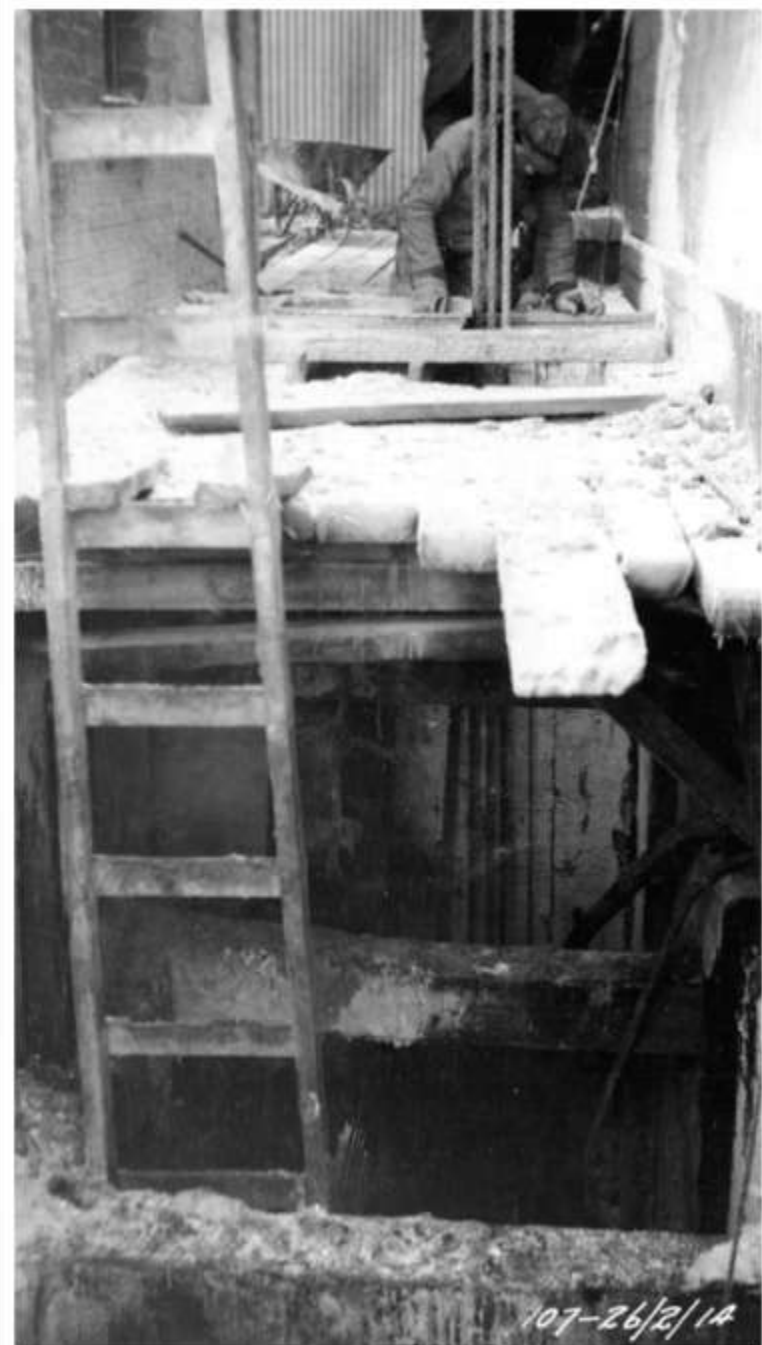
Site of Accident to A.
Perrault

- Row K to 16 deg
- Row I to 8 deg
- Row H to vertical

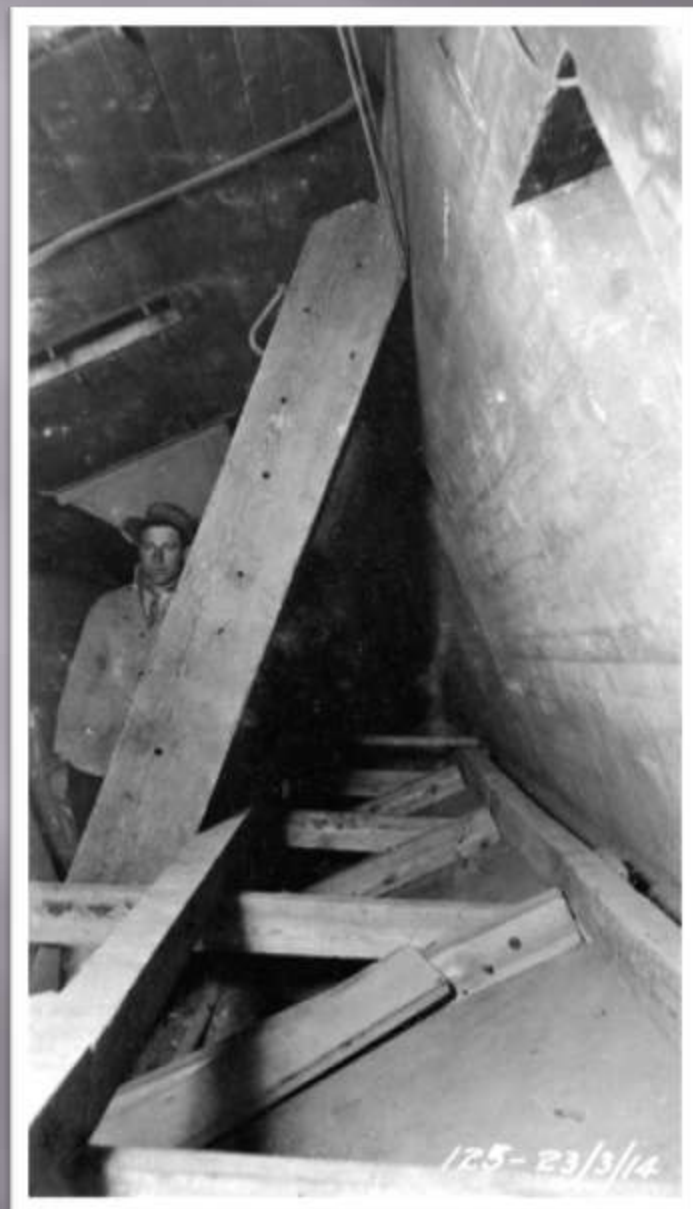
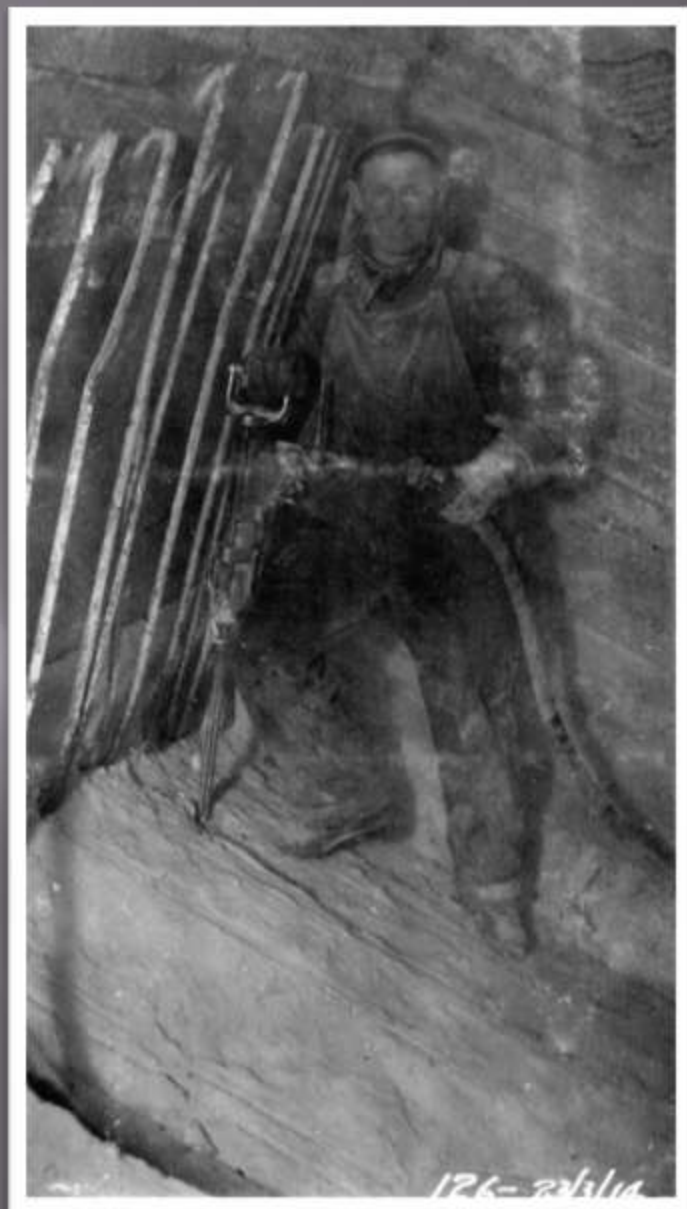
Cross Bracing in Conveyor Tunnel (left) & Steam
Powered Jackhammer (right)

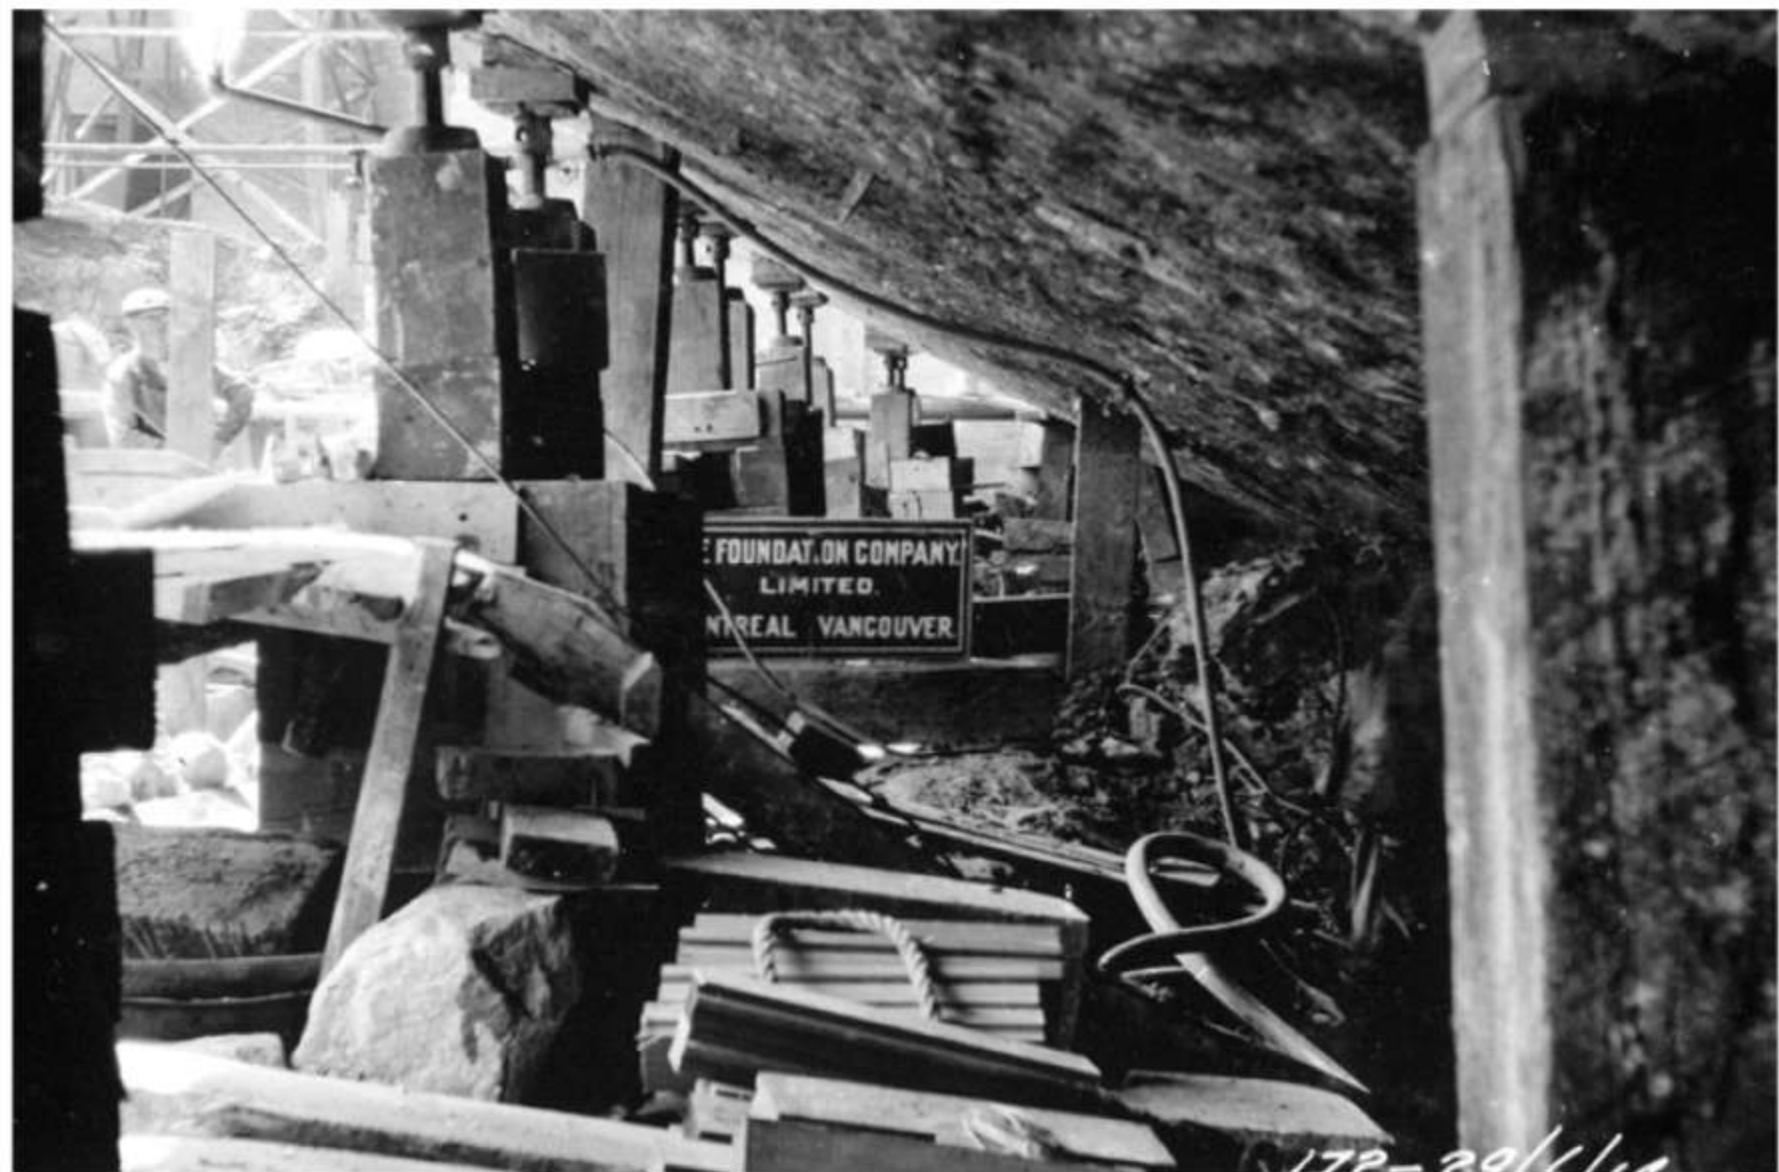
Cribbing and Jacks on "G" Row

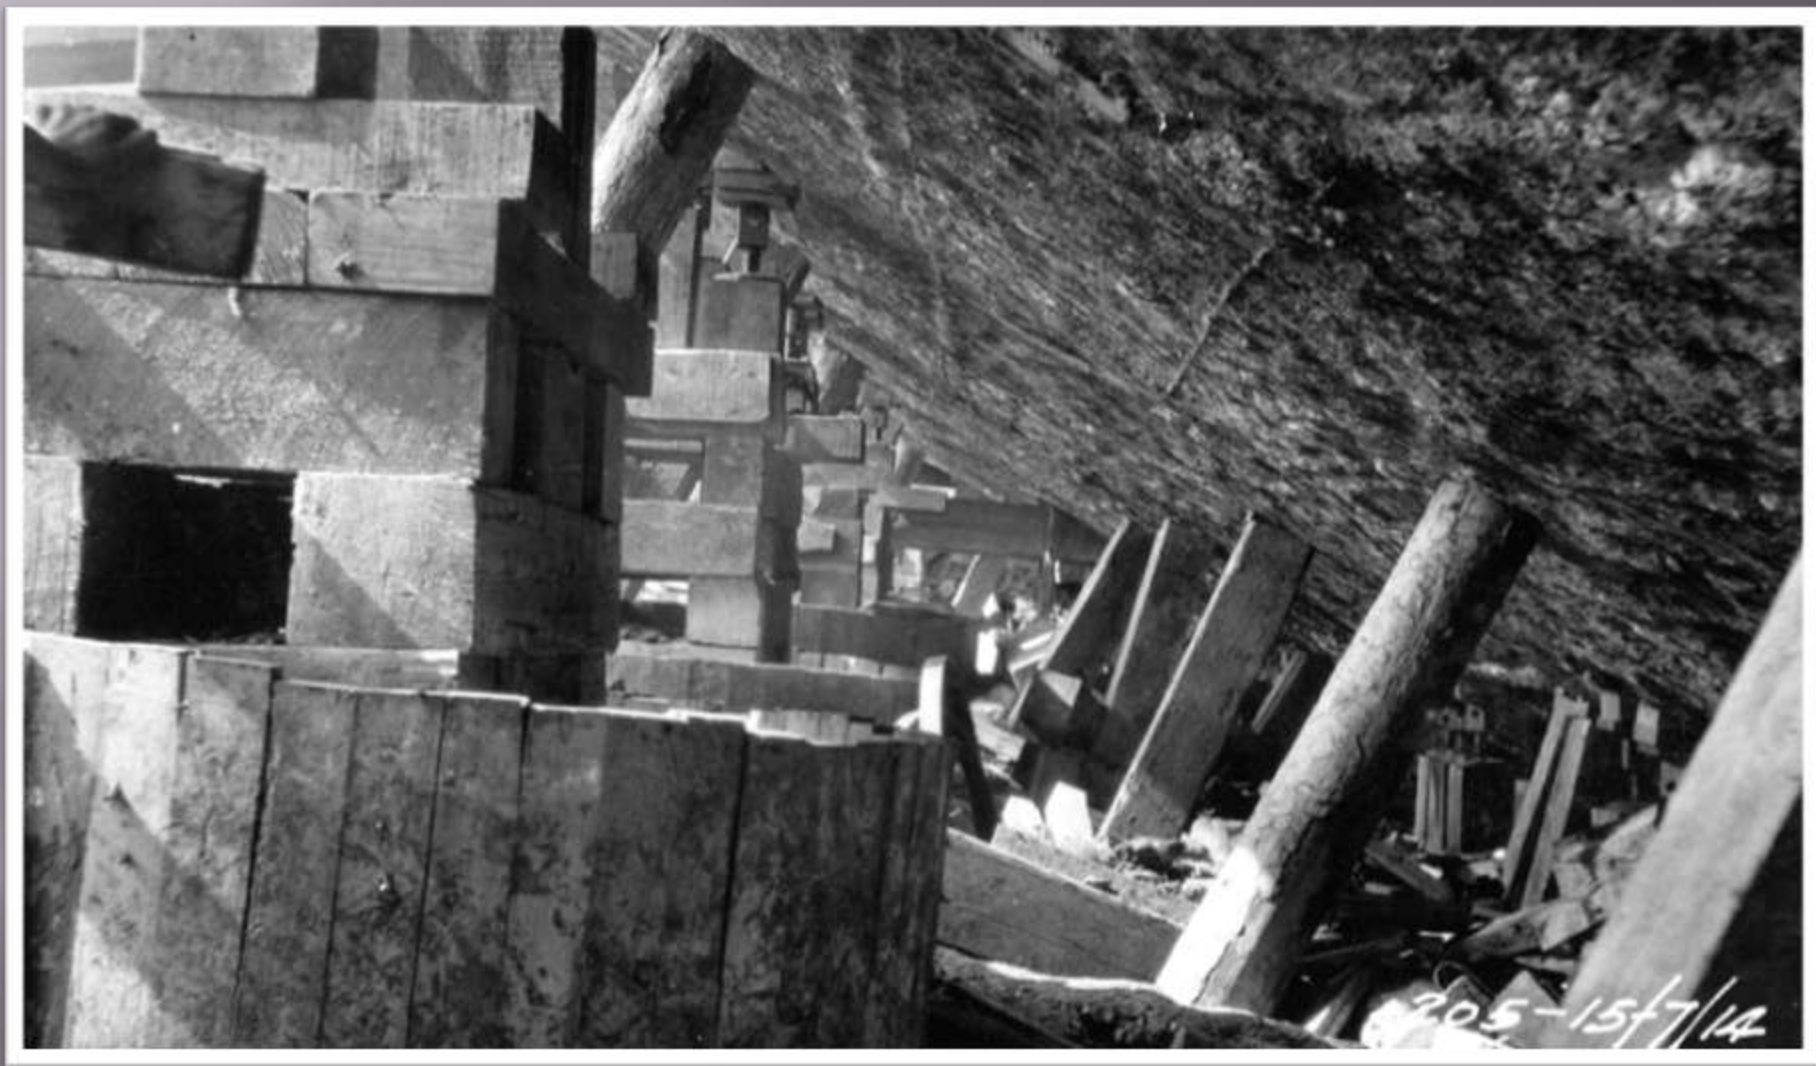
Wells, Cribbing, Jacks & Inclined Posts Under Mat

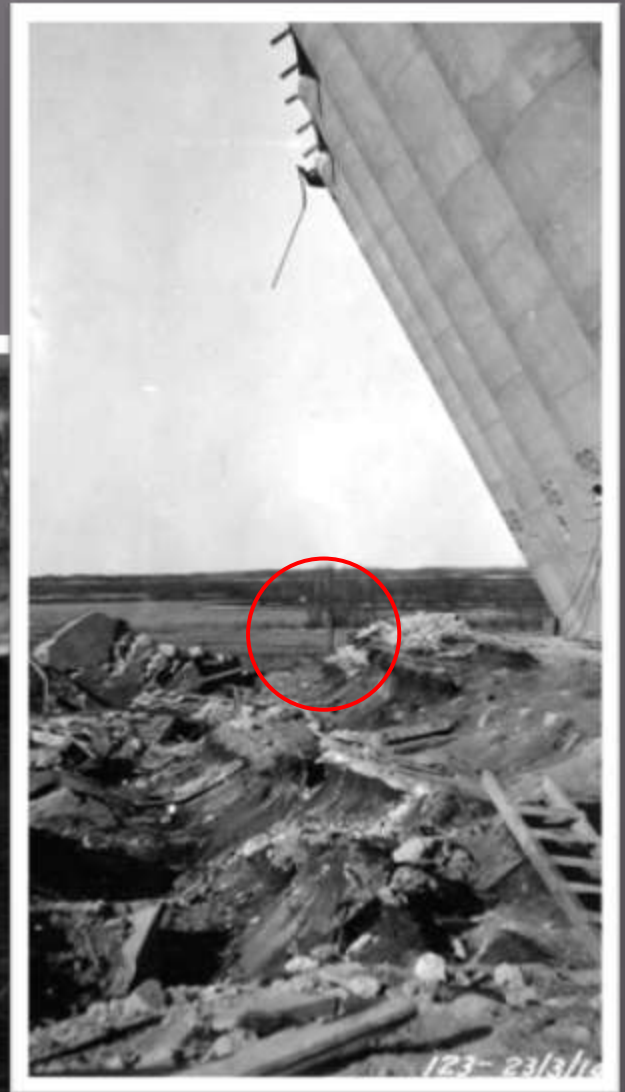
Protractor in Bins (bottom) &
Plumb Bob (right) Showing
Inclination of Binhouse

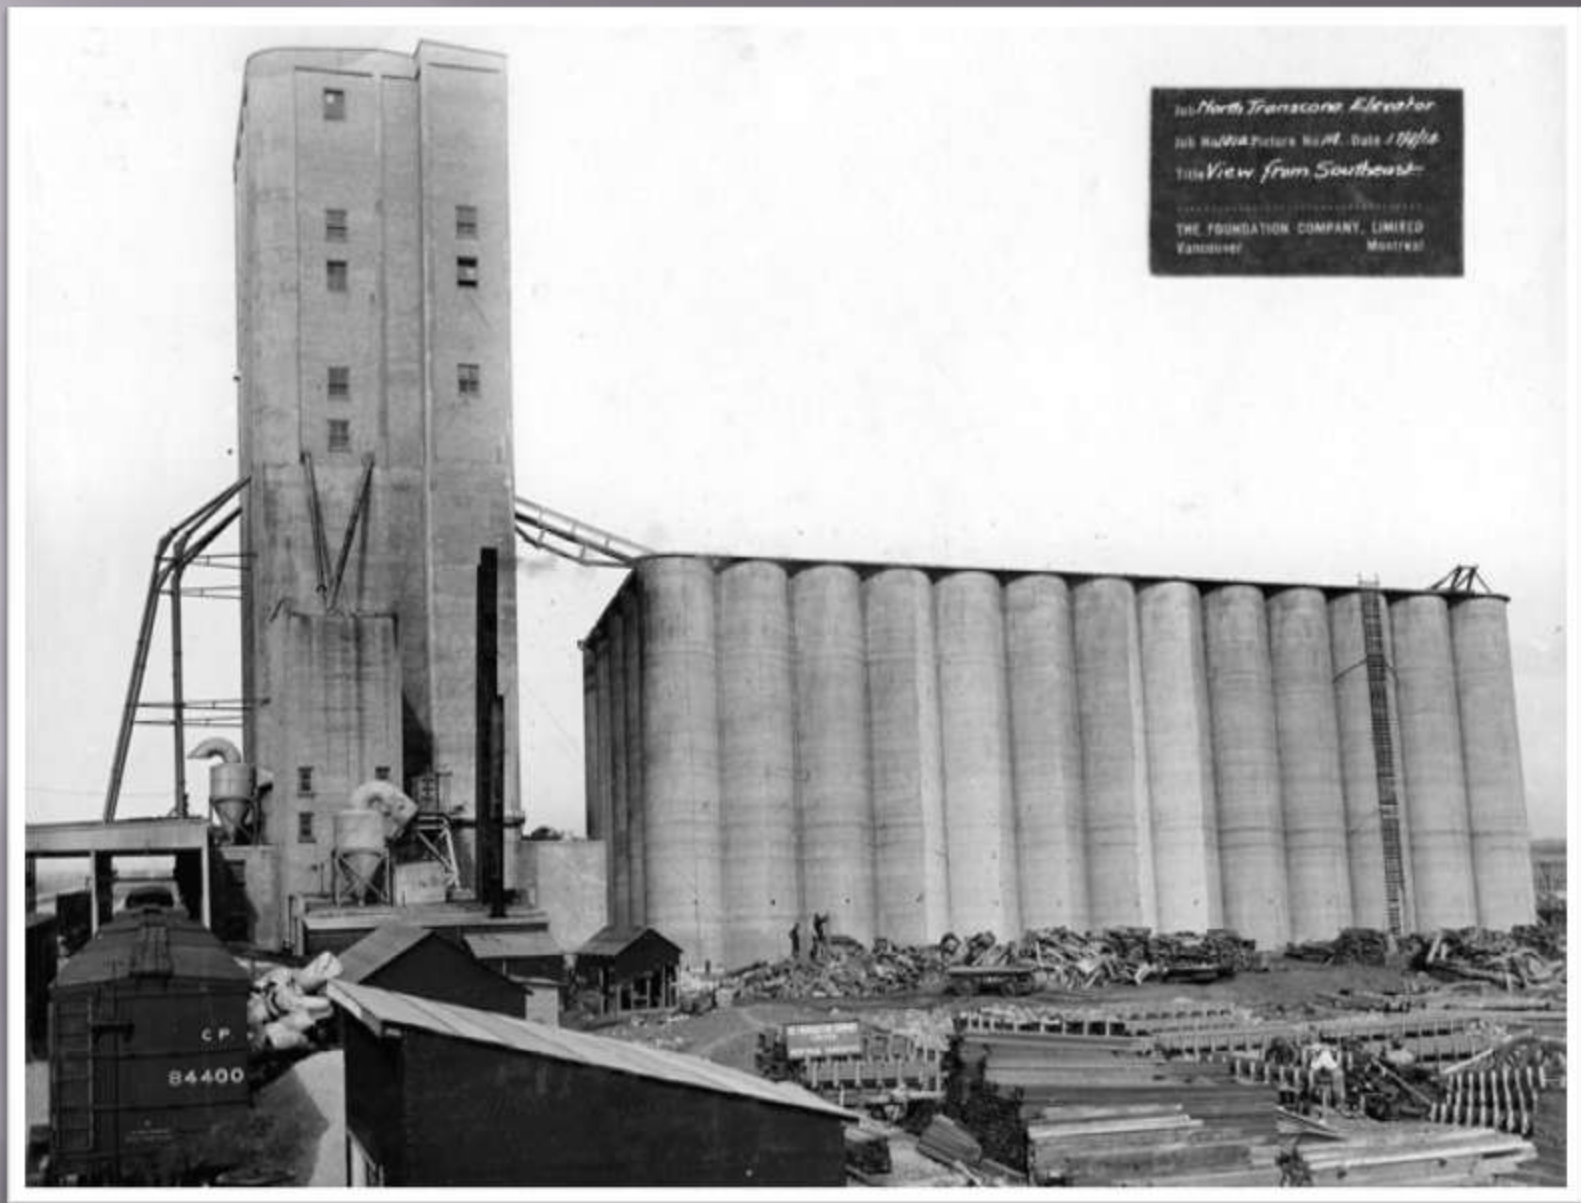
View From Southeast During Righting

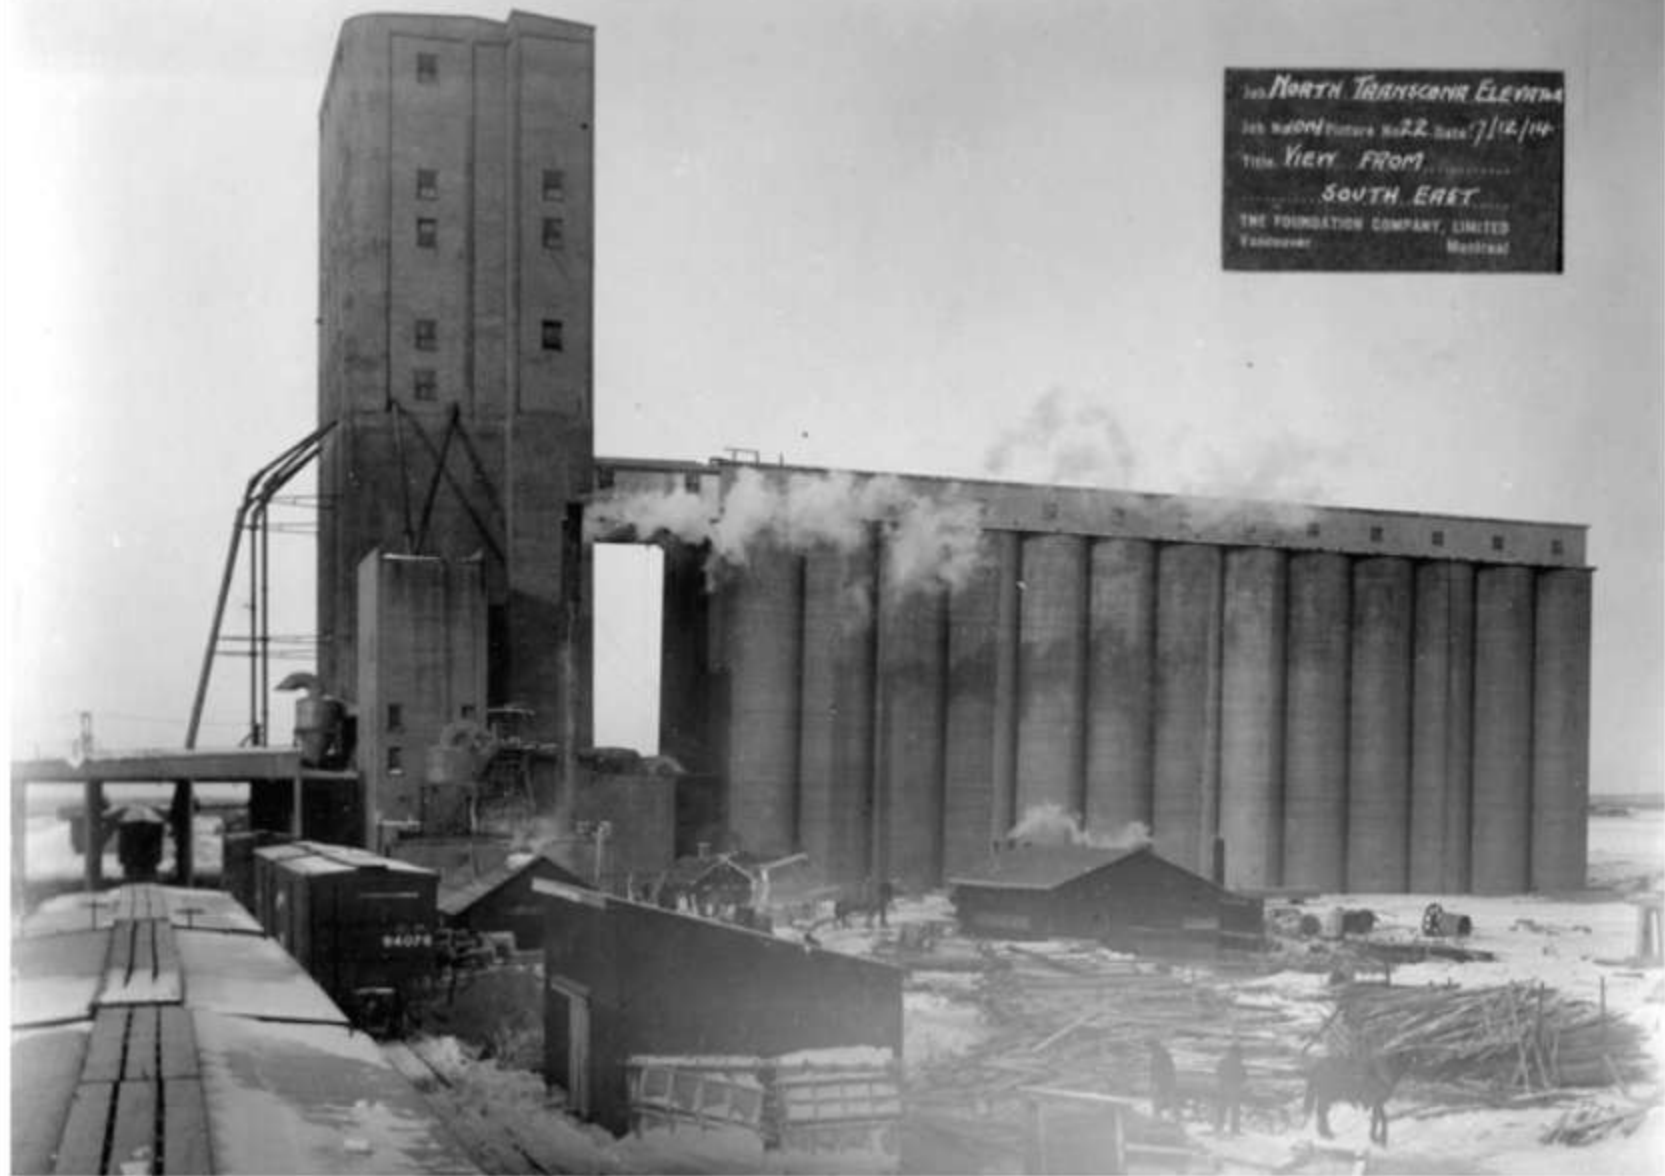
View From Southeast After Righting
