THE FAILURE AND RIGHTING OF THE TRANSCONA GRAIN ELEVATOR

THE FAILURE OF THE TRANSCONA GRAIN ELEVATOR

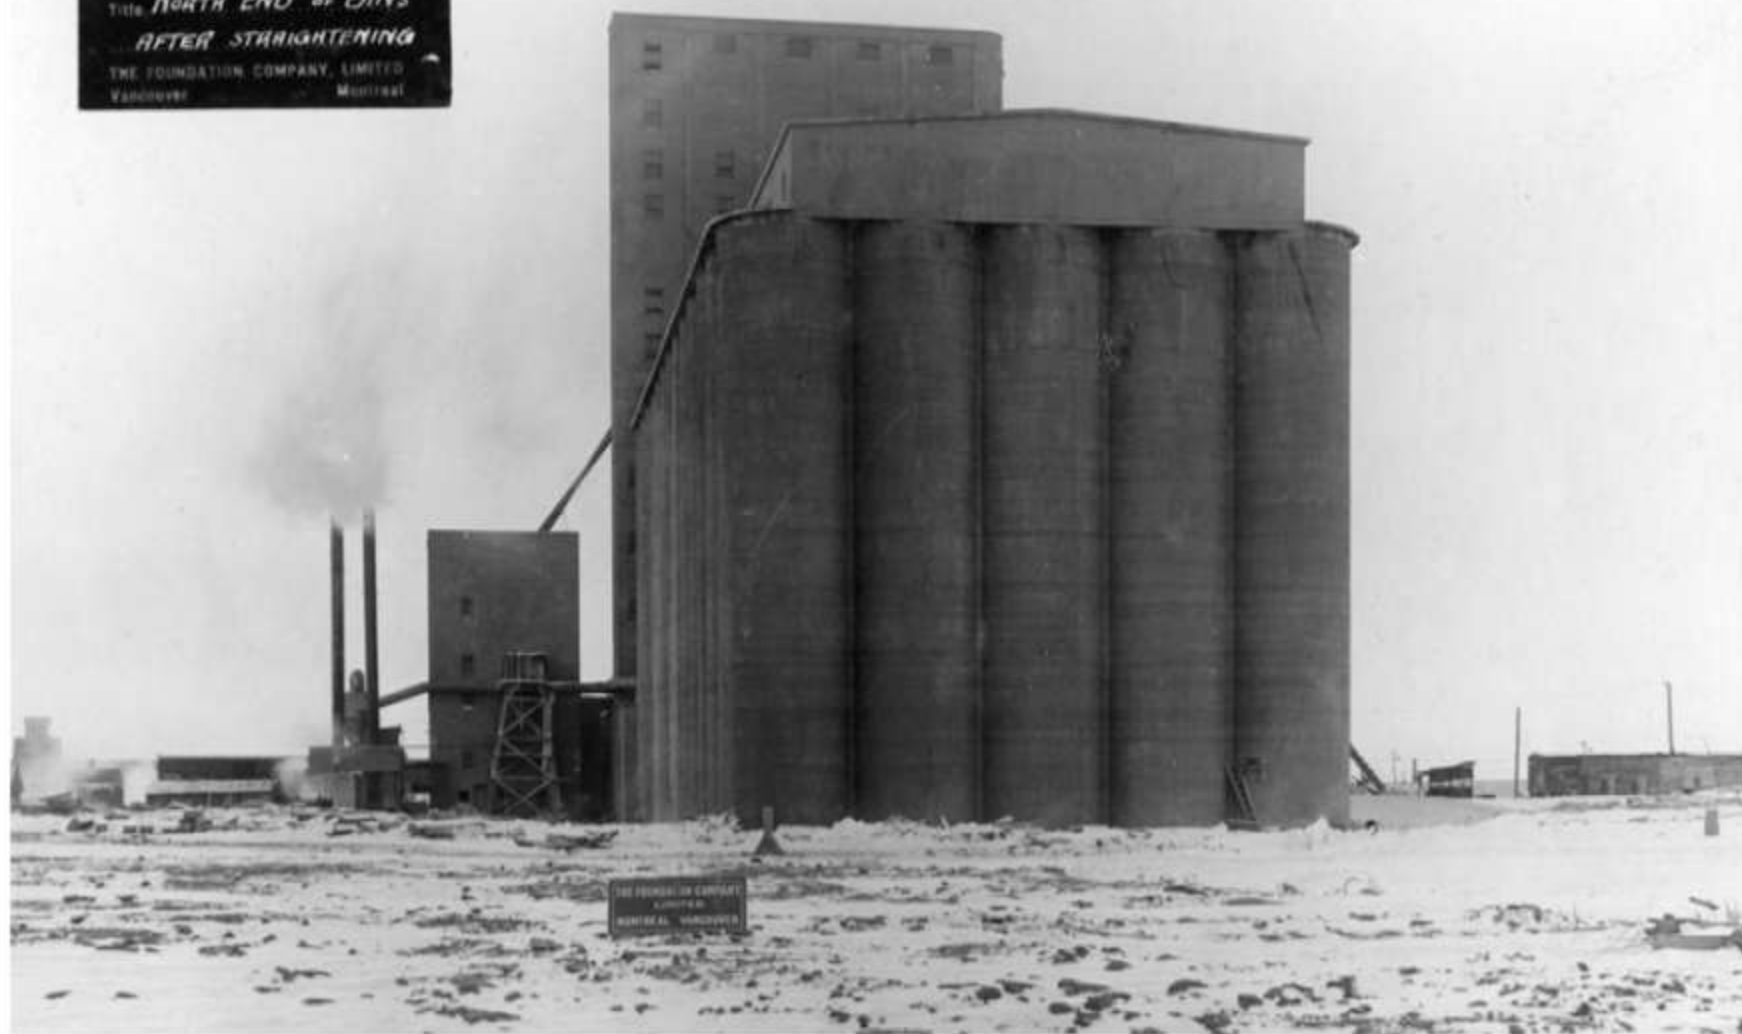
North End of Bins After Righting

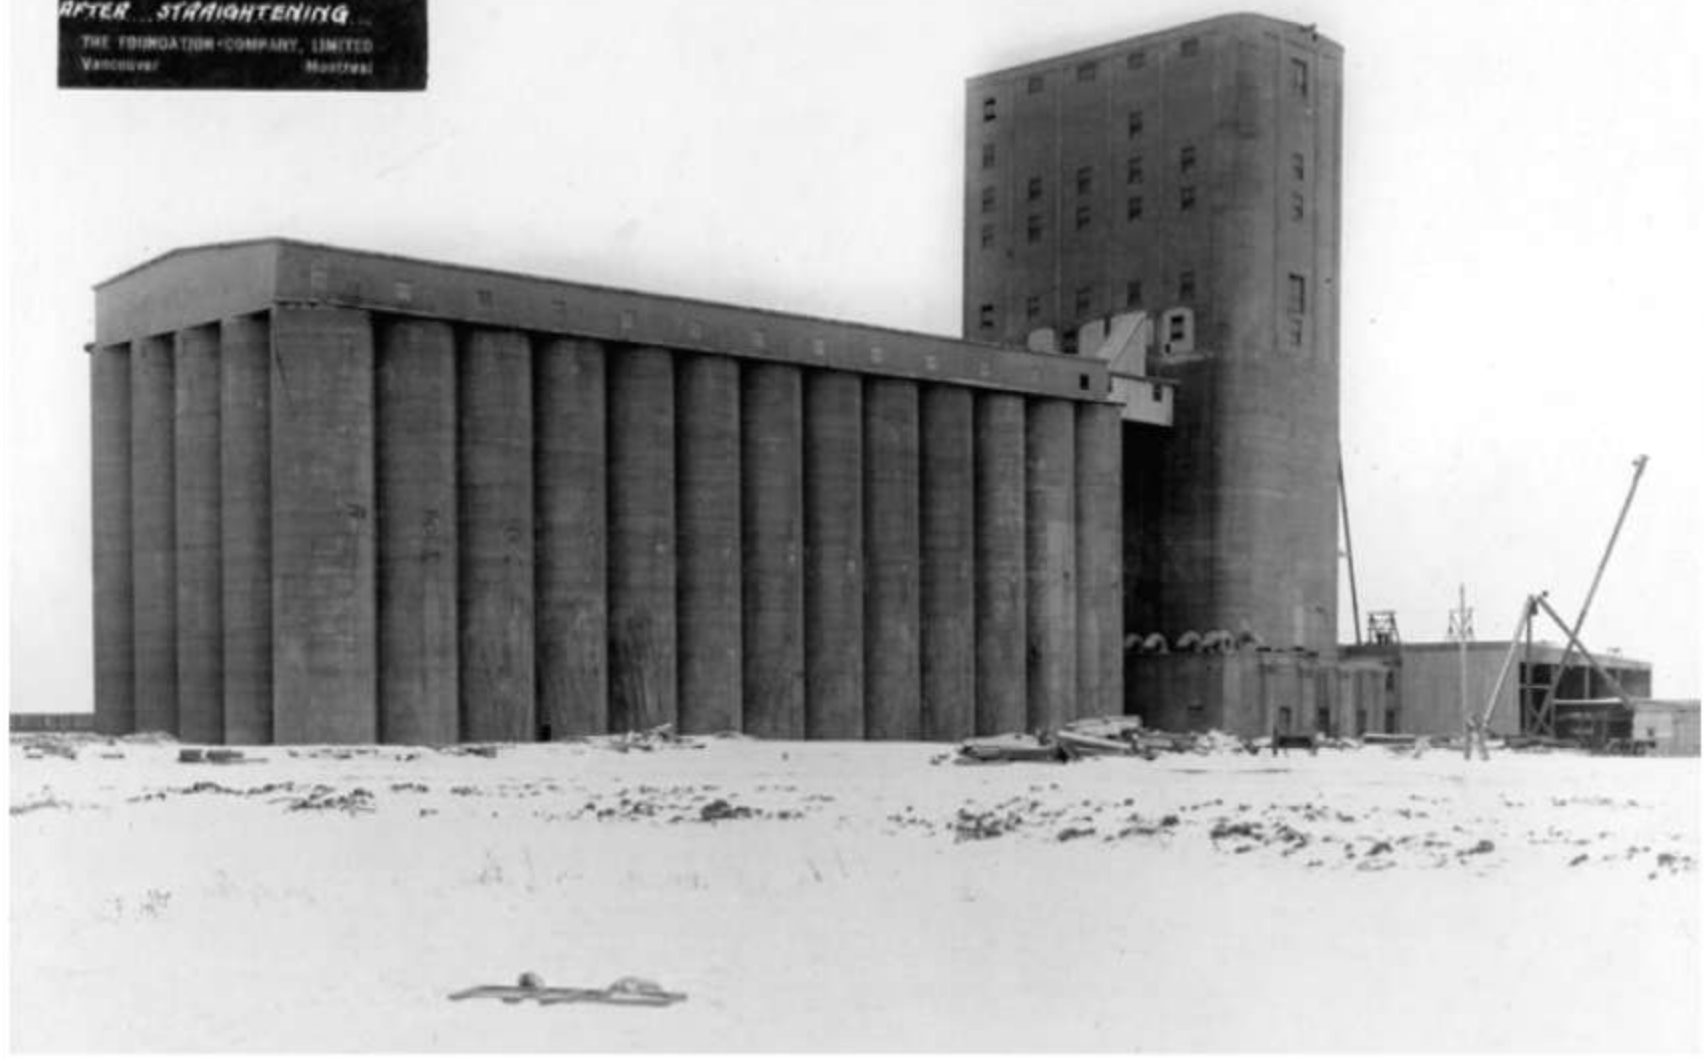
Northeast Corner After Righting

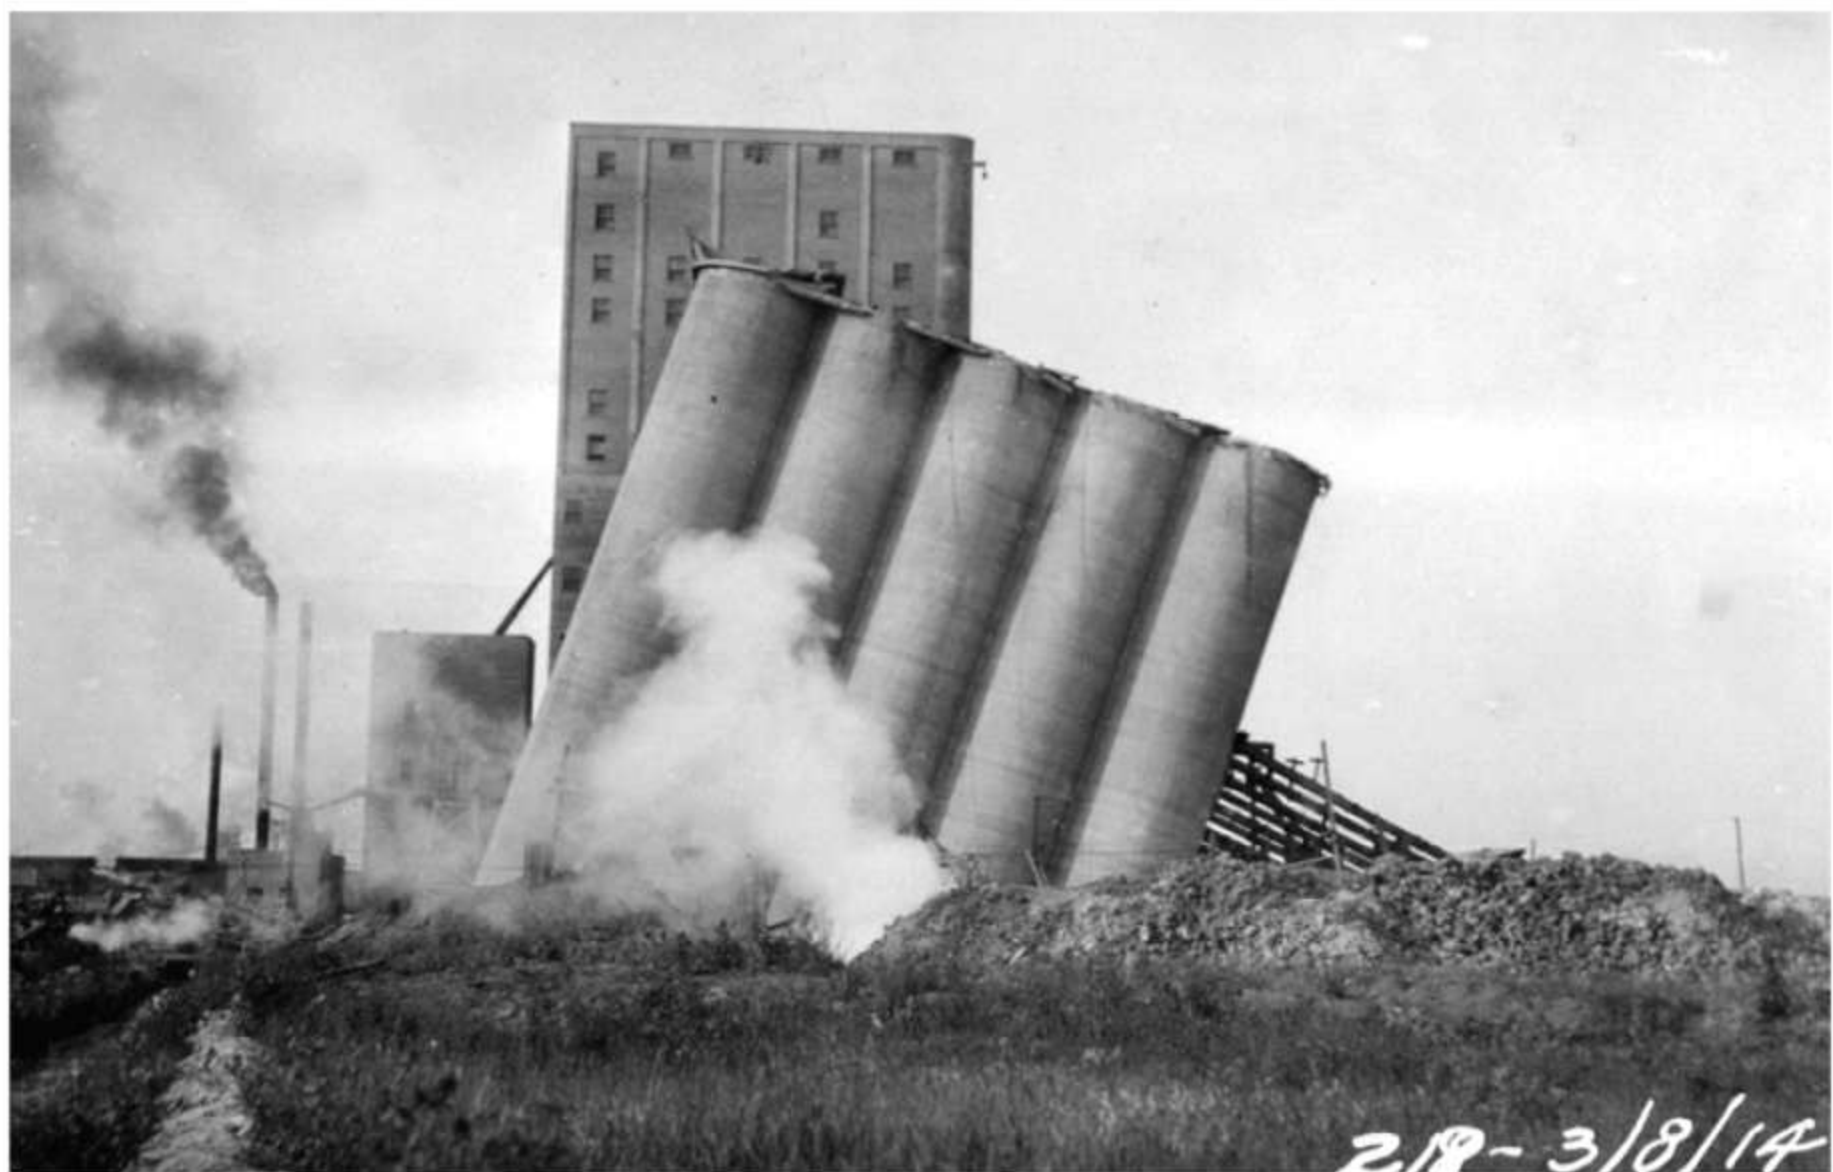
Progress View of North End of Bins

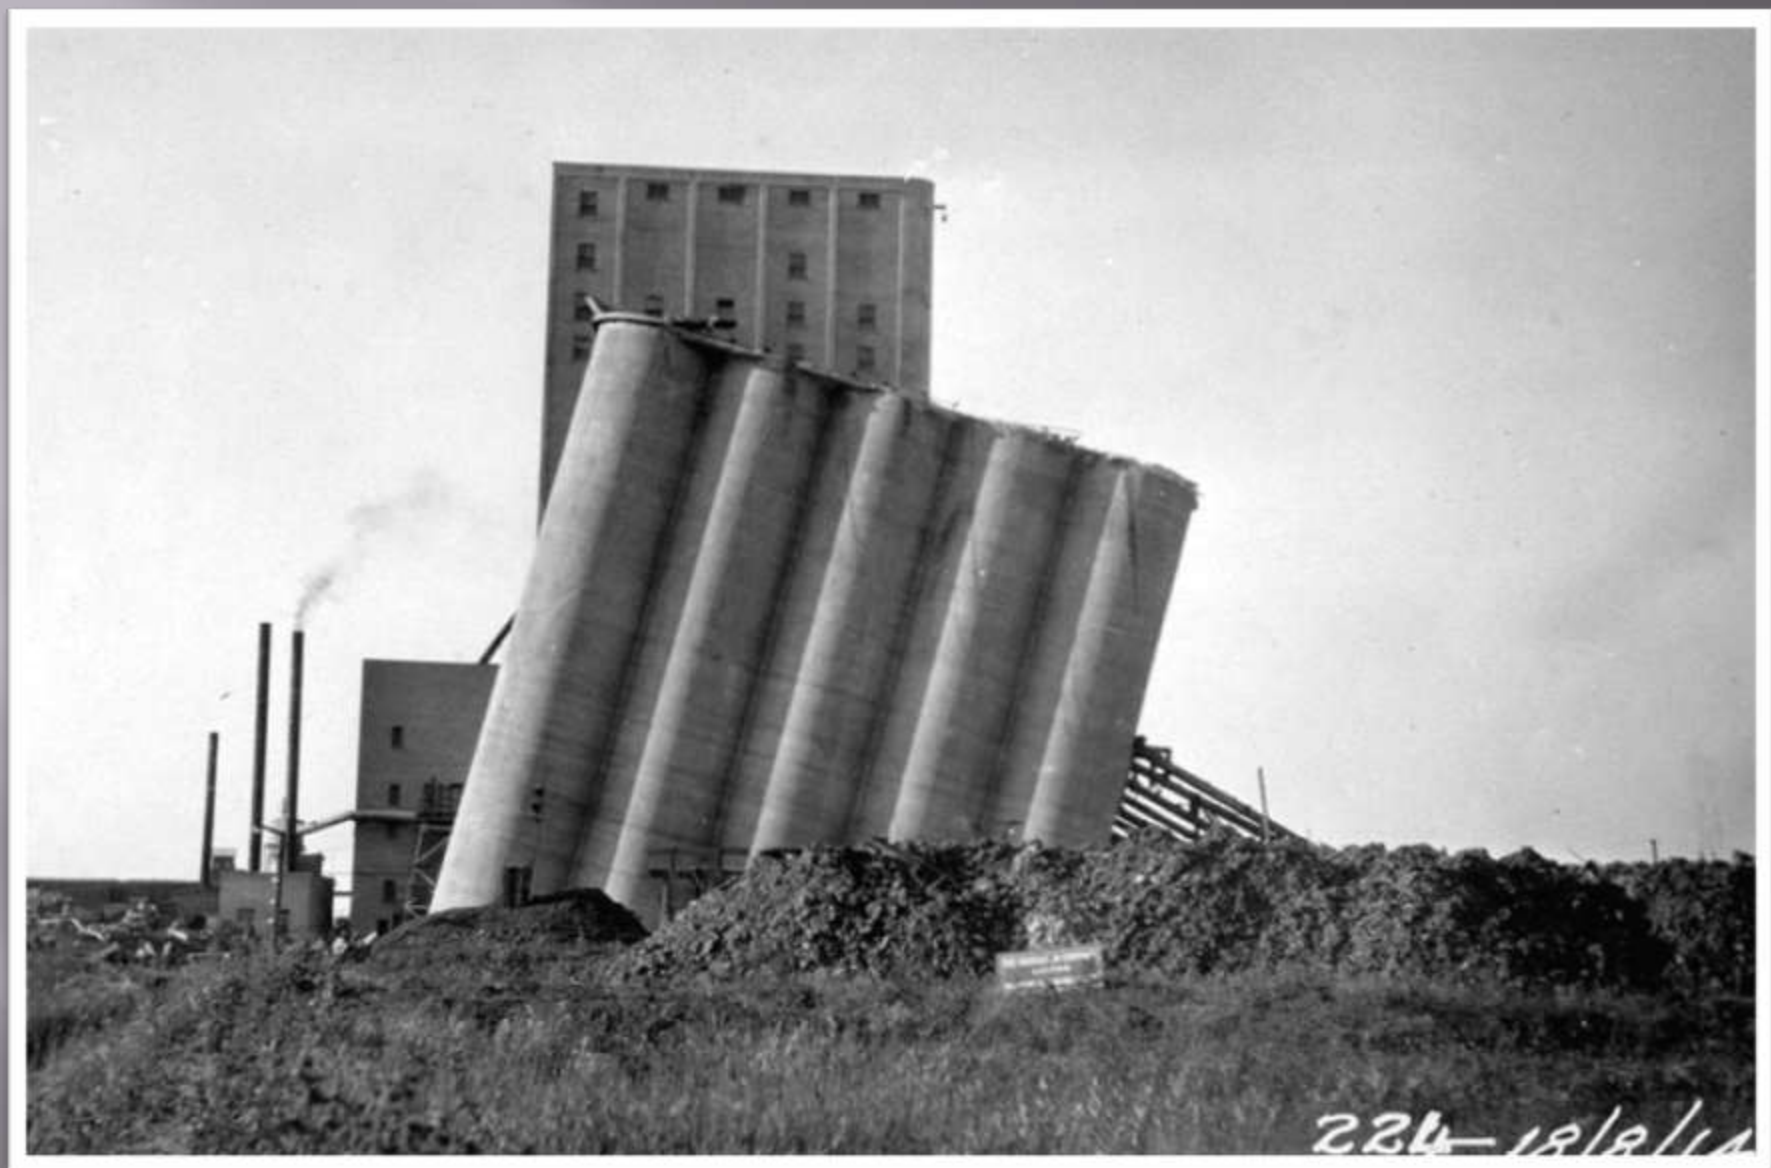
Progress View of North End of Bins

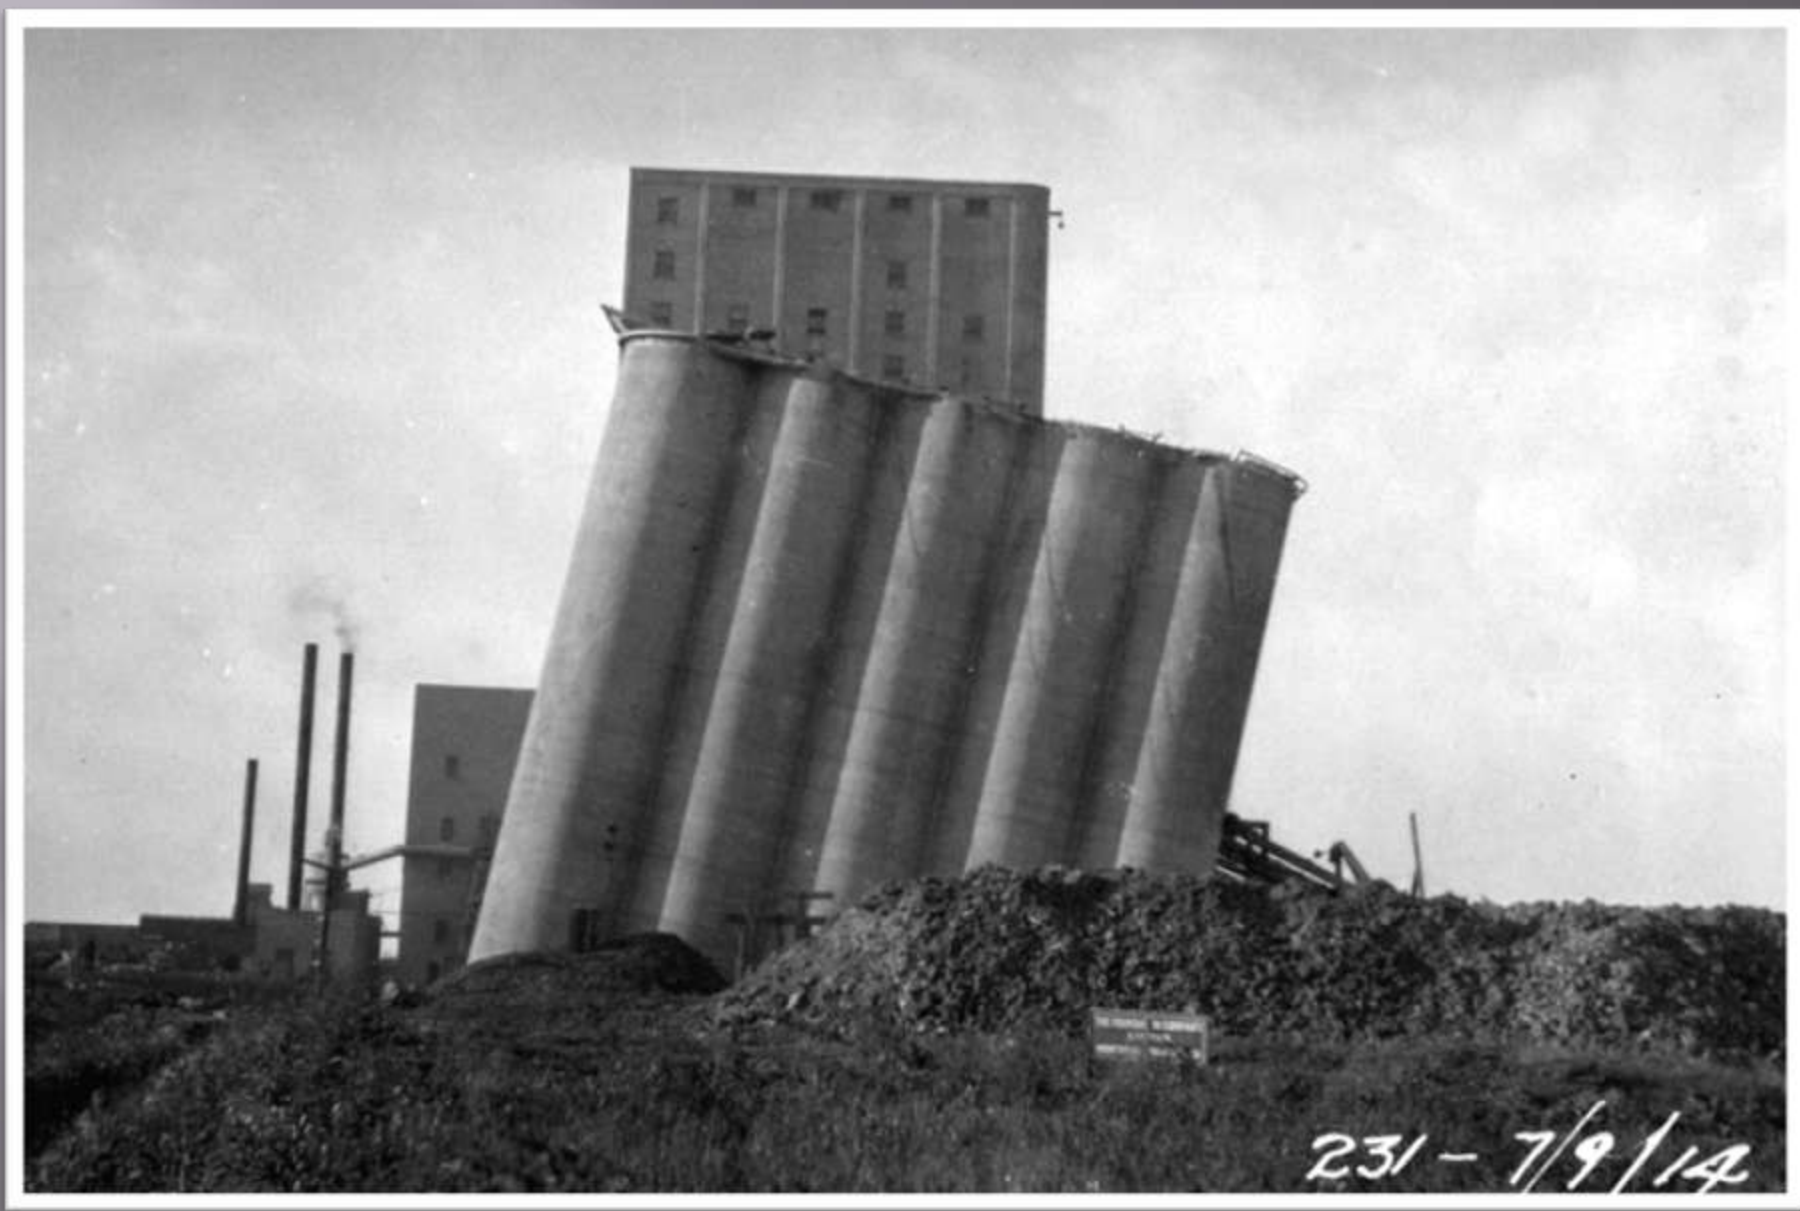
Progress View of North End of Bins

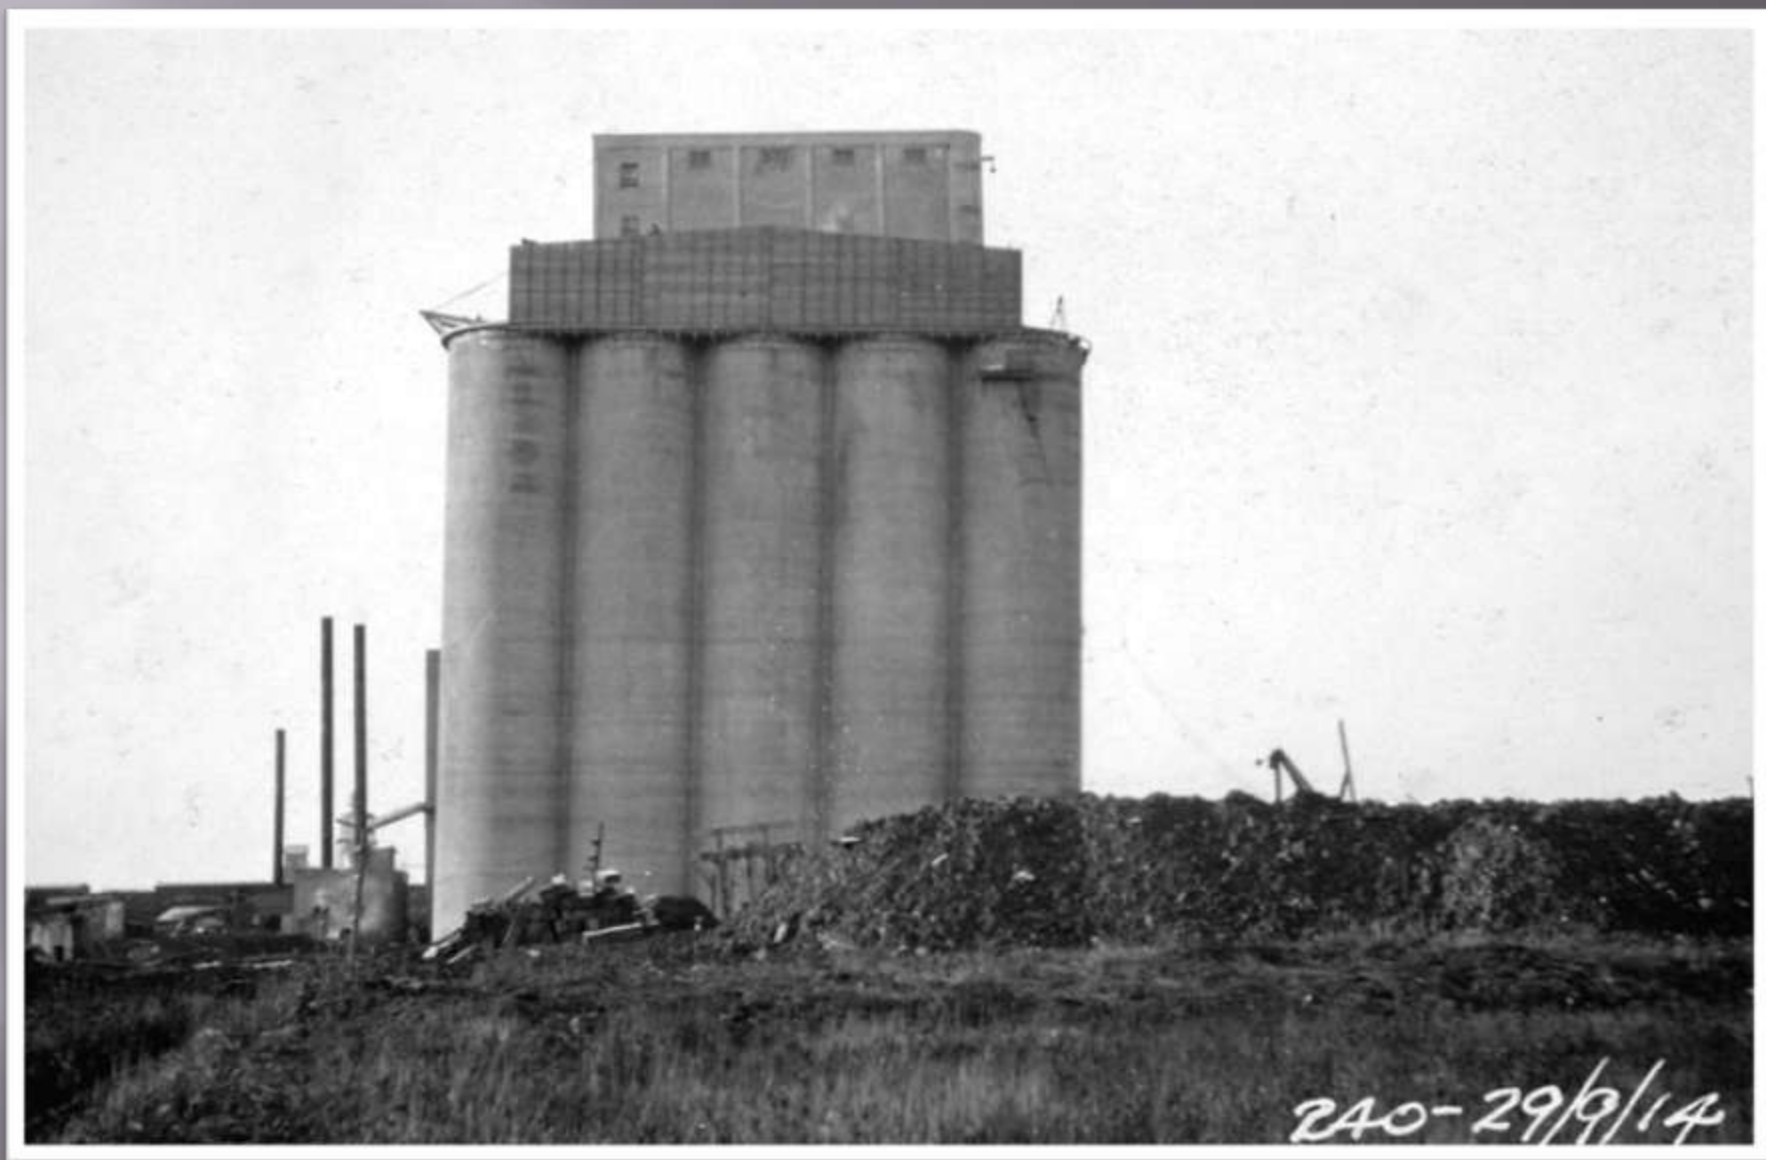
Progress View of North End of Bins

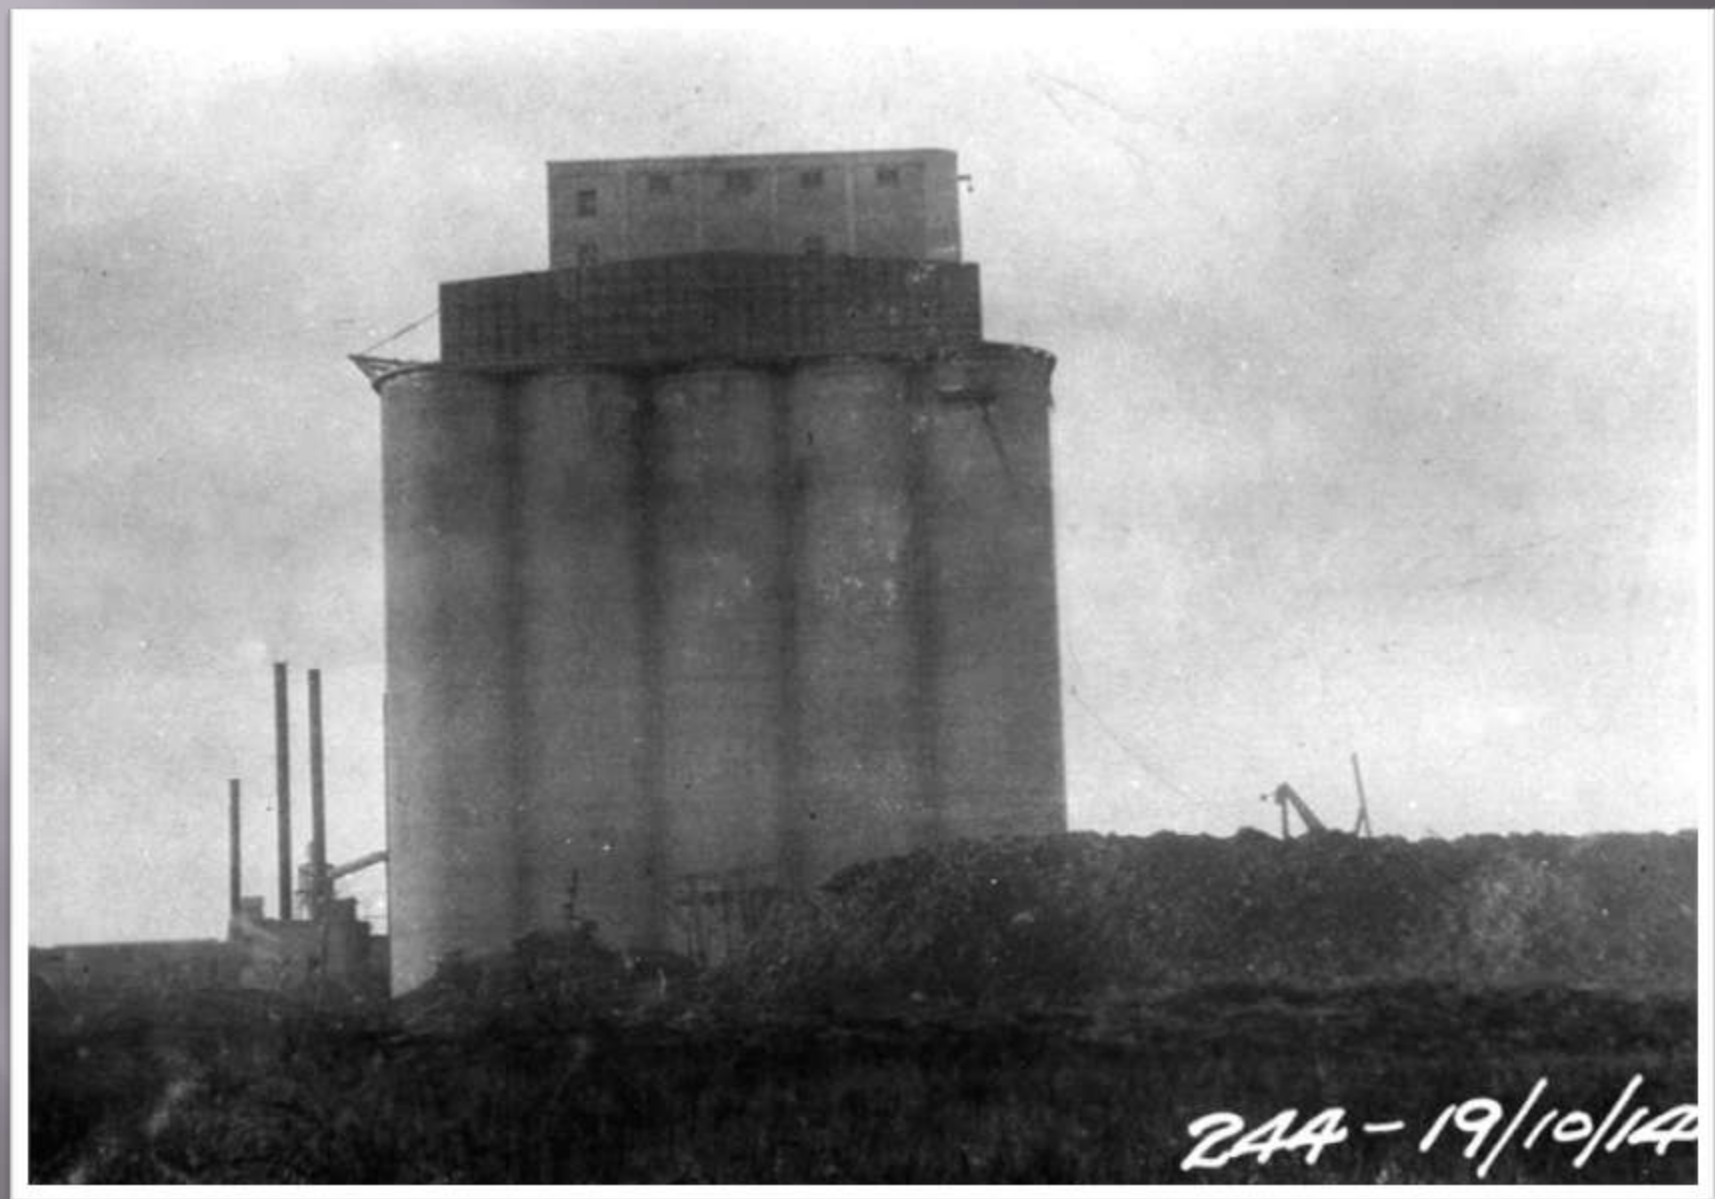
Bins Righted – October 17, 1914 at 10:15 AM

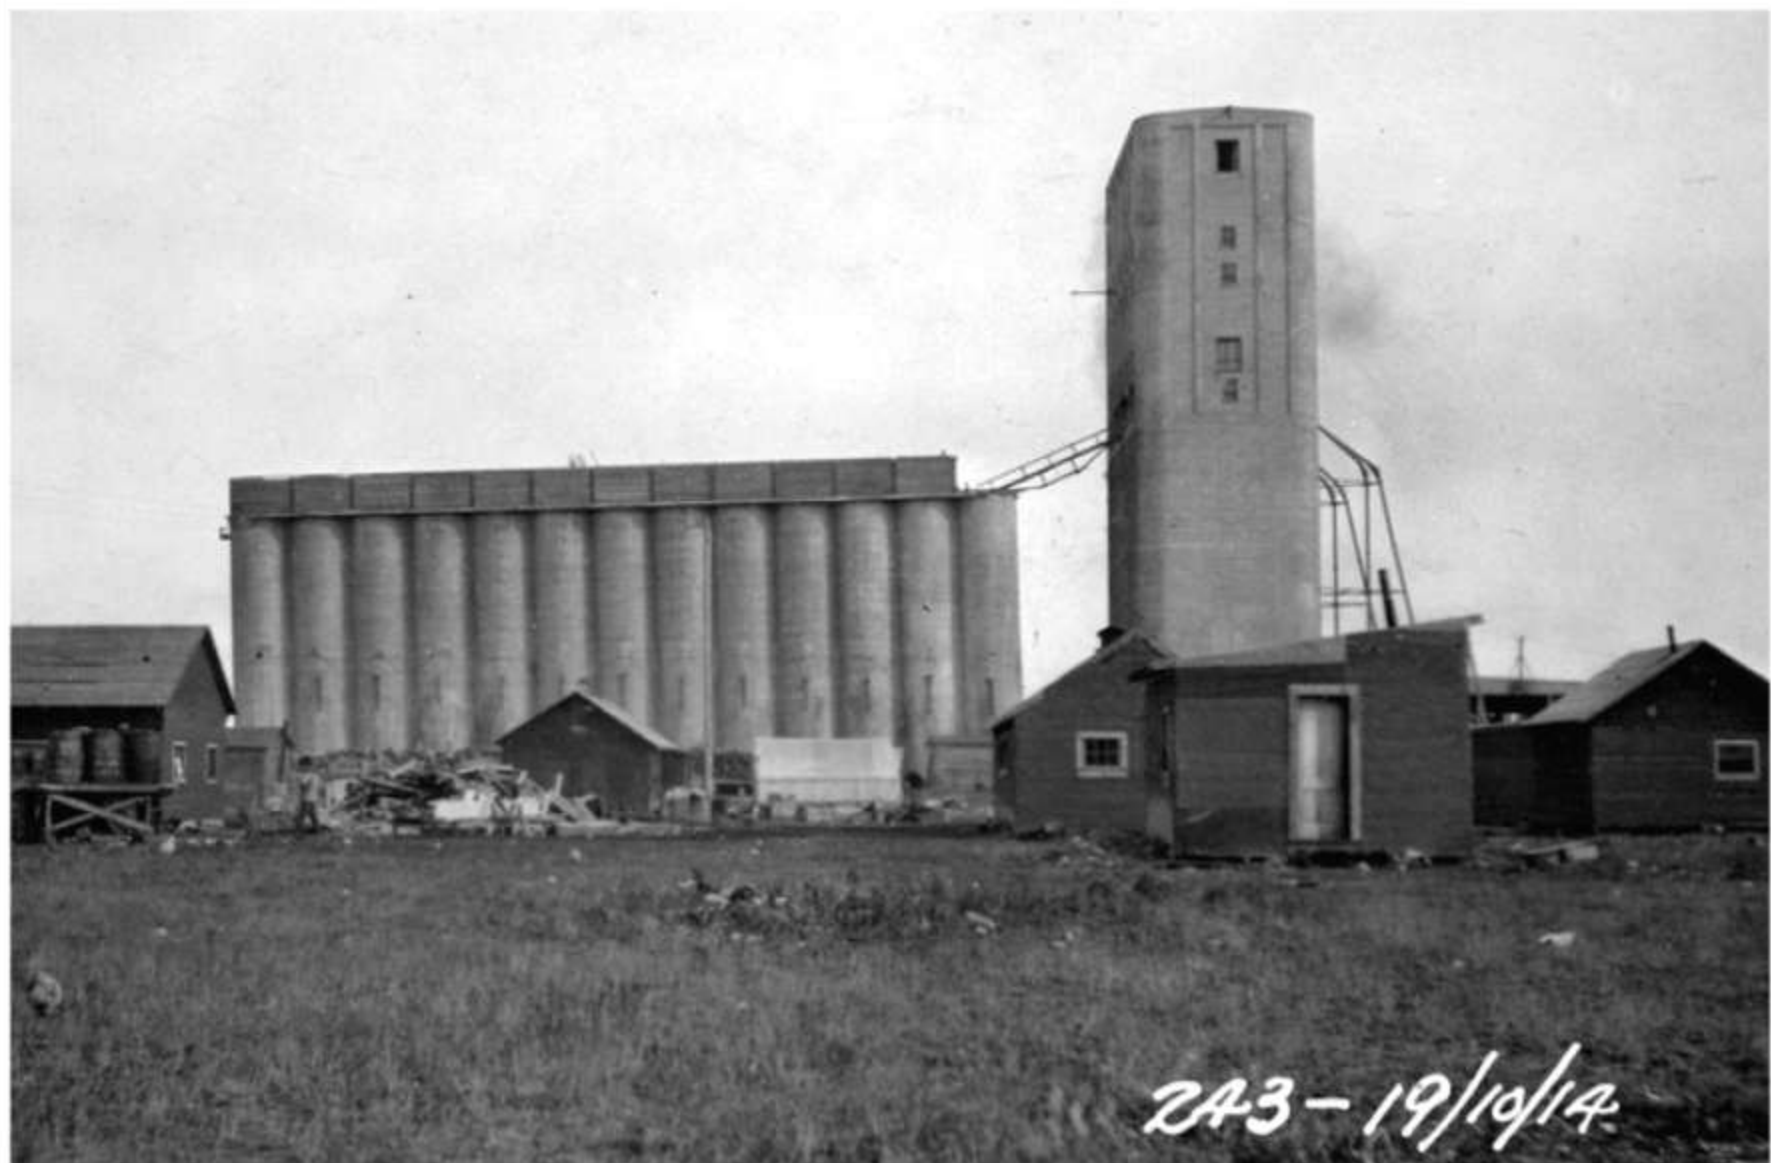
West Side of Bins After Righting

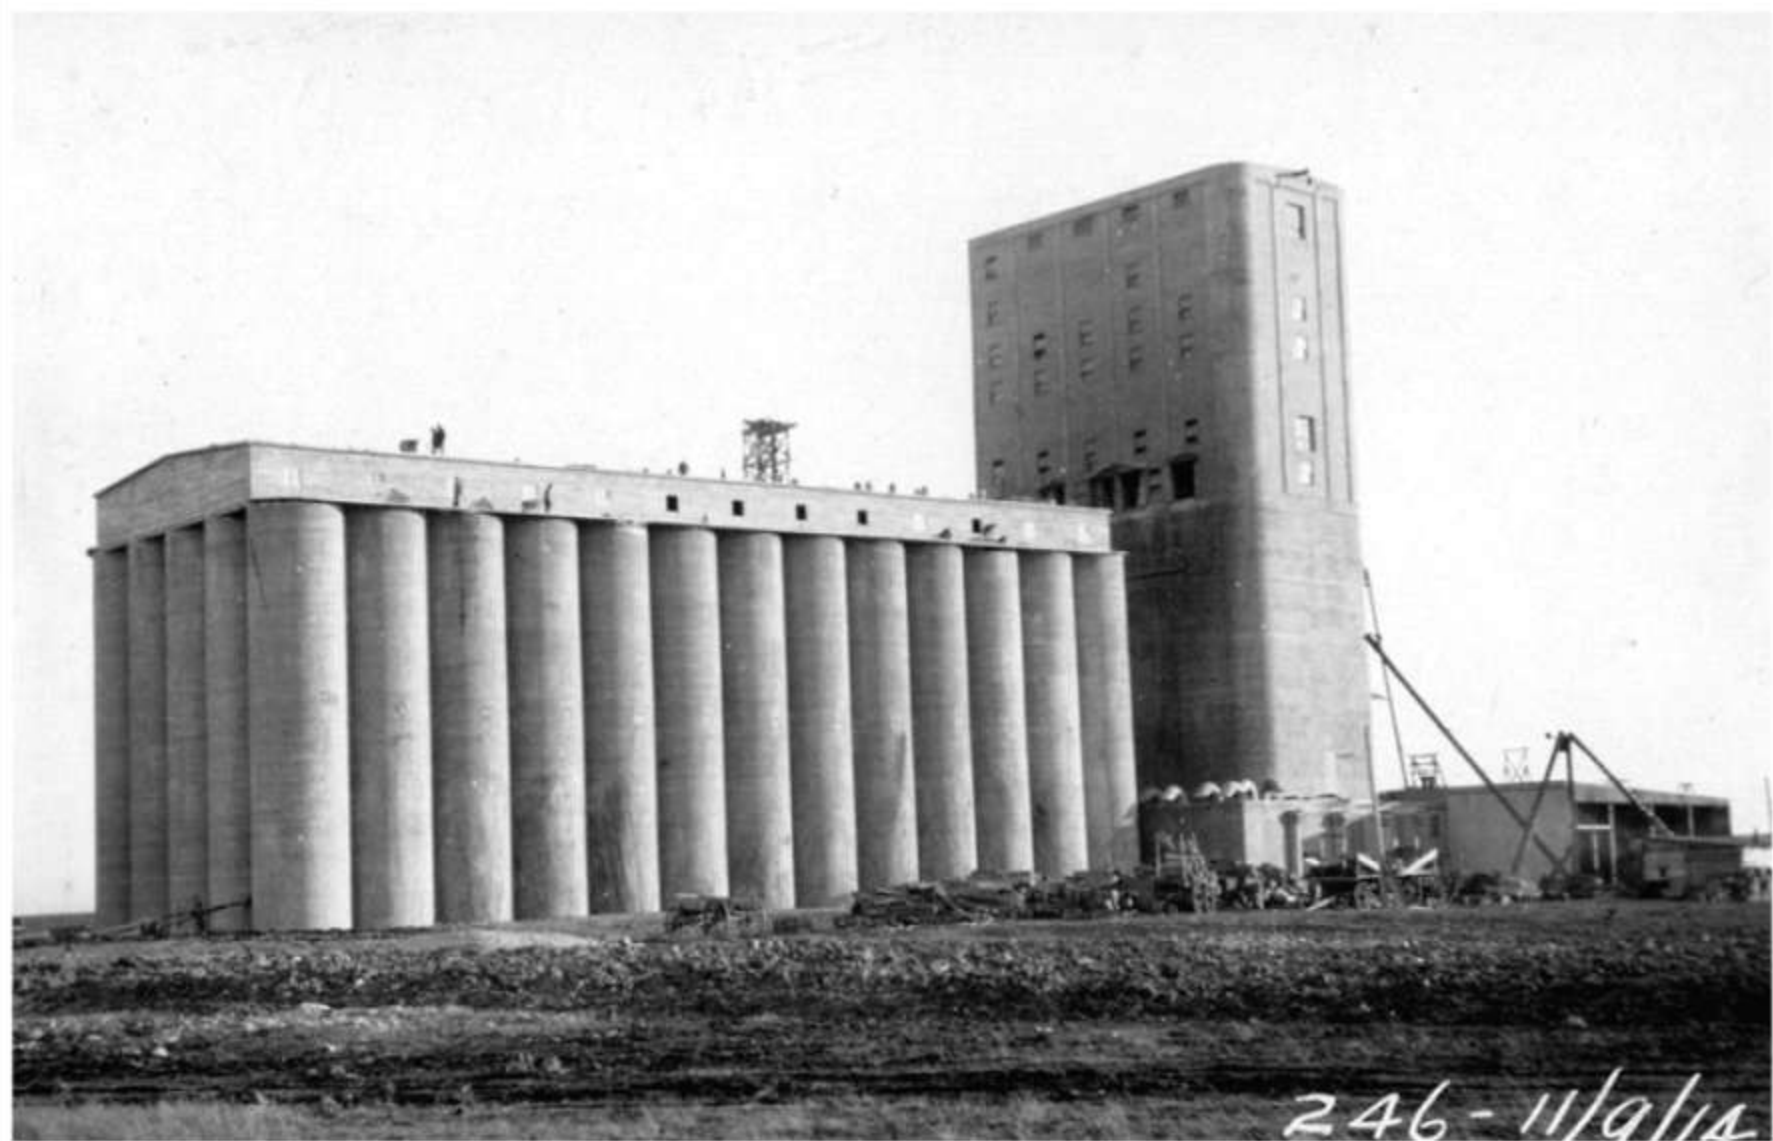
Northwest Corner of Bins After Righting

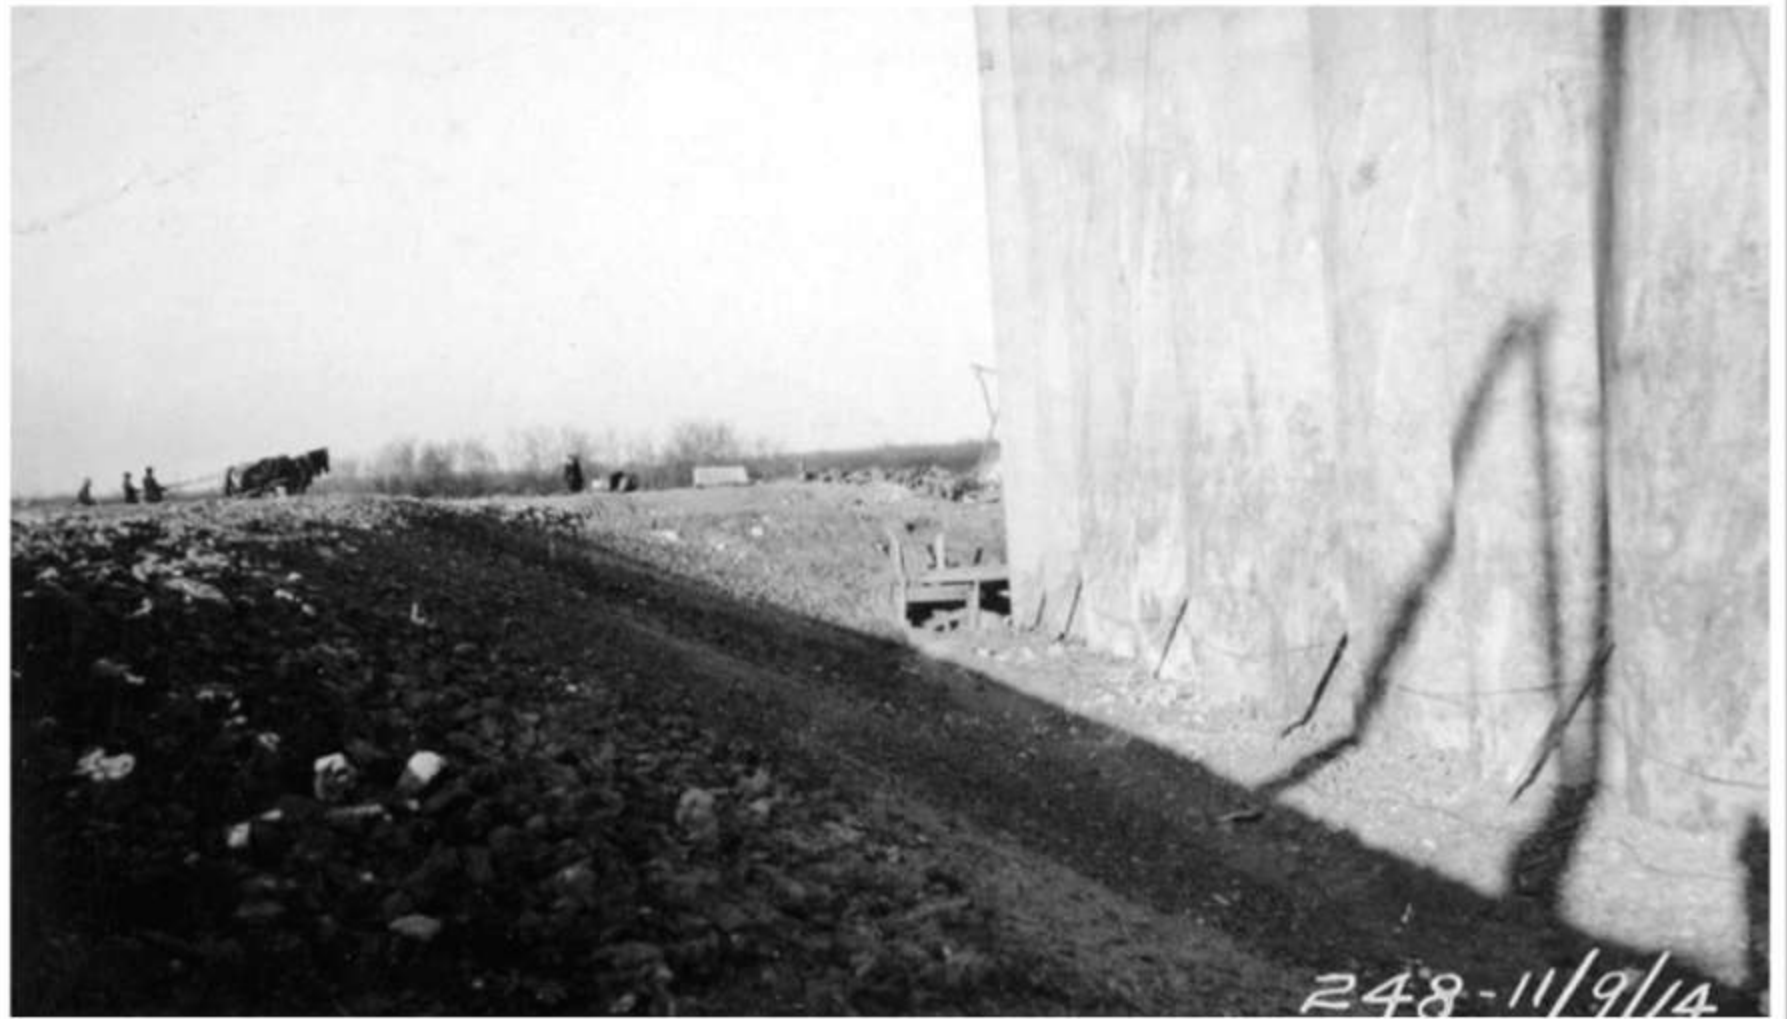
Grading West Side of Bins
